SOLUTIONS

Ford 3.8L Intake Manifold Isolator Bolts

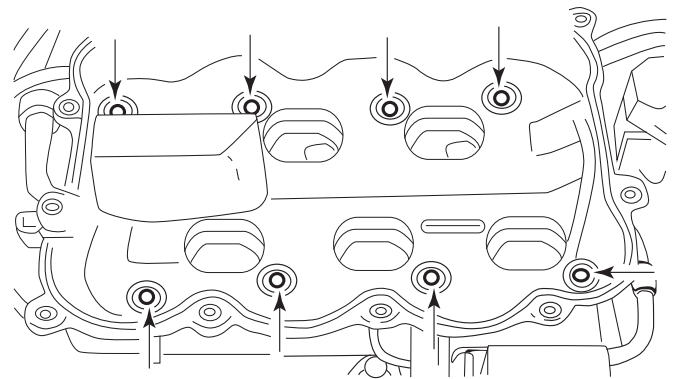
Upper Intake Manifold Spacer Bolt Set Location

Misfiring, hard start and poor fuel economy are all issues associated with lean drivability conditions. A check engine light with a Diagnostic Trouble Code (DTC) is a common problem for the 1999-2003 Ford Windstar equipped with the 3.8L VIN 4 engine. Very often leaking intake manifold isolator bolts cause this lean condition. Experienced technicians replace the eight (8) upper intake manifold isolator grommets at the same time they replace the intake manifold gaskets. A failure to replace the grommets will result in a repeat of the lean condition.

MAHLE Original has the new isolator bolts with Fluoroelastomer (green color) grommets in packages of eight (8) – available now! We also offer the isolator grommets separately from the bolts making it possible to reuse the bolts if you desire. No more wasted trips to the dealer or downtime waiting for a separate delivery. More importantly – no more expensive comebacks!
