## Issue no. 4/2014: Turbo tip—excessive crankcase pressure in vehicles with turbochargers 030TC14011000 or 082TC15850000

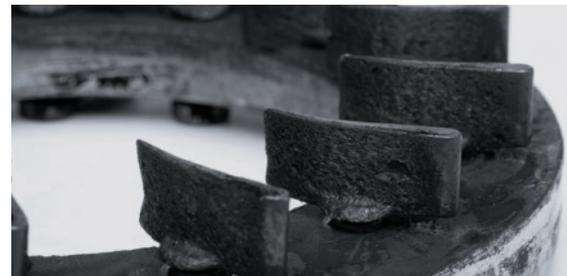
Our advice is therefore: check the pressure in the crankcase first. This can be determined using a pressure gauge on the guide tube of the oil dipstick. If the crankcase ventilation and oil mist separator are blocked or defective, the crankcase pressure increases. At an overpressure of a few millibars, engine oil is forced out of the turbocharger in the intake and exhaust gas tract—resulting in the above-mentioned symptoms. The oil that is forced out is burnt in the turbocharger and engine. As a further consequence, the mechanism of the VTG adjustment becomes sluggish and eventually clogged due to oil carbon build-up.

*VTG: heavy oil carbon build-up blocking the mechanism*

These problems cannot be resolved by merely replacing the turbocharger. The cause needs to be found and eliminated. In general, we recommend to systematically replace the oil mist separator along with the turbocharger.
