Turbochargers

Damage scenarios,
causes, remedies, and avoidance

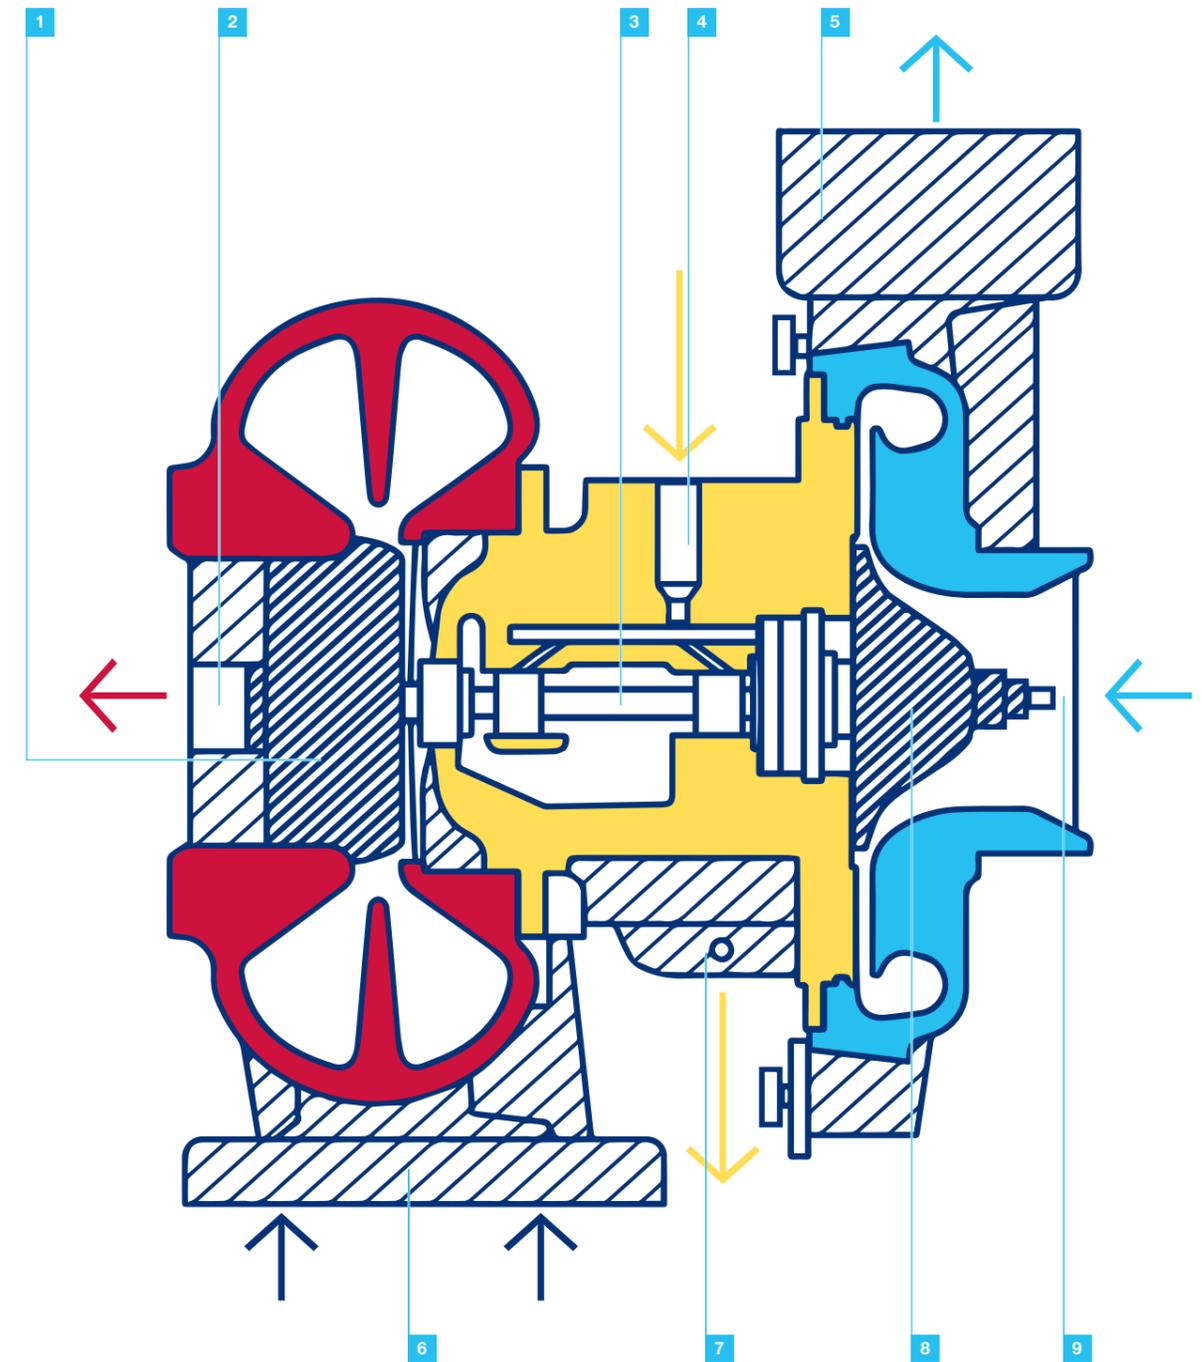
A successful repair depends on analyzing and eliminating the cause of the failure. Otherwise, the new turbocharger might fail again after a short period of time.

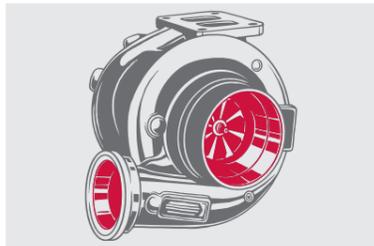
Lack of lubrication is one of the most common causes of turbocharger failure. If the turbocharger is supplied with too little oil, damage will occur within a very short time. This is due to the turbocharger's very high rotational speeds.

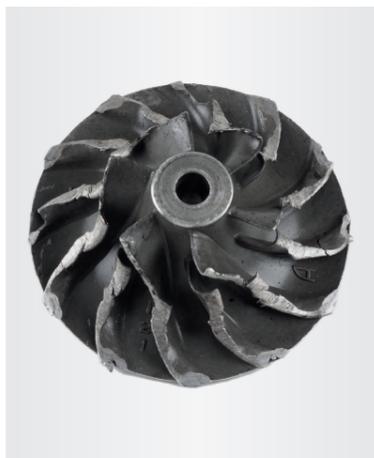
Fig. 1
Impeller after contact with housing

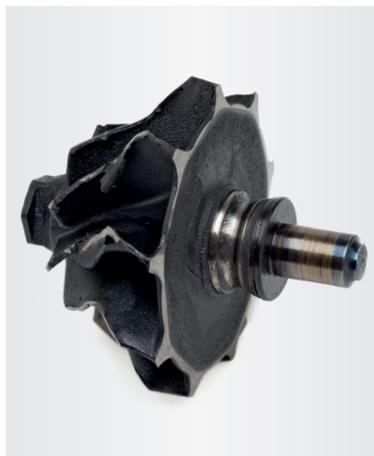
Fig. 5
Broken shaft shank

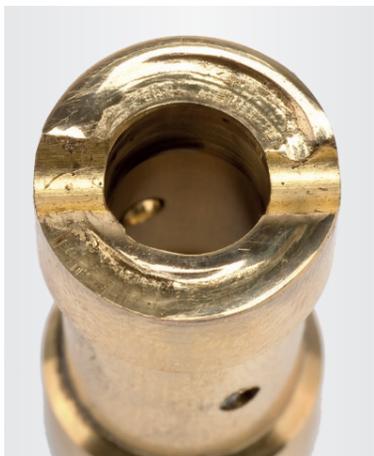
Fig. 6
Twisted bushing

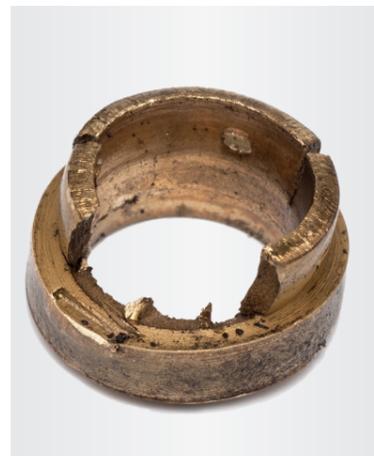
Fig. 7
Broken radial bearing

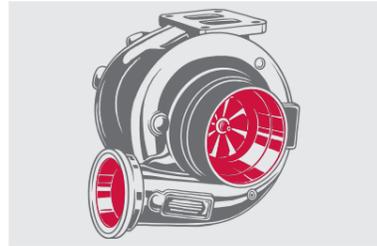
Dirt, soot, fuel, water, combustion residues, or metal abrasion can contaminate the oil. Even the smallest particles in the oil can cause serious damage to the turbocharger due to its extremely high rotational speeds.

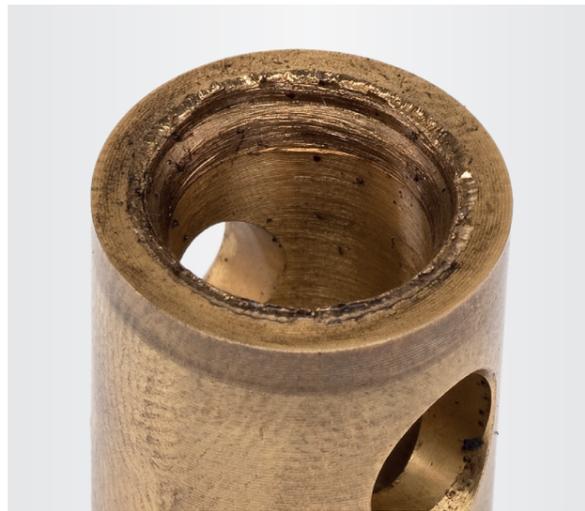
Fig. 1
Grooves in the radial bearing

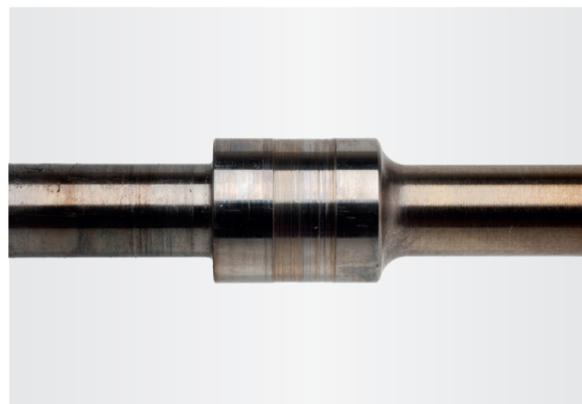
Fig. 4
Clear signs of wear on the shaft at the bearing point

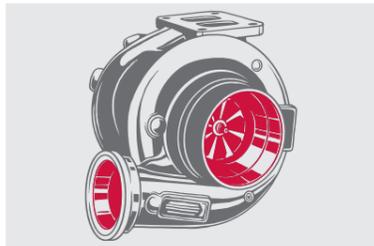
If the engine shows signs of increased oil consumption and emits blue smoke, the turbocharger should definitely be included in the root cause analysis. Important: Oil from a turbocharger is only forced out of the housing if there are different operating conditions in its environment.

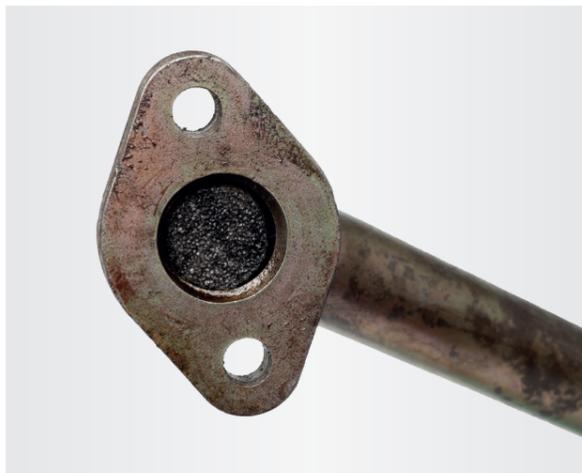
Fig. 1
Carbonized oil return line

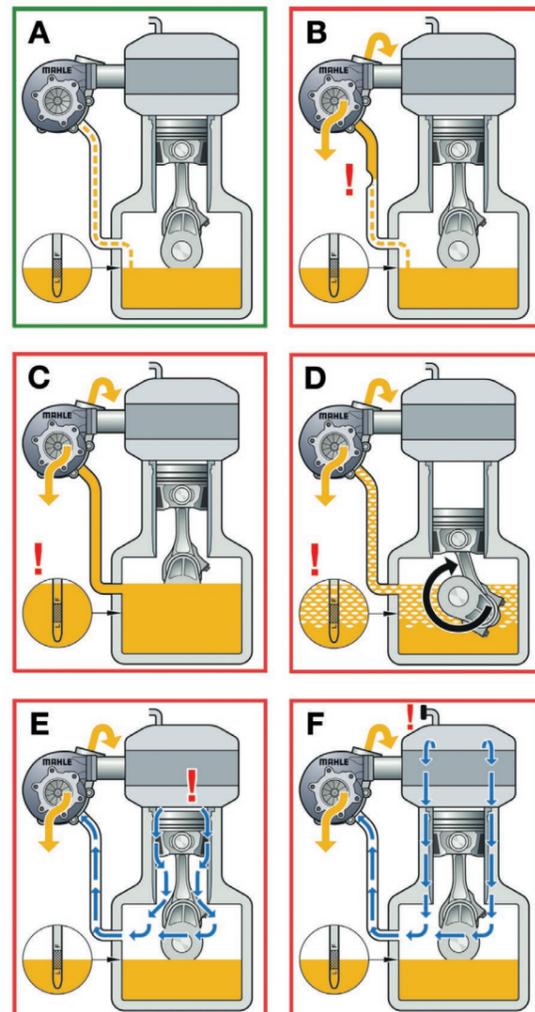
Fig. 2
Oil leaking from the turbocharger; diagram A shows the optimum state

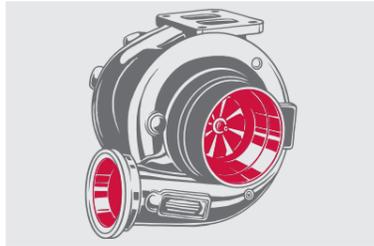
If foreign objects, such as dust, sand, screws, parts of piston rings or valves, and deposits, enter on the intake or exhaust side, this usually leads to total failure of the turbocharger due to the very high rotational speeds. Damage to the charge air cooler can also occur.

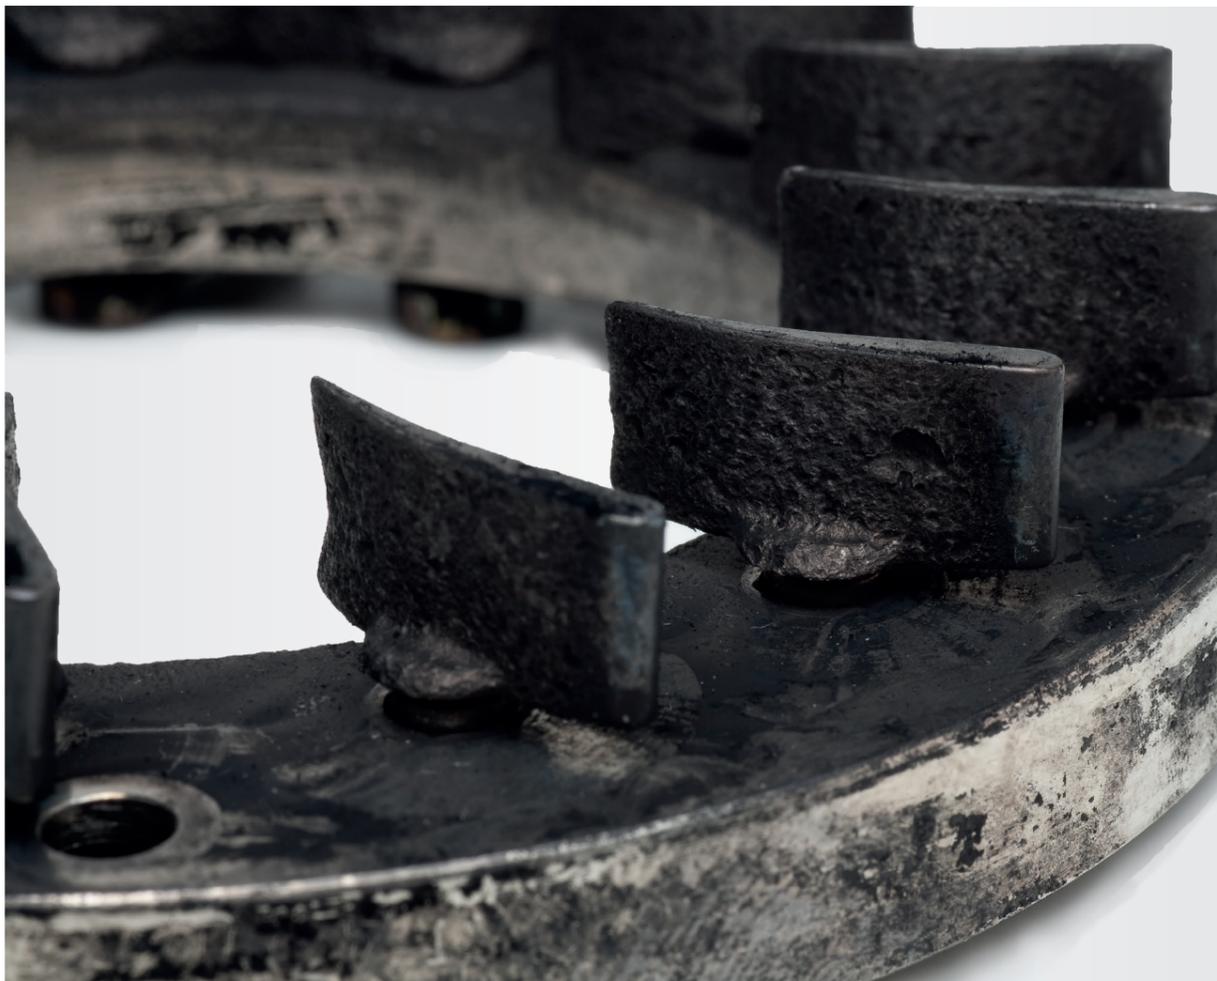
Fig. 1
Damaged air guide plates on a VTG unit

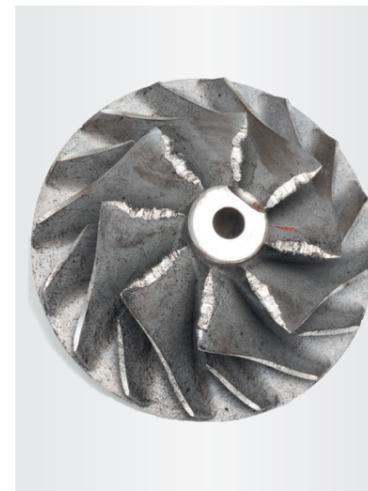
Fig. 2
Impeller damaged by foreign objects

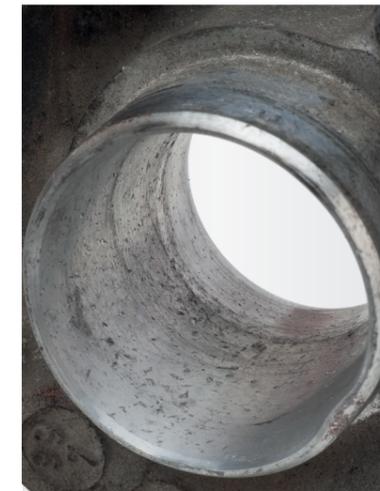
Fig. 3
Foreign object impact in the compressor housing intake passage

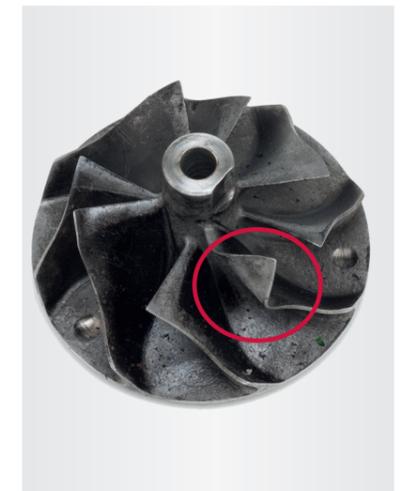
Fig. 4
Only one vane of the impeller damaged

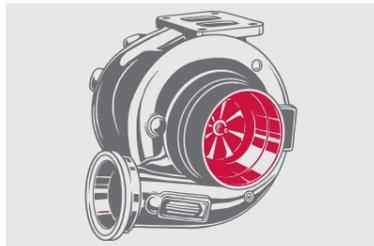
Each turbocharger is designed to operate within a defined temperature range. If this is exceeded, the turbocharger can fail after just a few seconds.

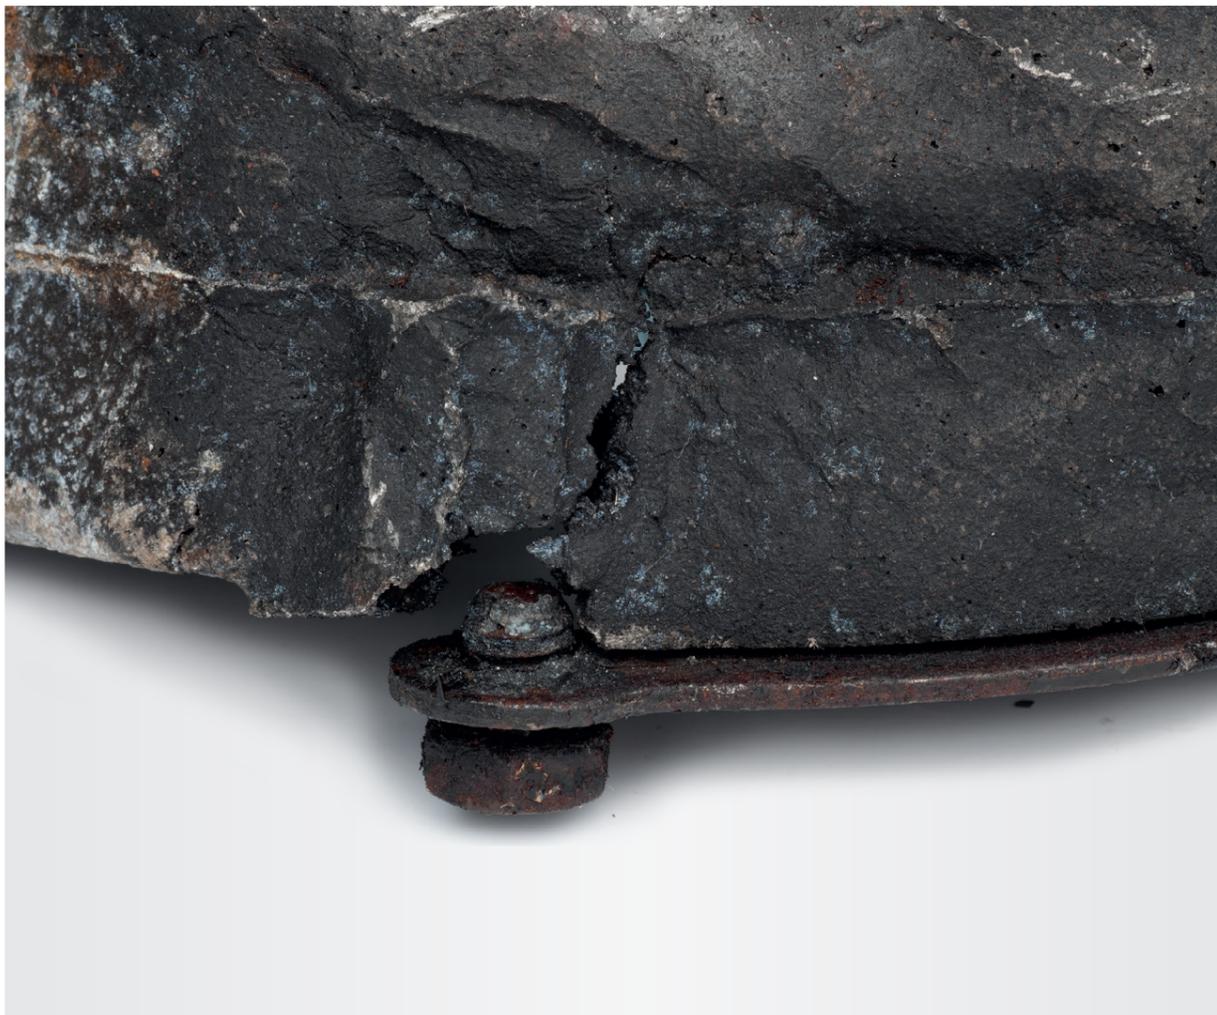
Fig. 1
Crack in the turbine housing

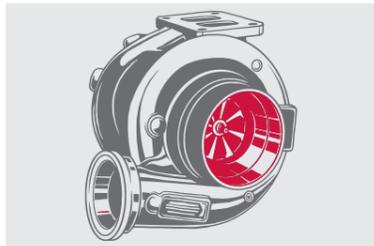
The parts installed in the turbocharger are designed for a defined speed range. If this range is exceeded, major turbocharger damage can occur within seconds.

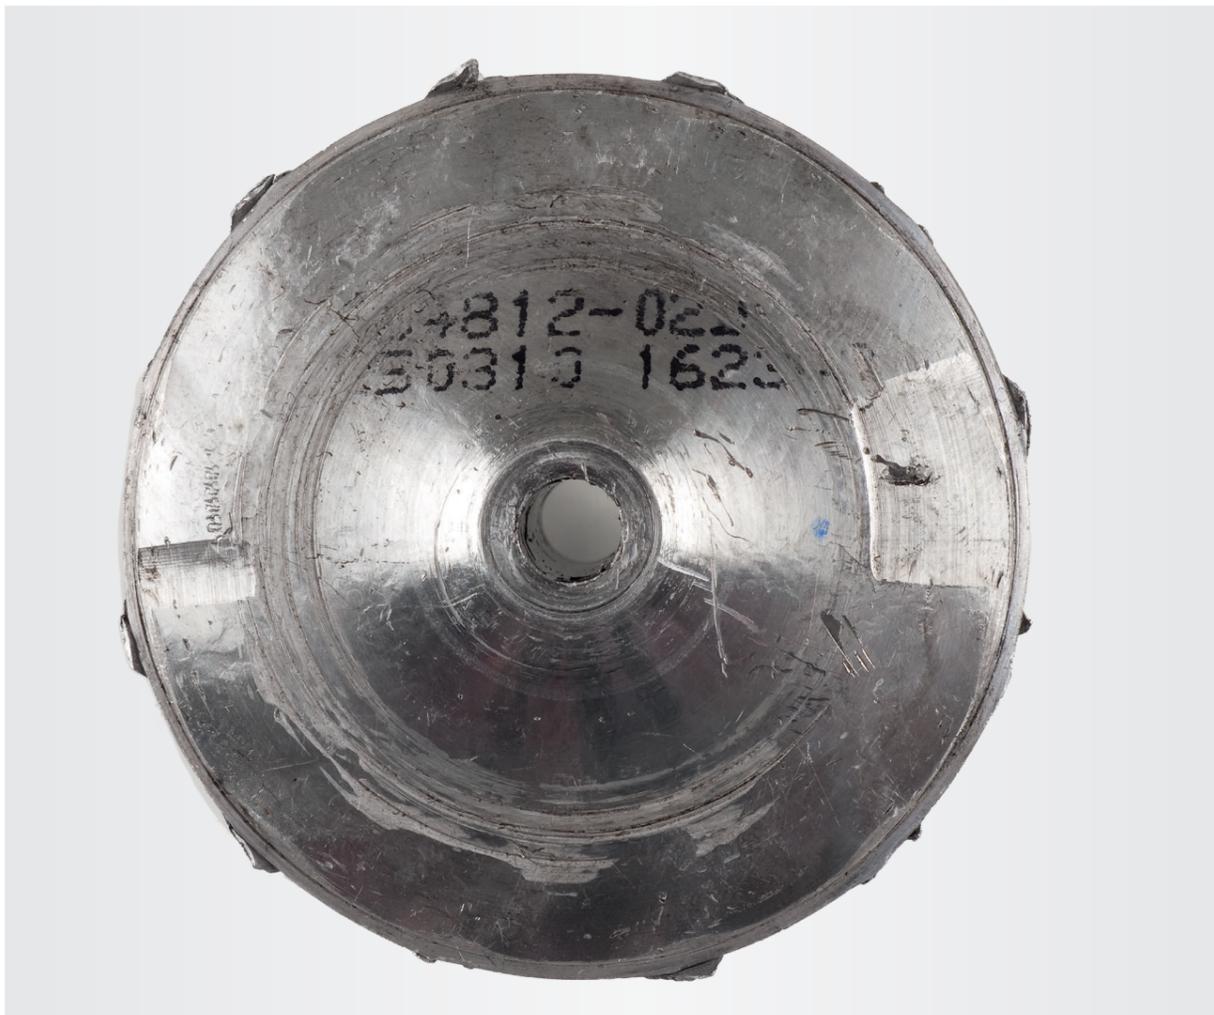
Fig. 1
Dents on the rear of the impeller

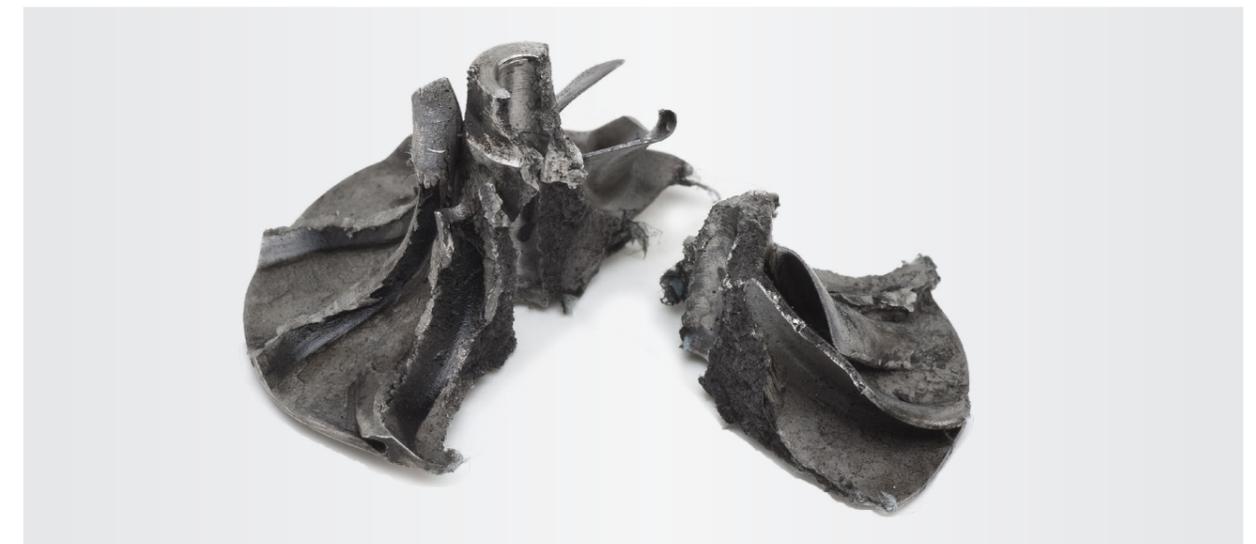
Fig. 2
Broken-apart impeller
