# Engine components

Damage scenarios:  
Causes, remedies, and avoidance

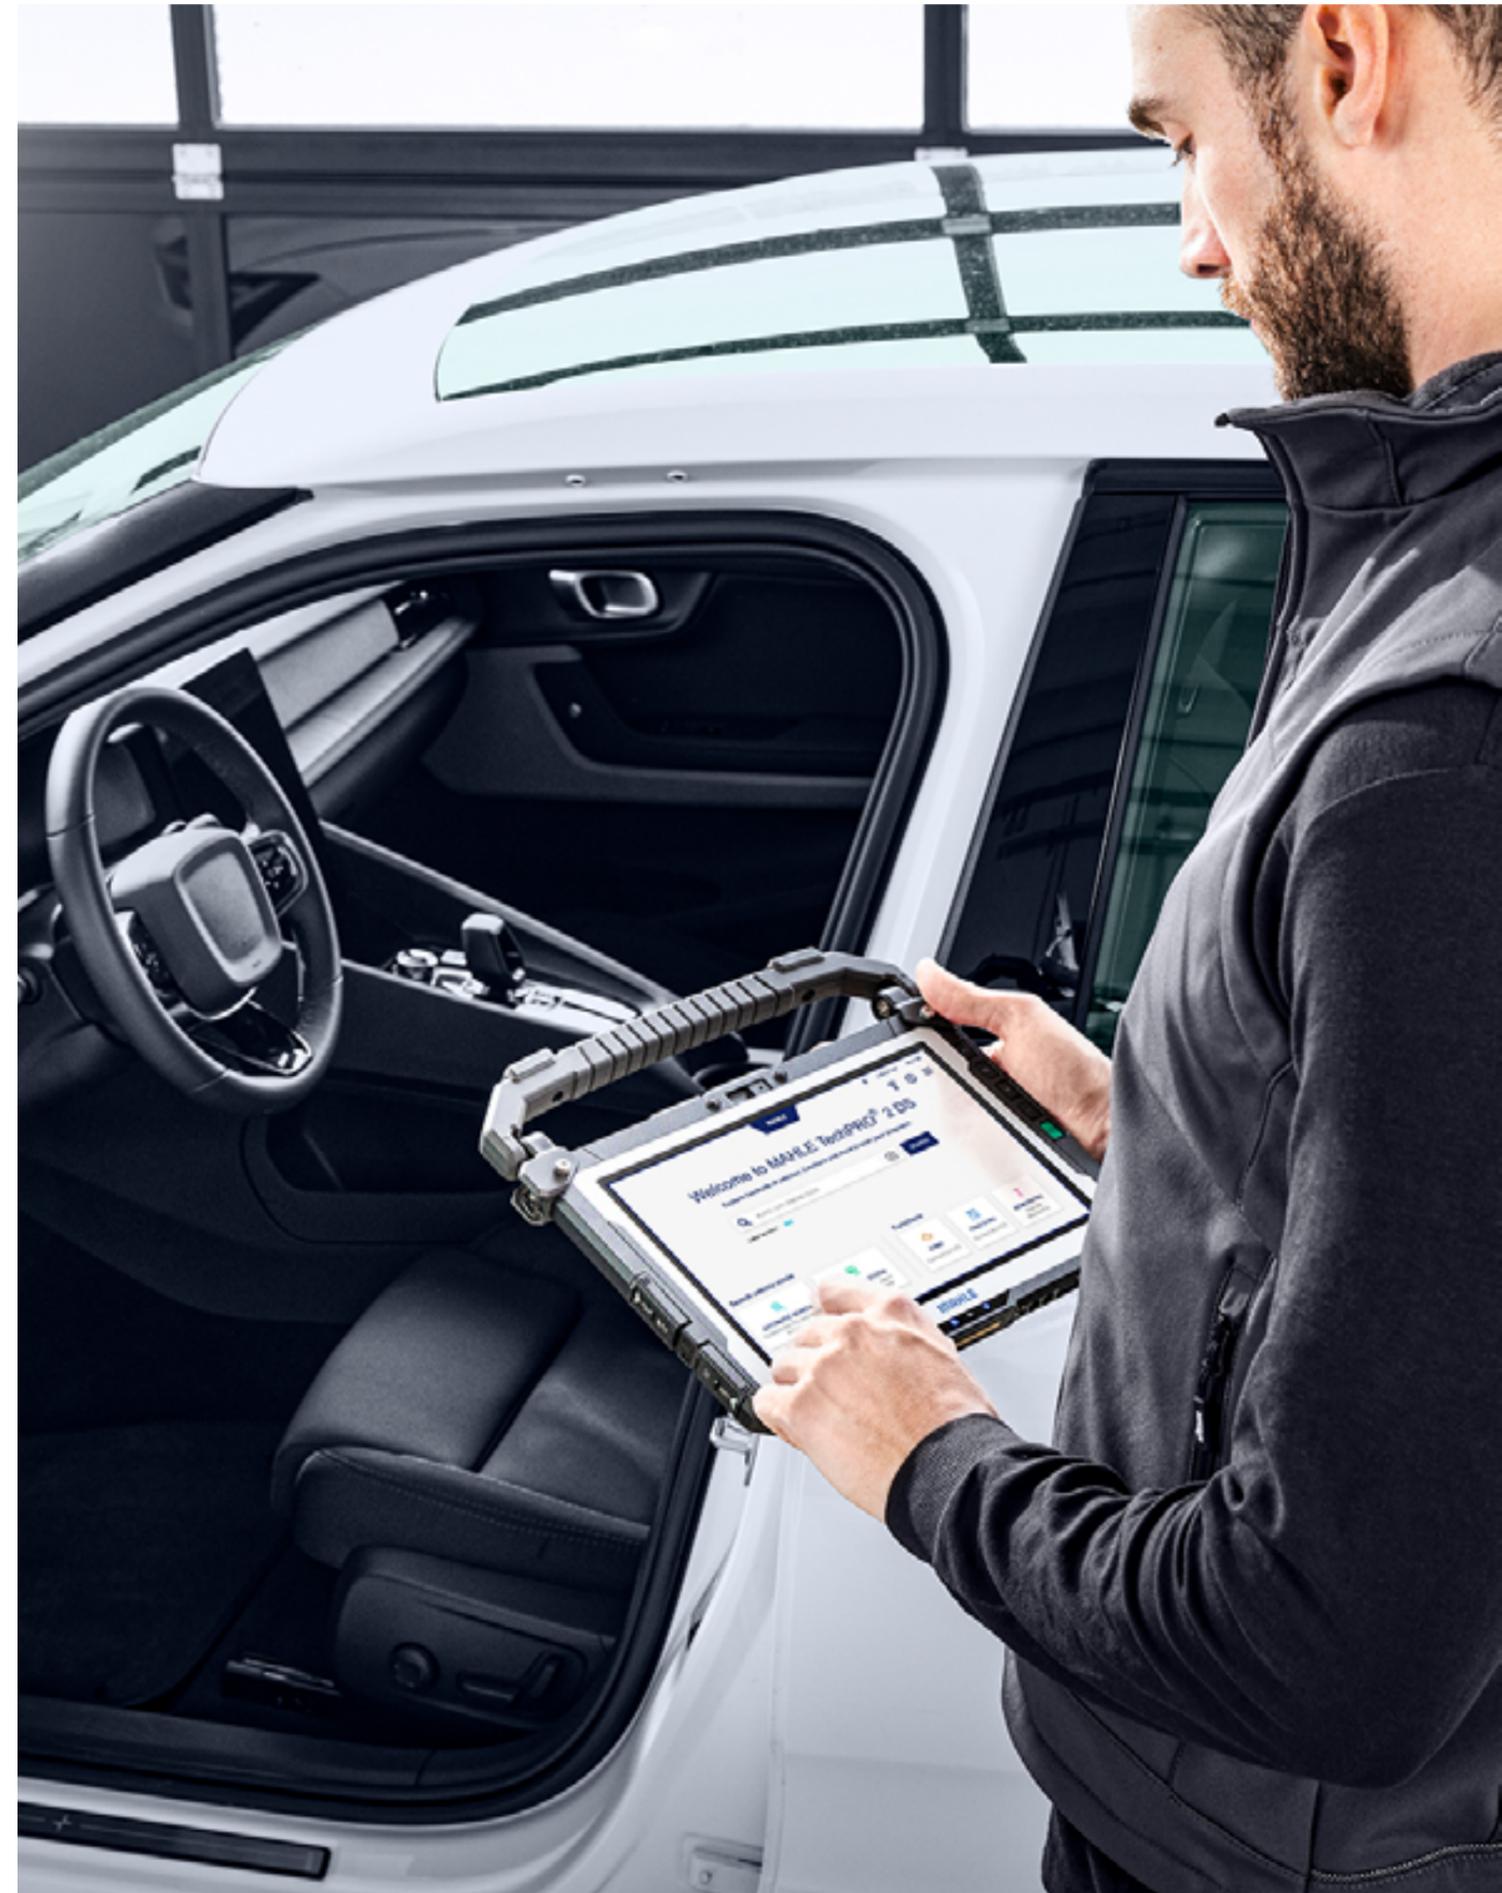
Our experts are also confronted with complex damage scenarios that go beyond the scope of this brochure. In cases where damage to our products cannot be readily diagnosed, we are more than willing to examine them at our premises and put together an expert damage report for you. Please contact your local sales partner.

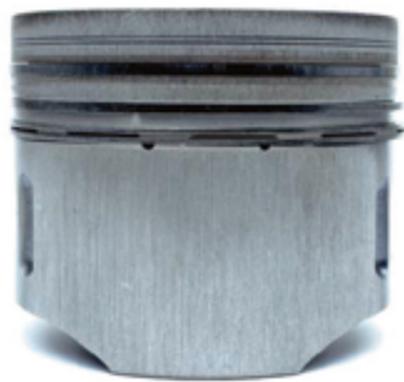
Fig. 1: Wear on the piston caused by contamination—deep longitudinal grooves

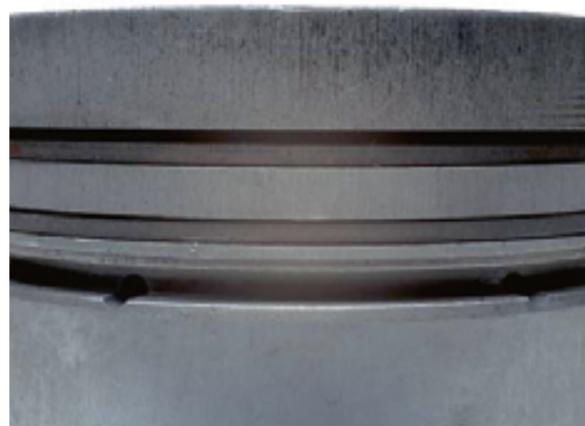
Fig. 2: Axial wear on the piston rings

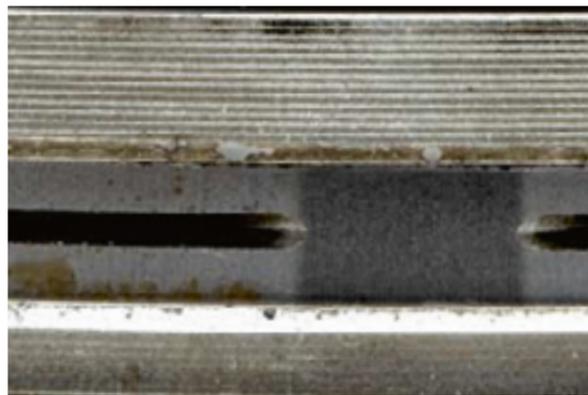
Fig. 3: Severely worn oil control ring

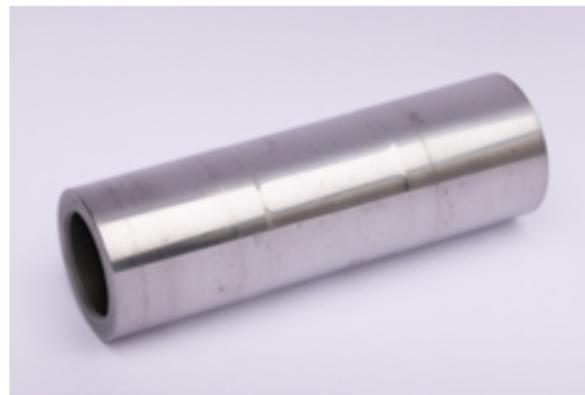
Fig. 4: Worn piston pin

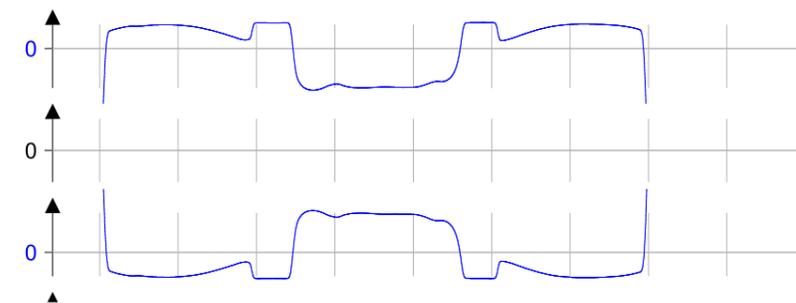
Fig. 5 Mantle lines on a piston pin

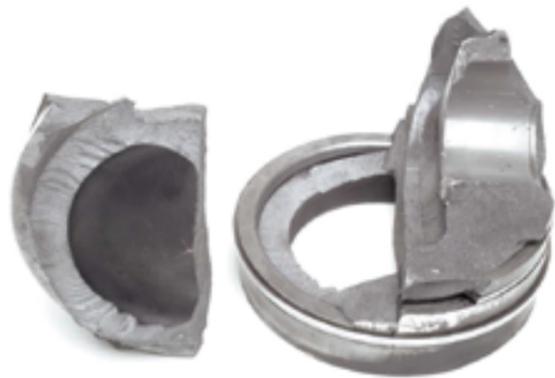
Fig. 1: Piston in a commercial vehicle shattered due to hydraulic lock

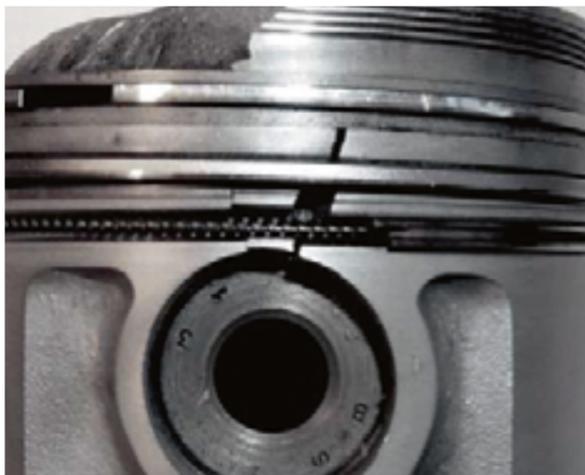
Fig. 2a: Forced fracture from the top of the piston to the pin bore

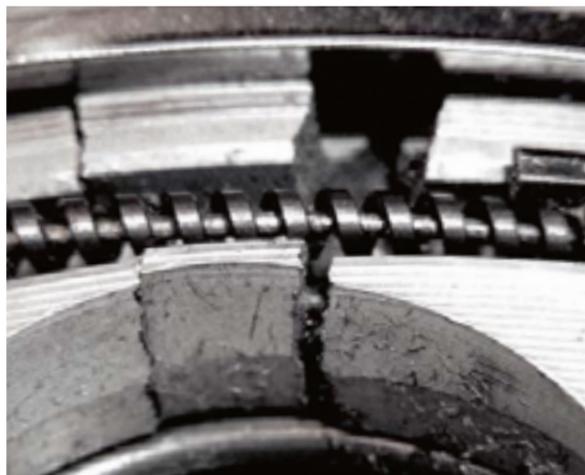
Fig. 2b: Close-up of a forced fracture

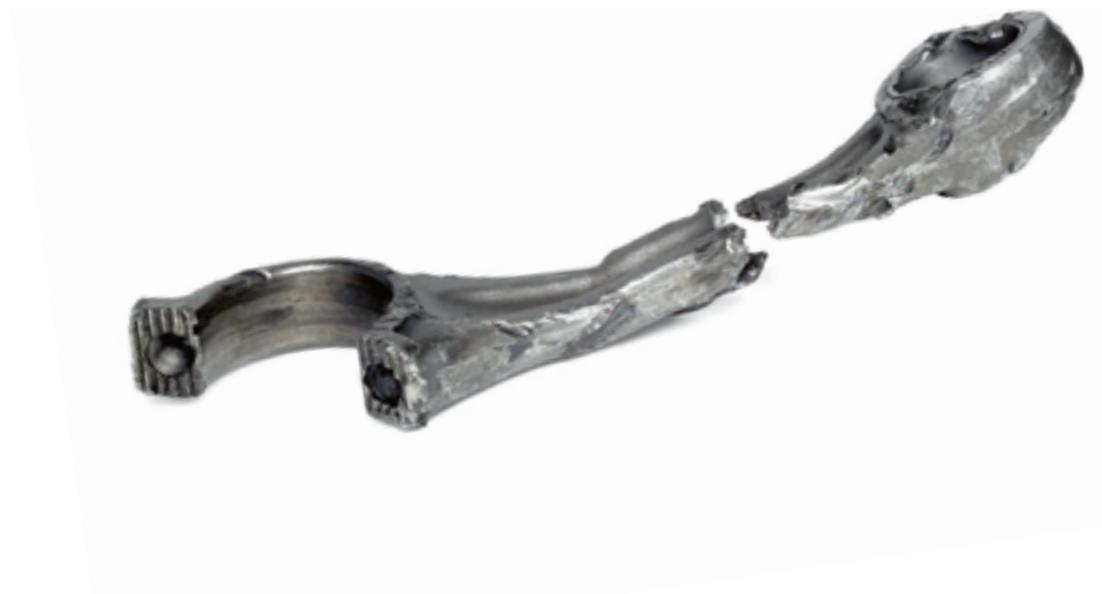
## 1.4 Increased oil consumption

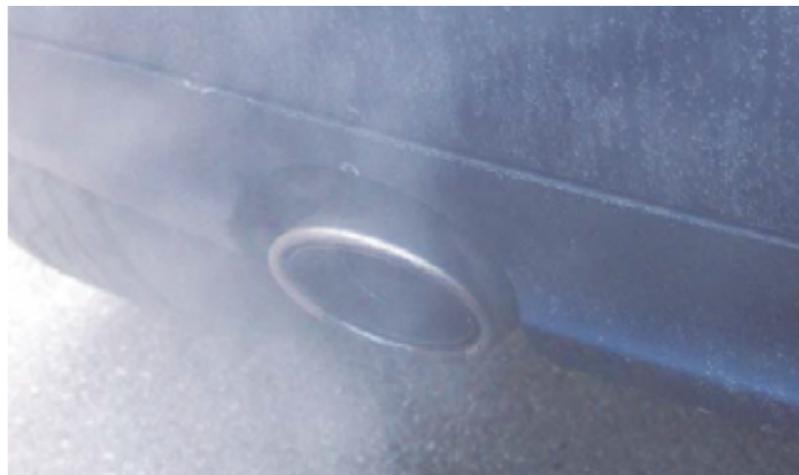
Fig. 2: Smoky tailpipe

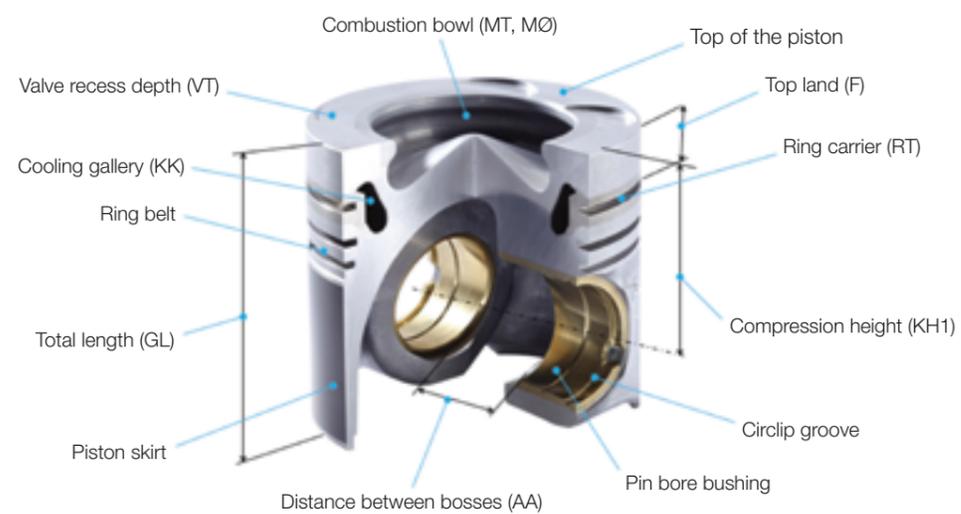
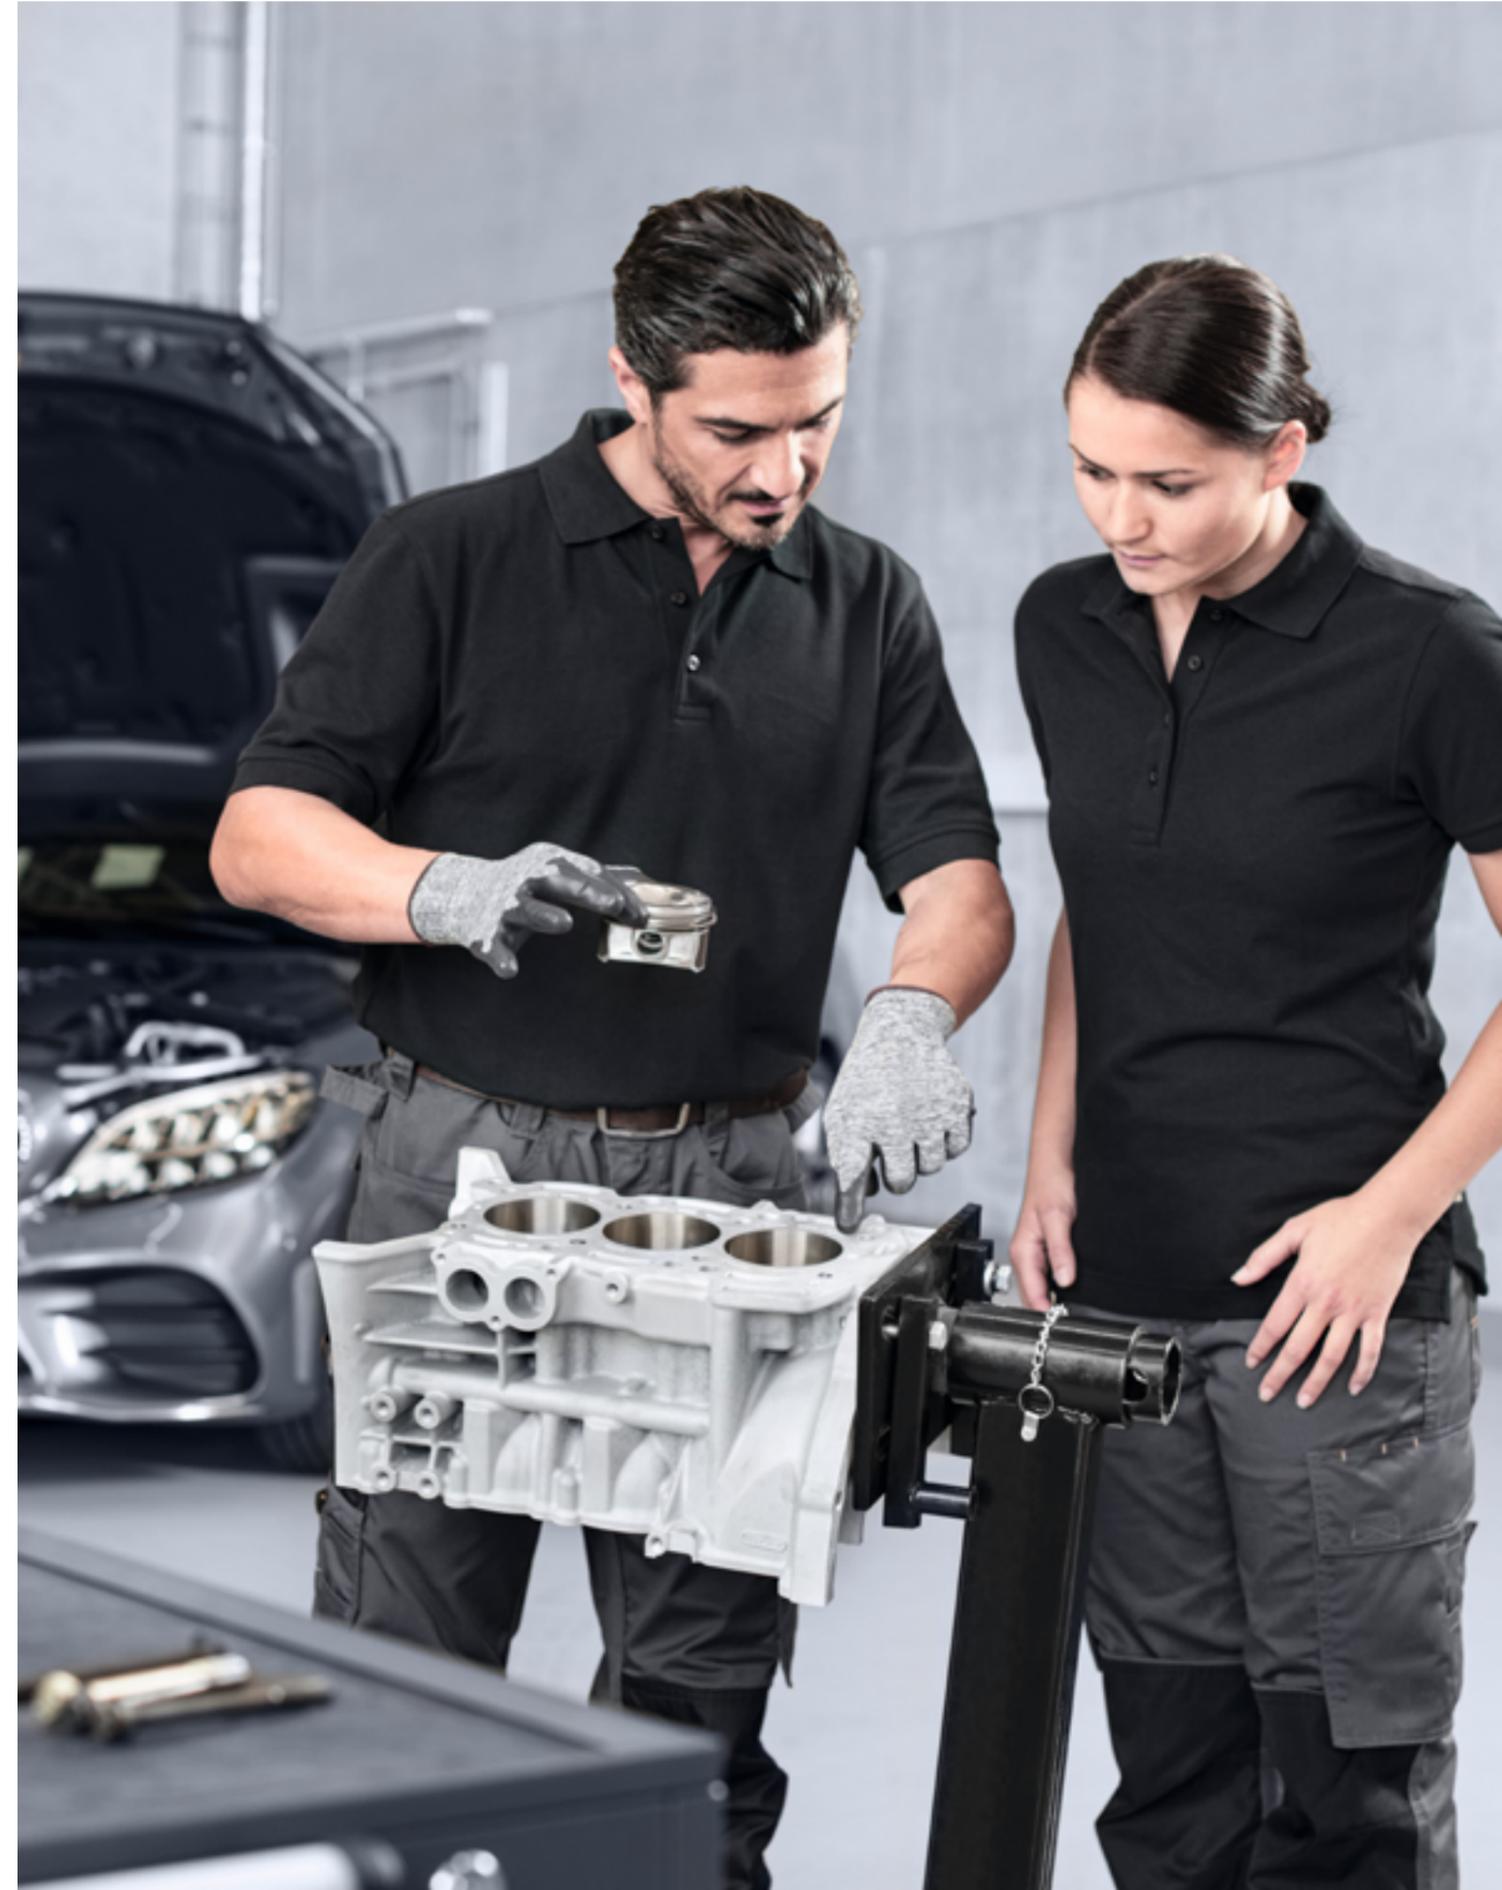
When installing the piston, it is important to take note of the installation direction. The gaps on the individual piston rings should be evenly distributed around the circumference. The circlip must be fitted so that the gap faces upward or downward. The cylinder bore or the pistons and the rings must be oiled. To avoid damage when installing the piston in the cylinder bore, a suitable tool must be used (e.g., ring sleeve).

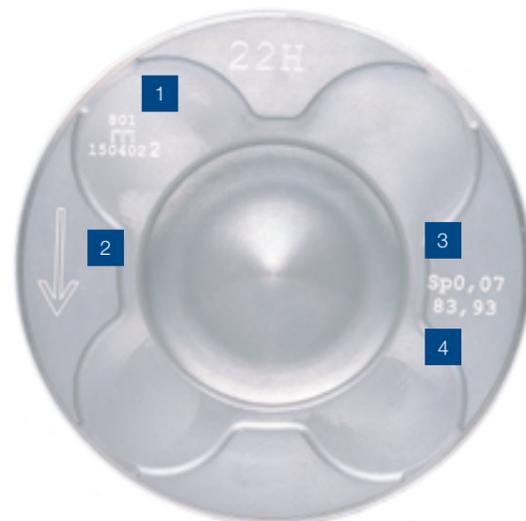
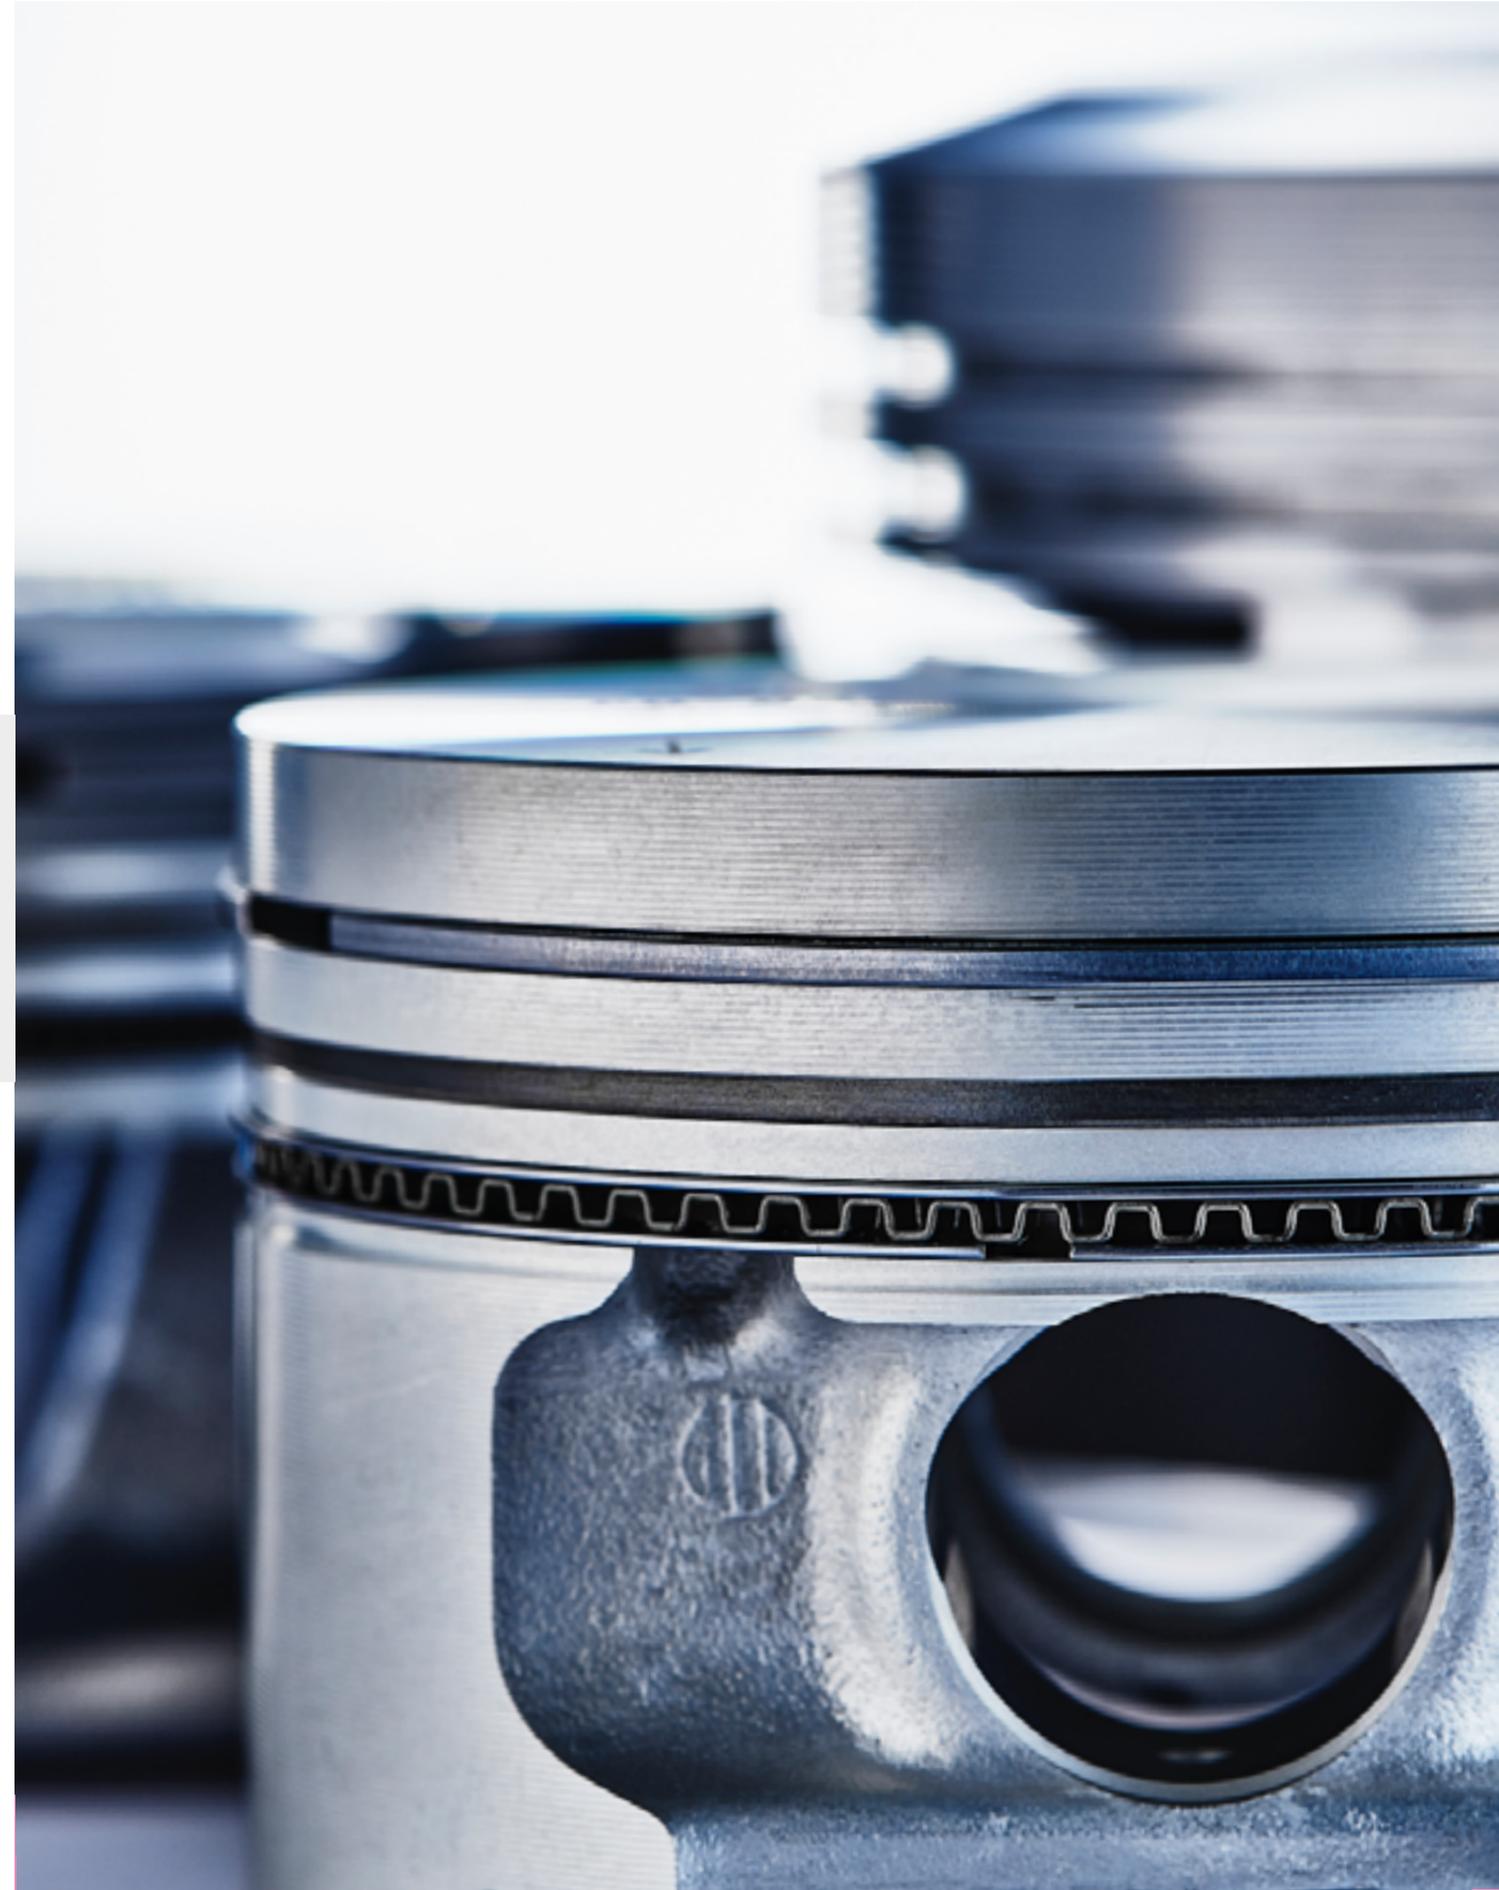
## 2.1.1 Hole burned through the top of the piston

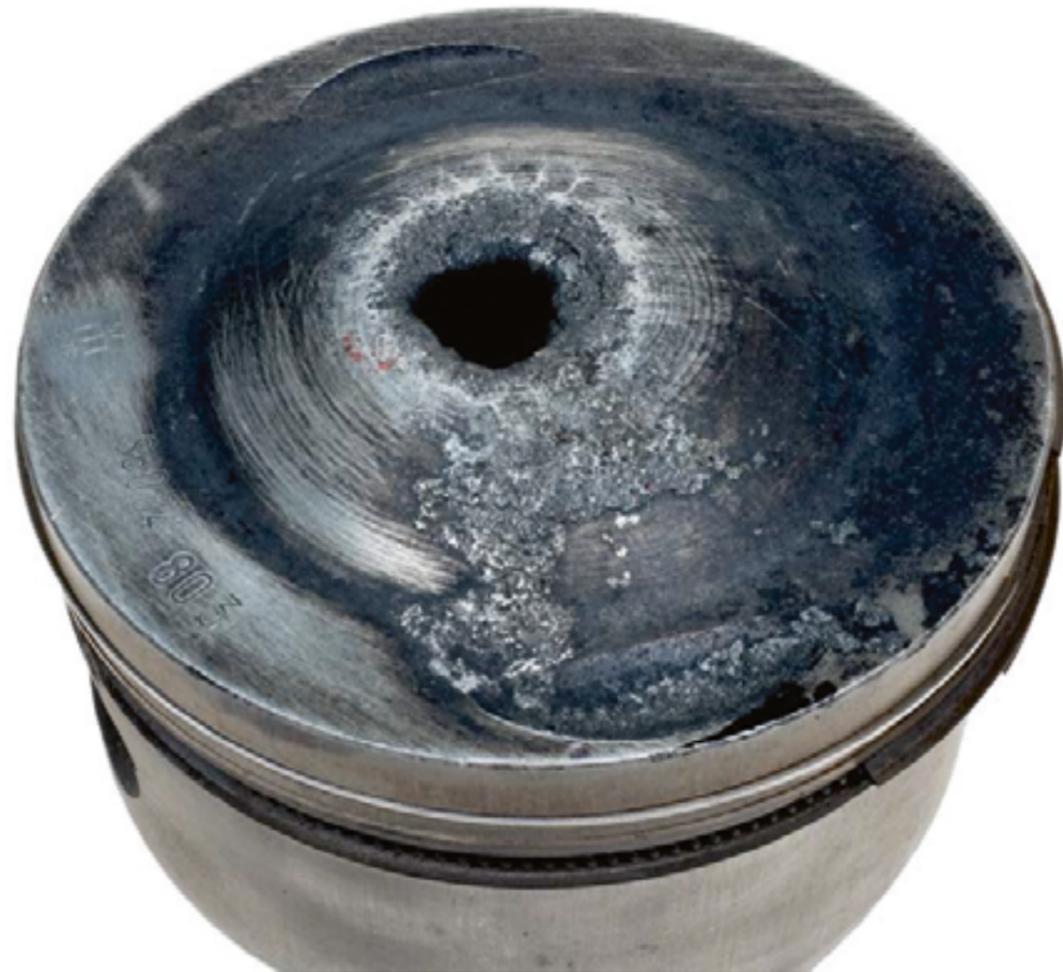
Fig. 1: Hole in the top of the piston caused by using spark plugs with the wrong heat rating

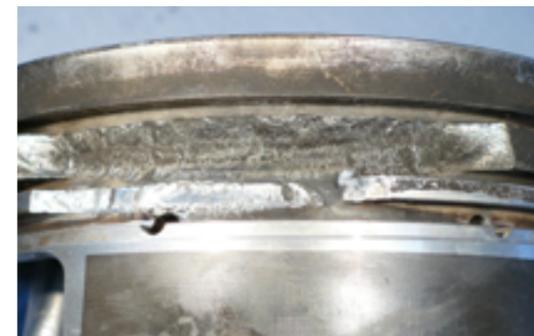
Fig. 3: Fractured ring land

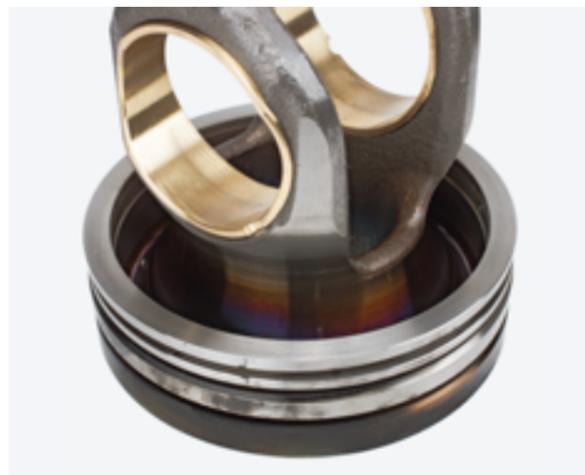
Fig. 3: Discoloration on a FERROTHERM® piston caused by overheating

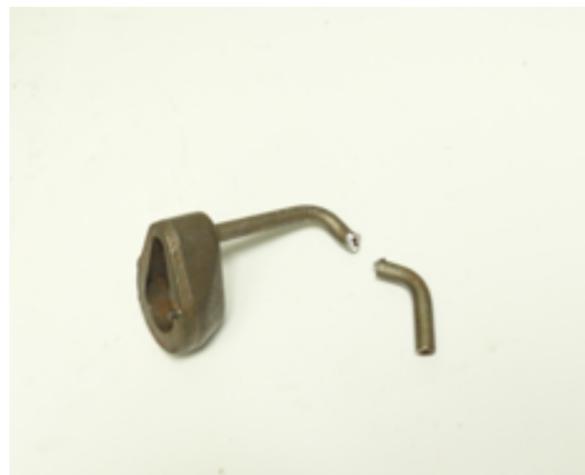
Fig. 4: Broken cooling oil nozzle

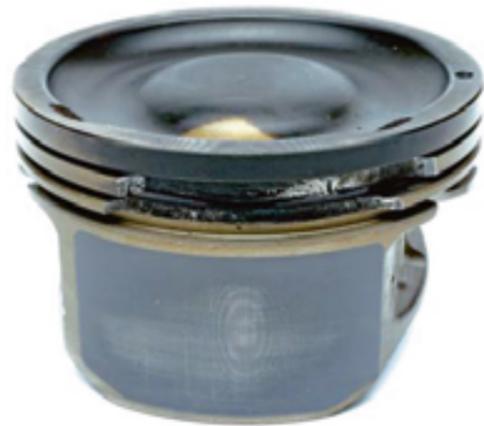
Fig. 1: Broken piston ring lands due to a malfunction in the combustion process

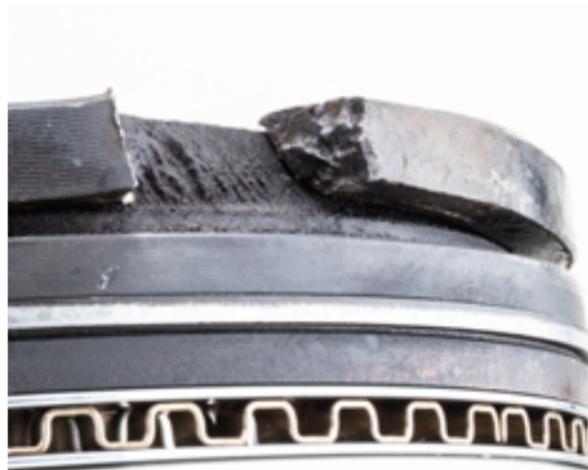
Fig. 2: Forced fracture in the top land

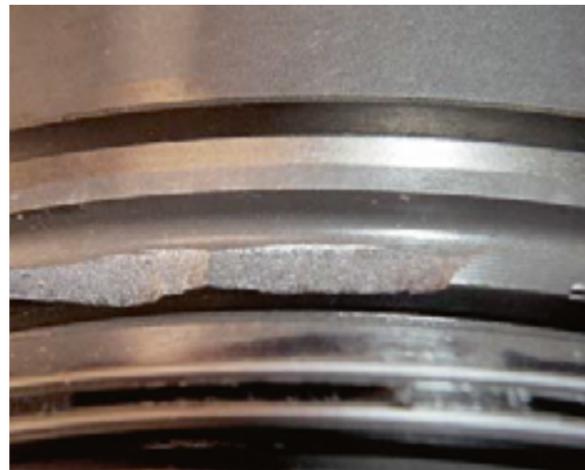
Fig. 3: Fracture running from bottom to top

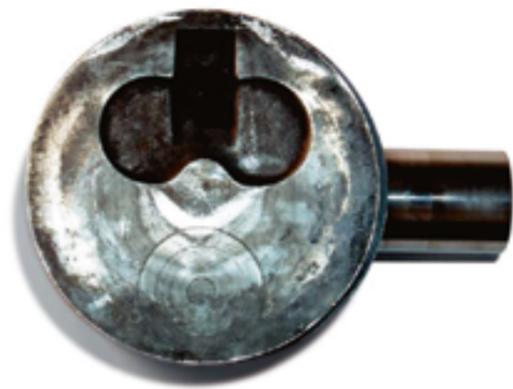
Fig. 1: Top of the piston with valve impact mark

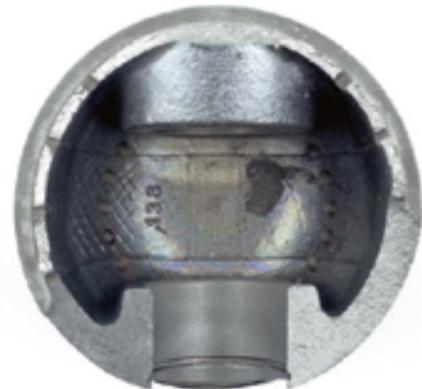
Fig. 3: Piston broken off at a right angle in line with the piston pin axis

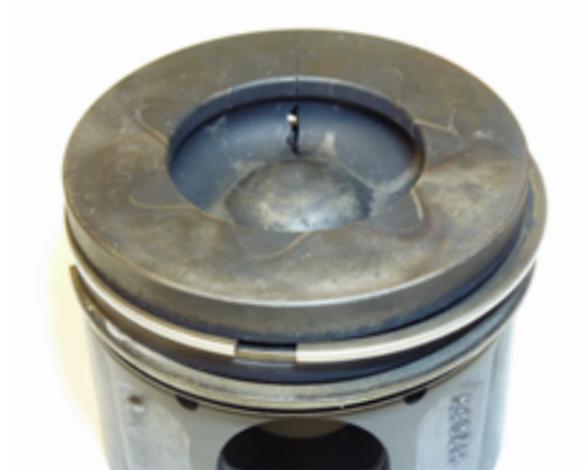
Fig. 1: Cracks in the bowl rim

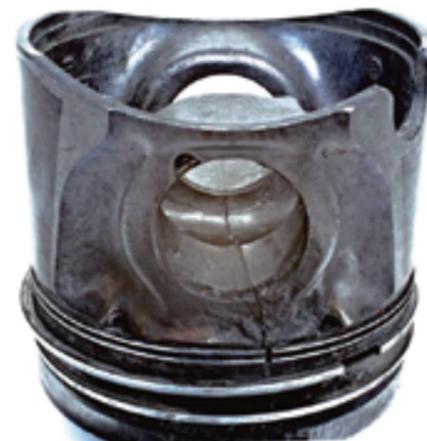
Fig. 2: Piston fractured right into the pin bore

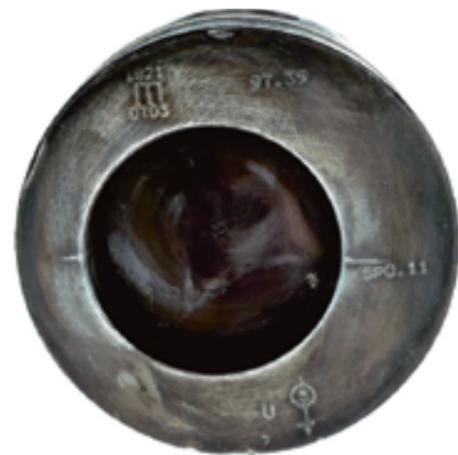
Fig. 3a: Cracks in the bowl rim

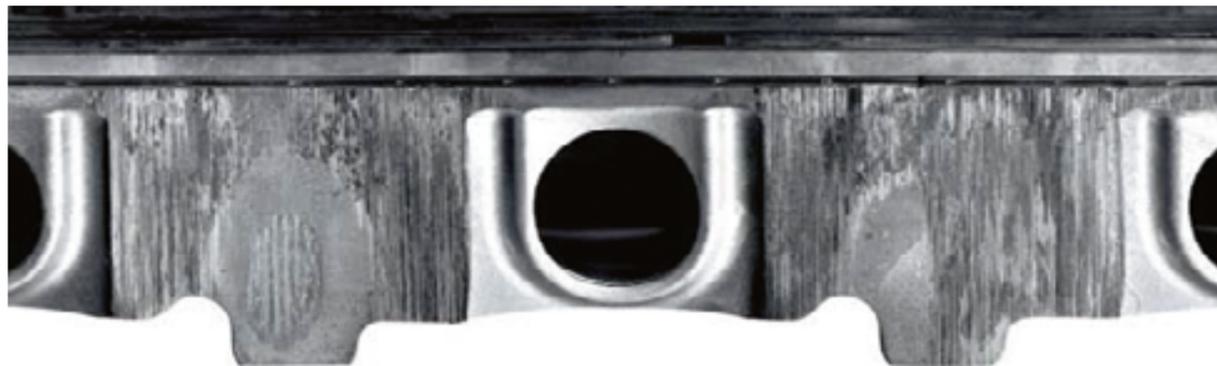
Fig. 2: Seizure marks on the piston skirt, caused by lack of clearance

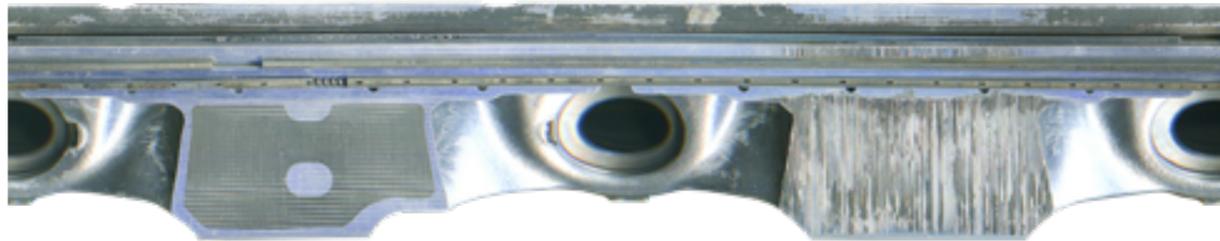
Fig. 1: Seizure marks on one side

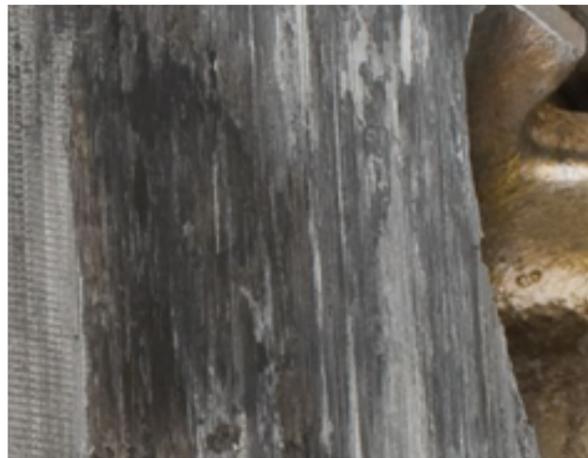
Fig. 1: Diagonal seizure marks next to the pin bore

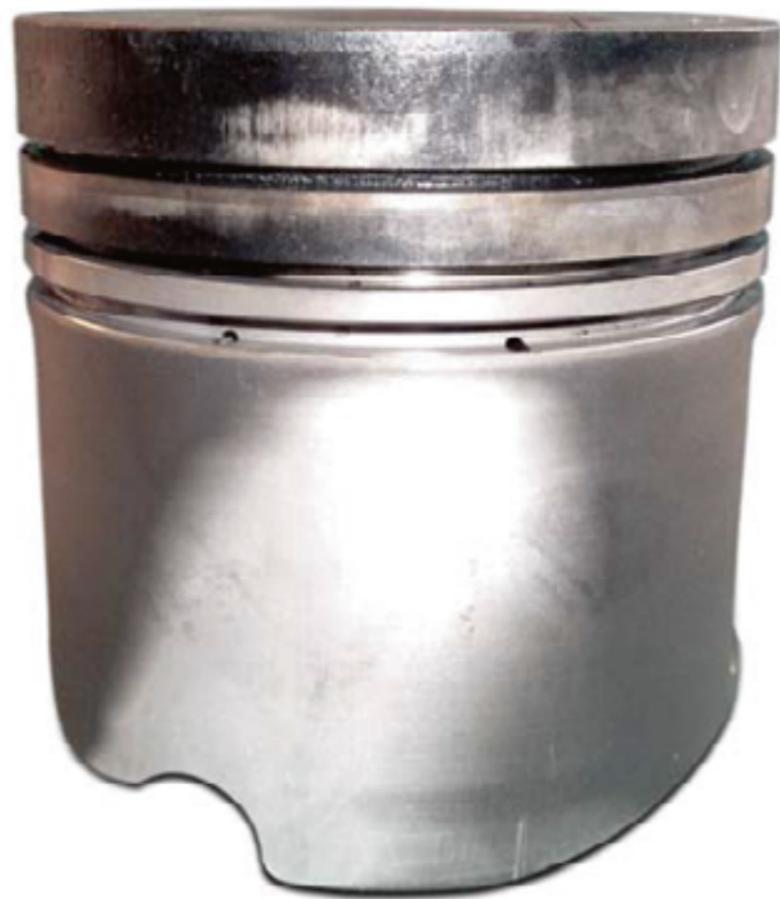
Fig. 1: Asymmetrical wear pattern (slanting) on the piston skirt

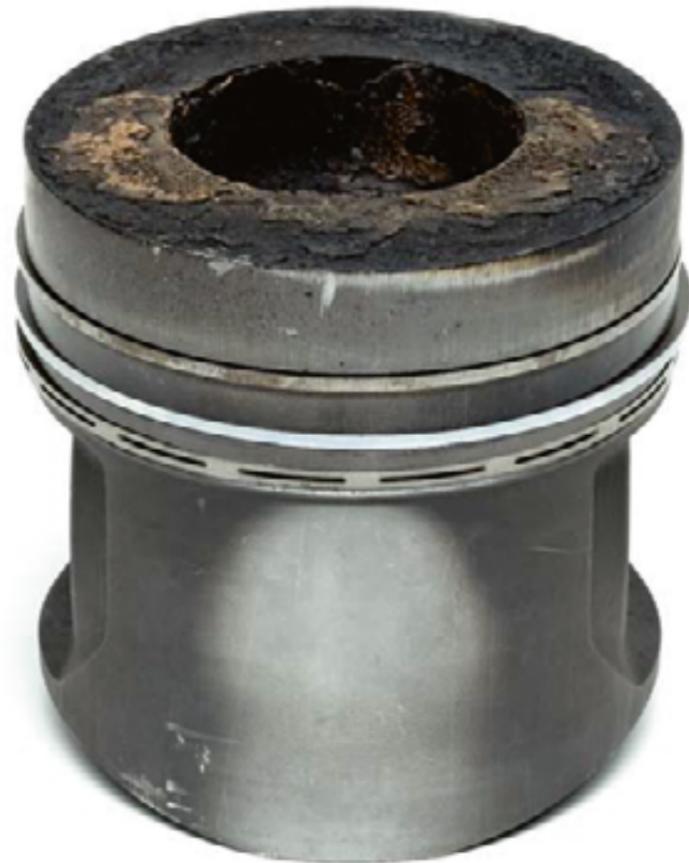
Fig. 1: Wear on the piston skirt caused by contamination

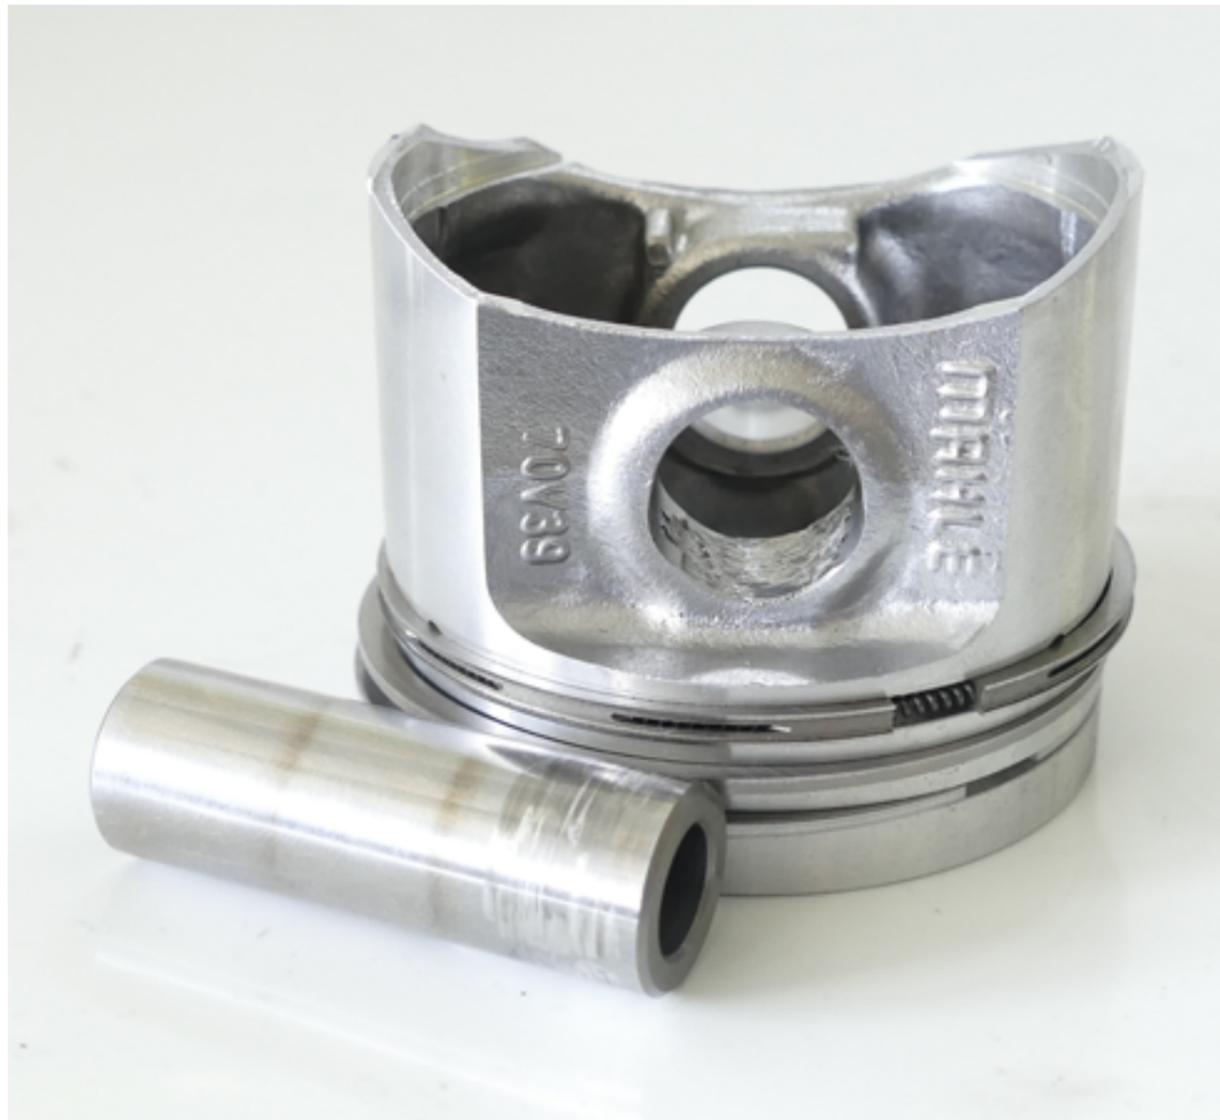
Fig. 1: Seizure marks in the pin bore

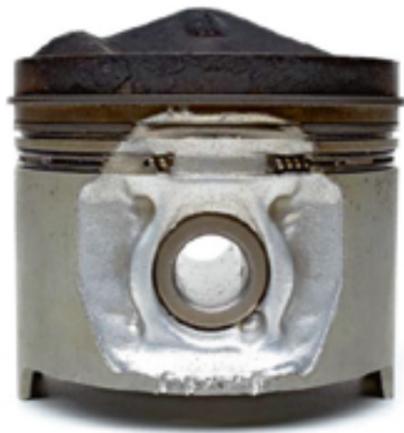
Fig. 1a: Cratered piston wall caused by a loose piston pin circlip or foreign matter in the bore of the piston pin

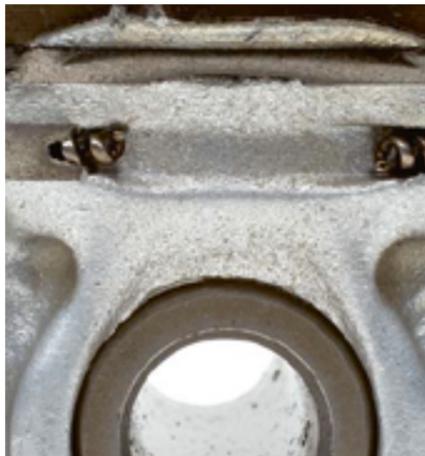
Fig. 1b: Close-up surface view of softer piston material and harder piston ring material that are worn to the same extent

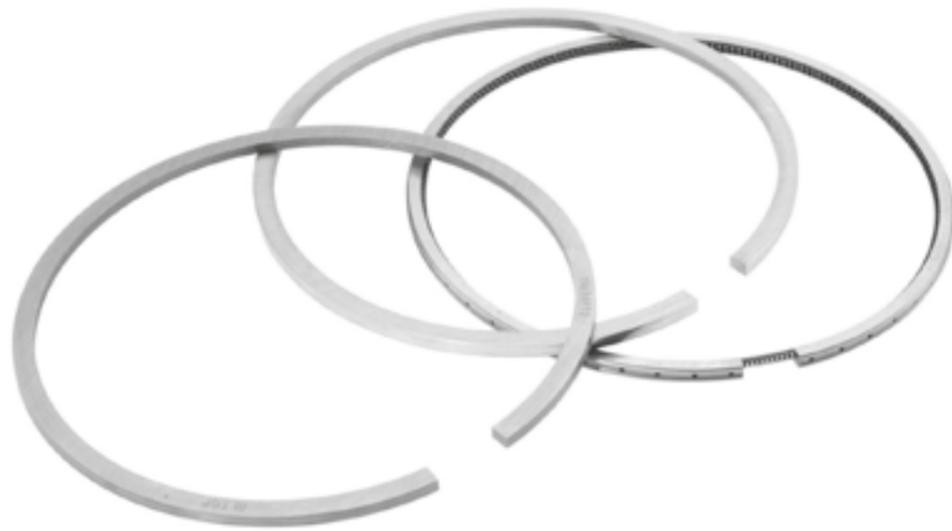
Piston rings must be mounted with the markings (e.g., "top" or "T") pointing upward (toward the top of the piston).
