# Engine components

Damage scenarios:  
Causes, remedies, and avoidance

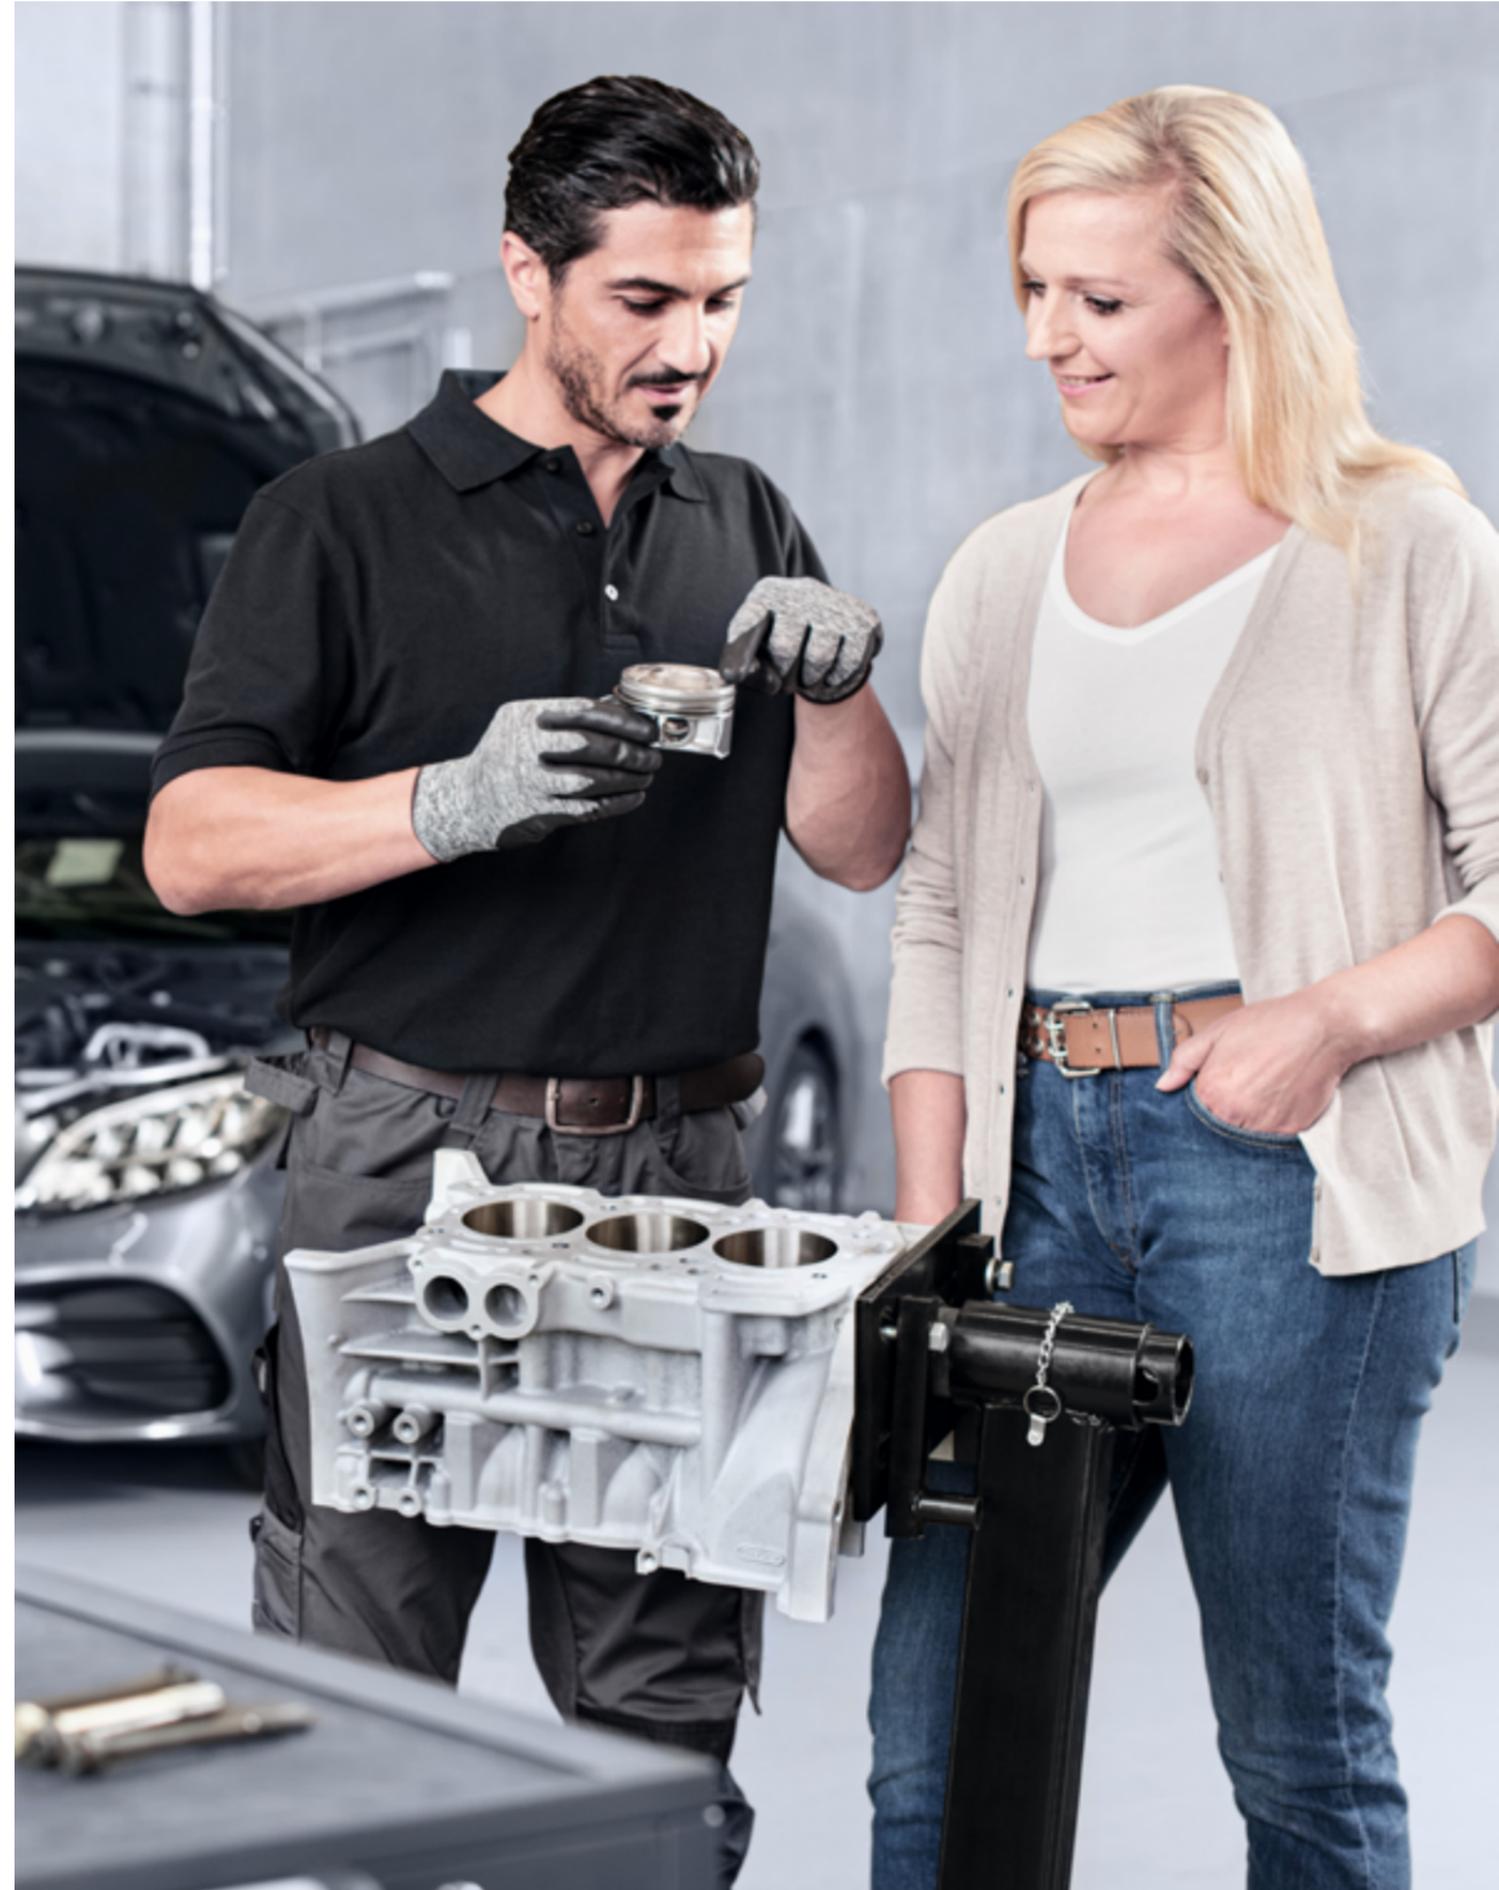
## Types and technical terms

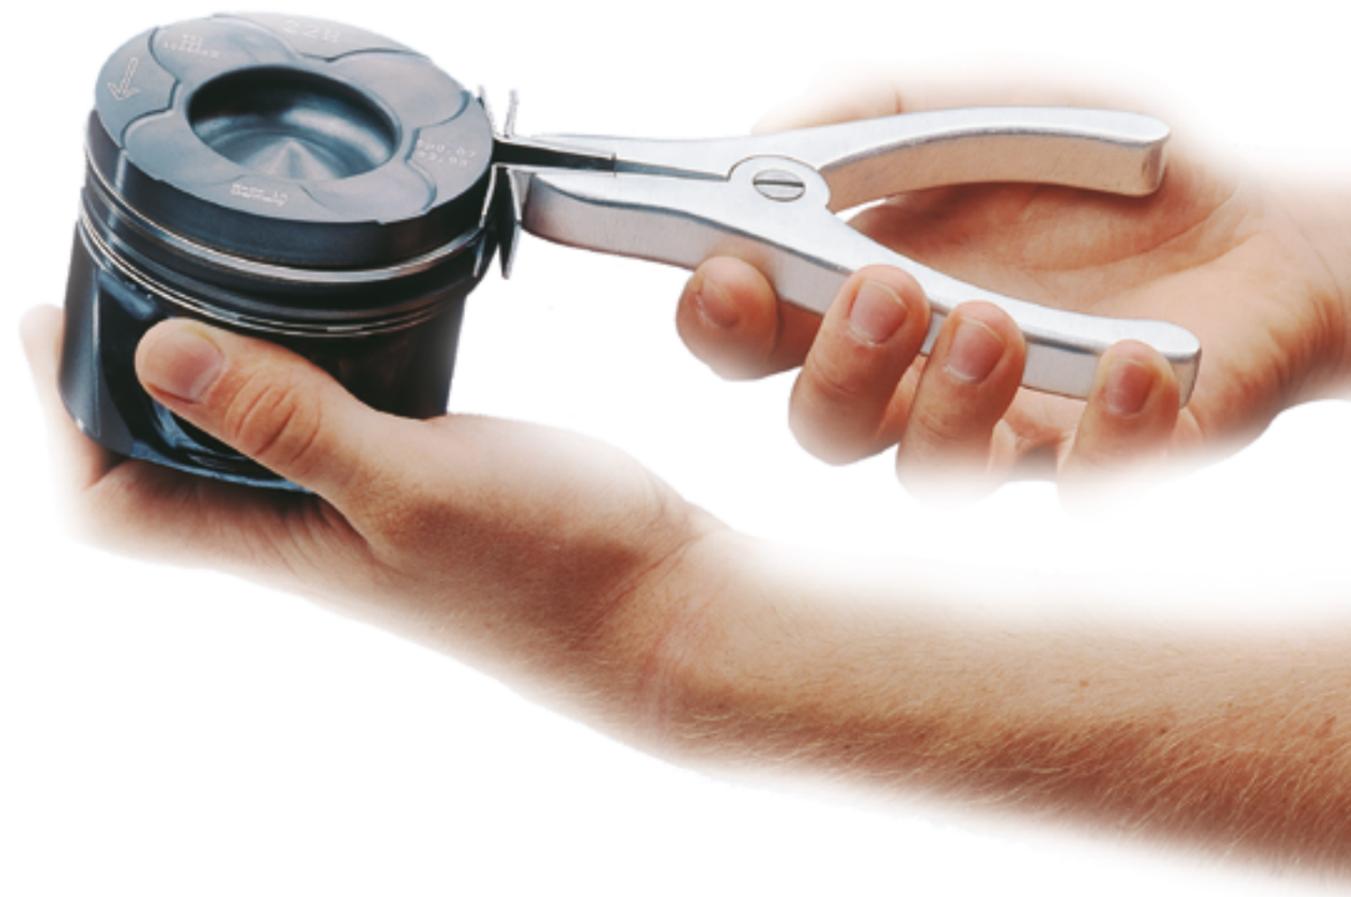
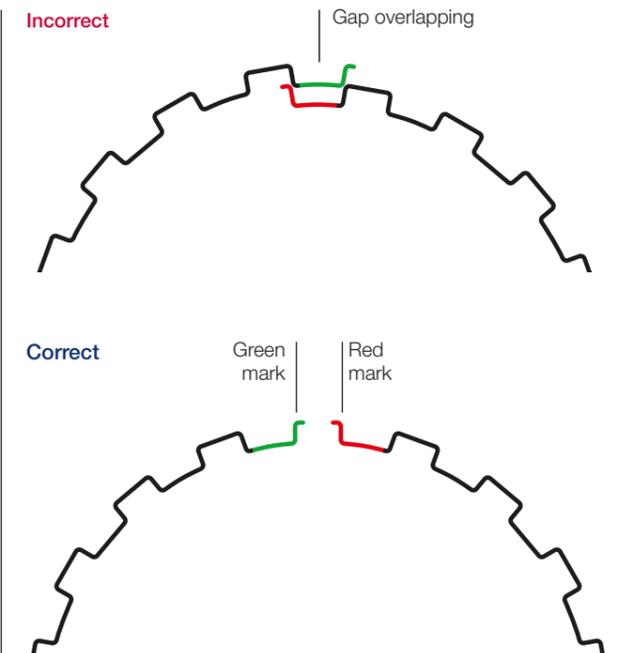
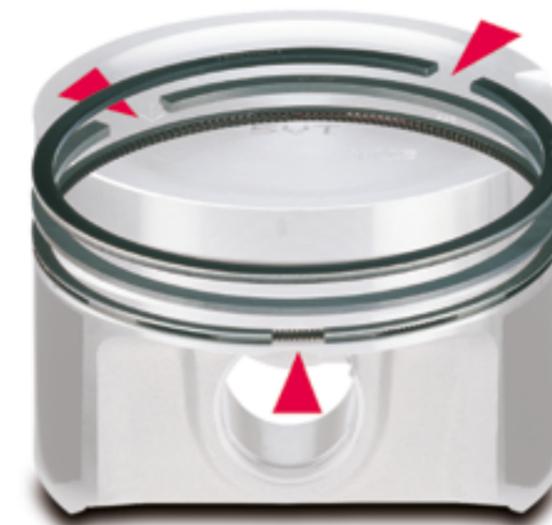
## 3.1 Piston rings with scuffing and seizure marks on the piston skirt

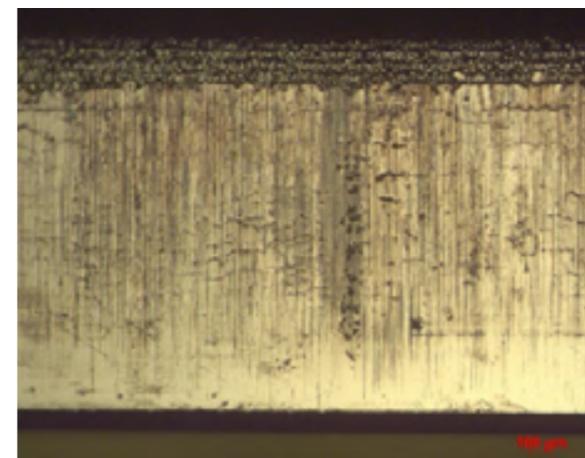
Fig. 3: Piston ring with seizure marks in the stroke direction

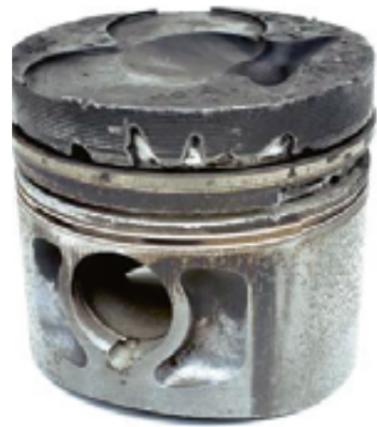
Fig. 1: Damage to the top of the piston due to individual ring carrier fragments

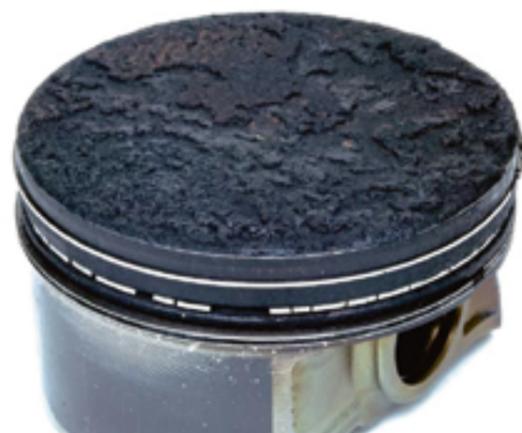
Fig. 2a: Piston ring fracture caused by knocking

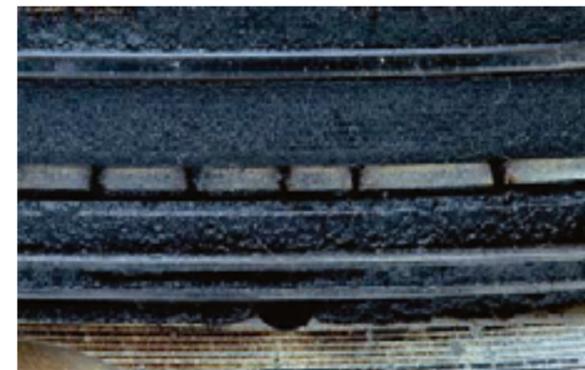
Fig. 2b: Close-up of a piston ring fracture

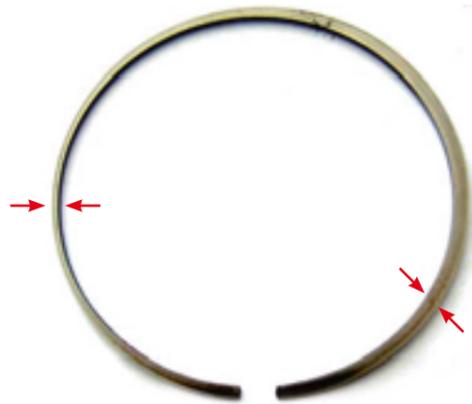
Fig. 1: Piston ring with severe radial wear

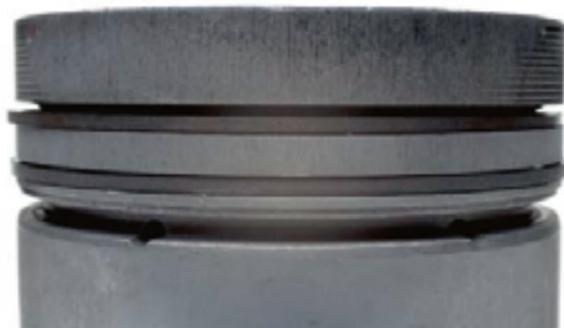
Fig. 2: Heavy axial wear, especially on the first piston ring

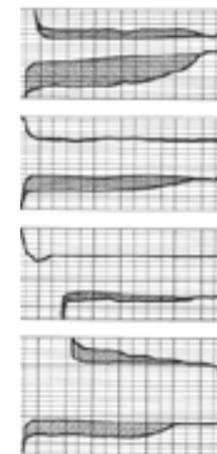
- Check the intake system for leaks.
- Check the air filter and replace it if necessary.
- Remove any dirt from the crankcase and the intake pipes before installation.
- Take care to maintain cleanliness during installation.
- Check and clean or replace the oil mist separator.

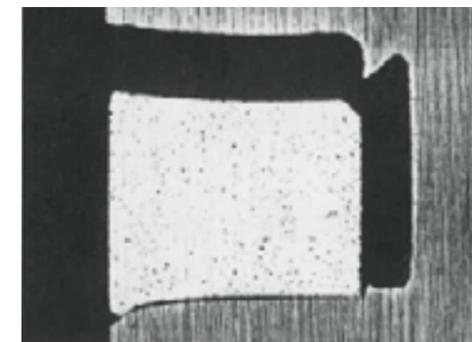
## 3.4 Heavy radial wear on the piston rings

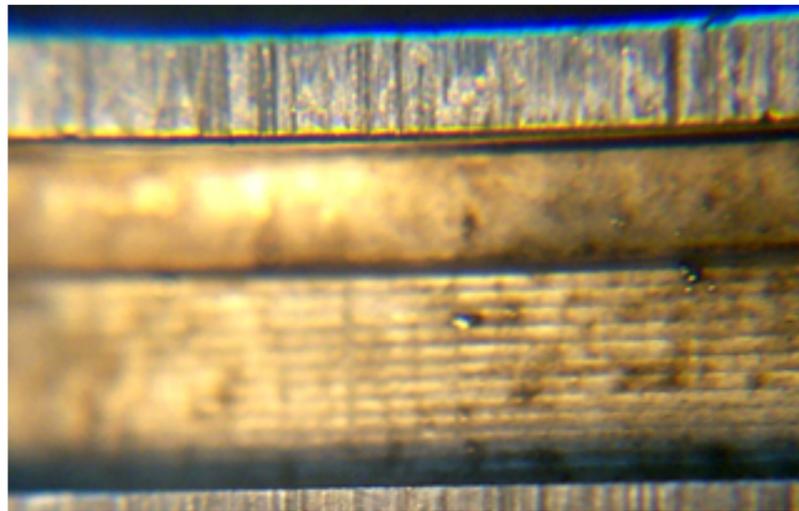
Fig. 1: Heavy radial wear with relatively low axial wear

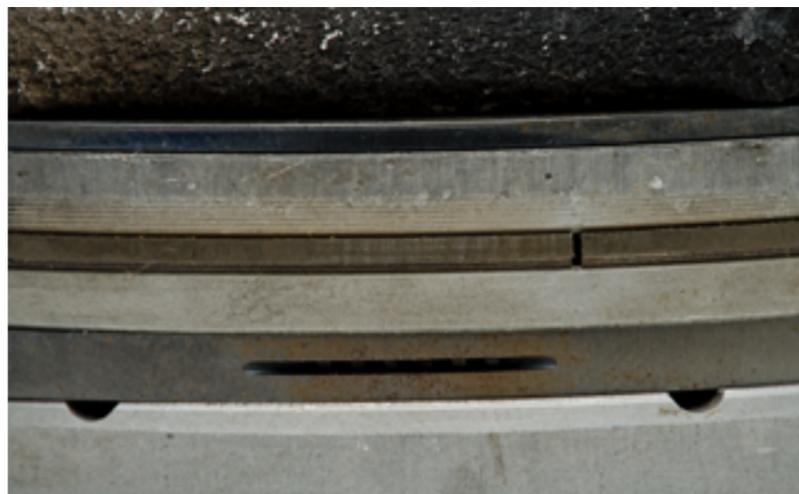
Fig. 2: Scoring and scuff marks on the piston rings

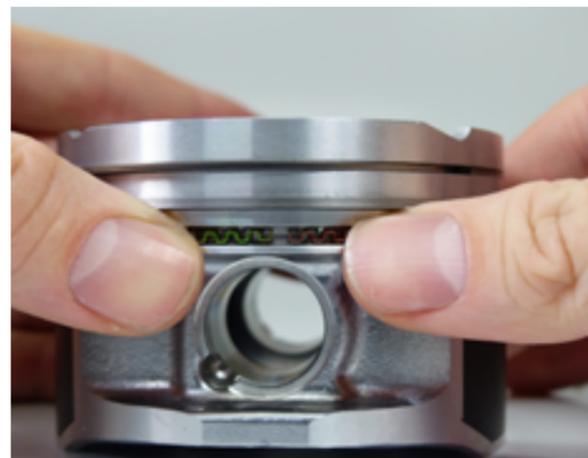
Fig. 1: Correctly inserted expander spring (both color markings visible)

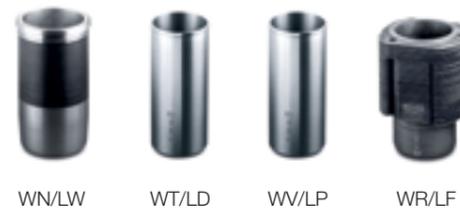
### Wet cylinder liners (WN/LW)

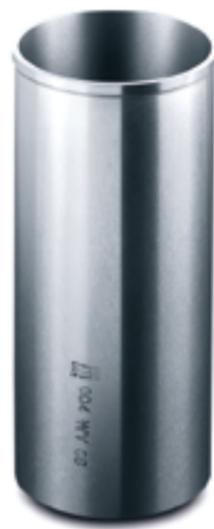
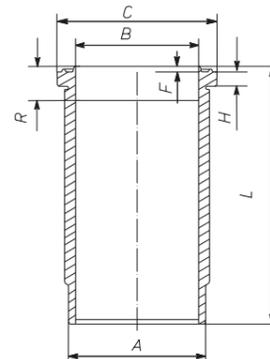
## Fitting recommendations for finned cylinders and cylinder liners

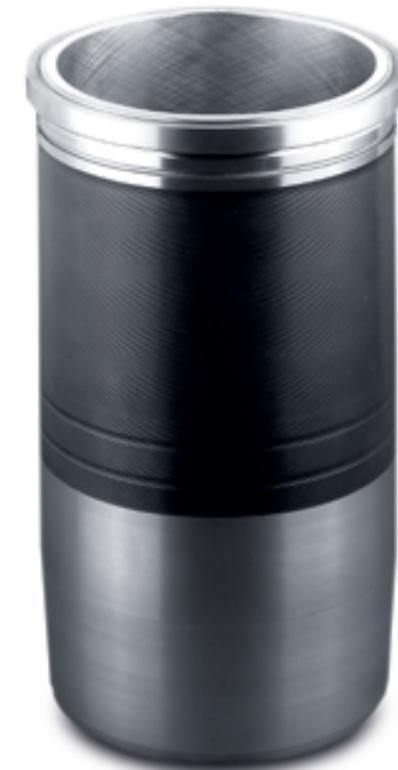
### Dry cylinder liners

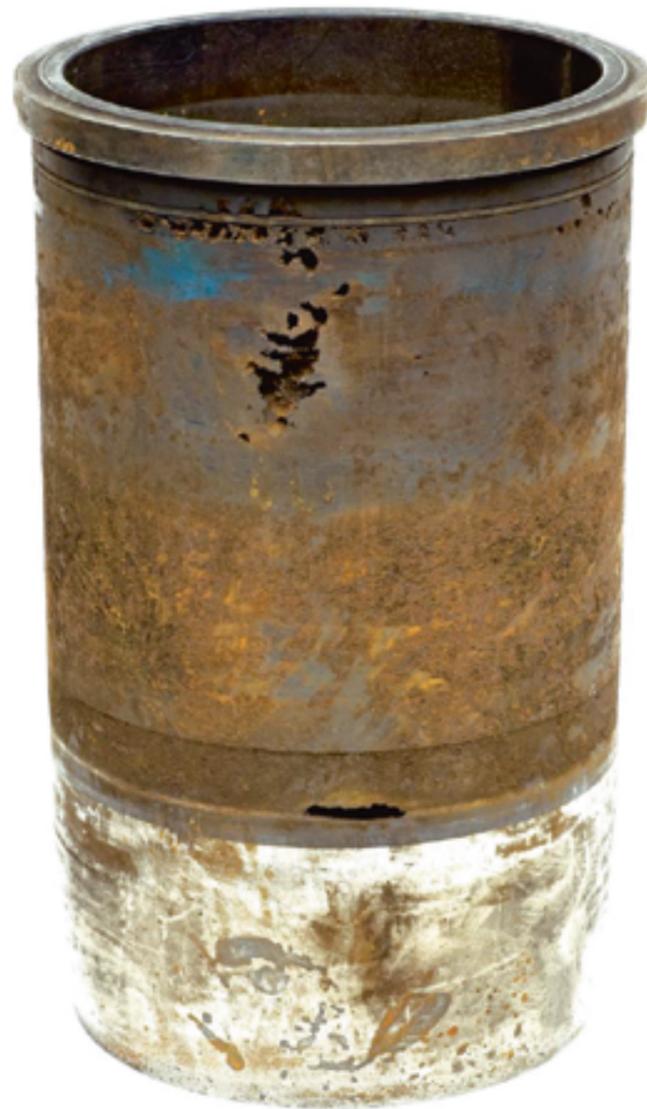
Fig. 1a: Cylinder liner with cavitation damage

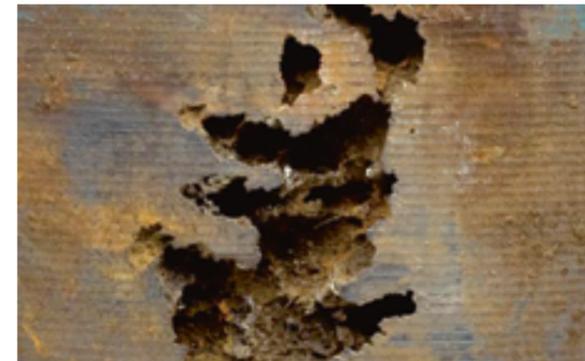
Fig. 1b: Close-up of the cylinder liner with sharp edges and holes that become larger toward the inside

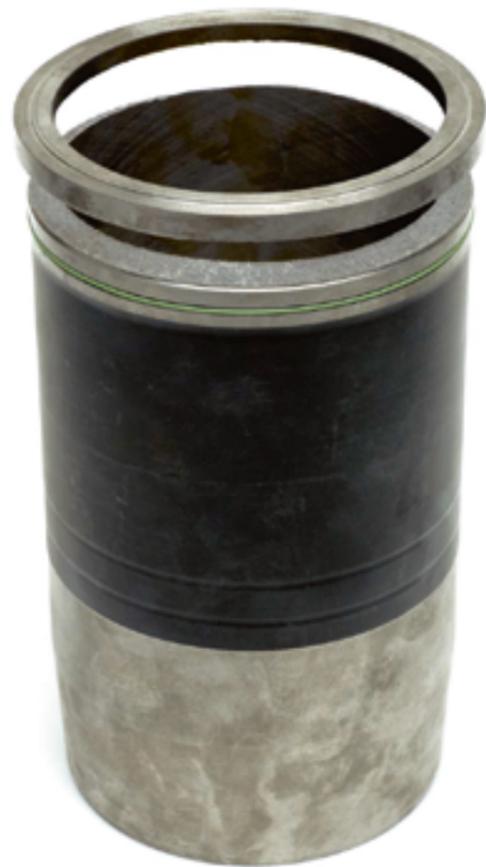
Fig. 1: Broken-off cylinder liner collar

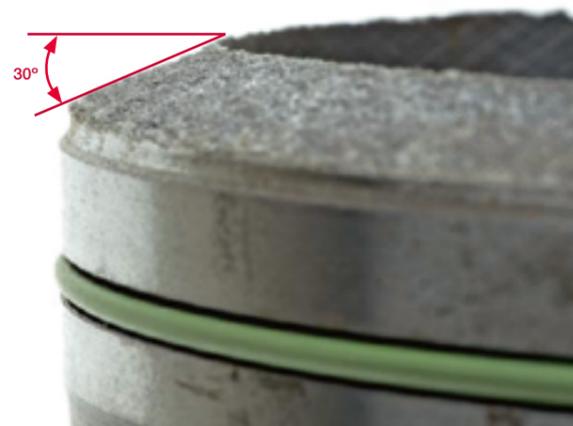
Fig. 2: Fracture with a coarse-grained structure, at an angle of approx. 30°

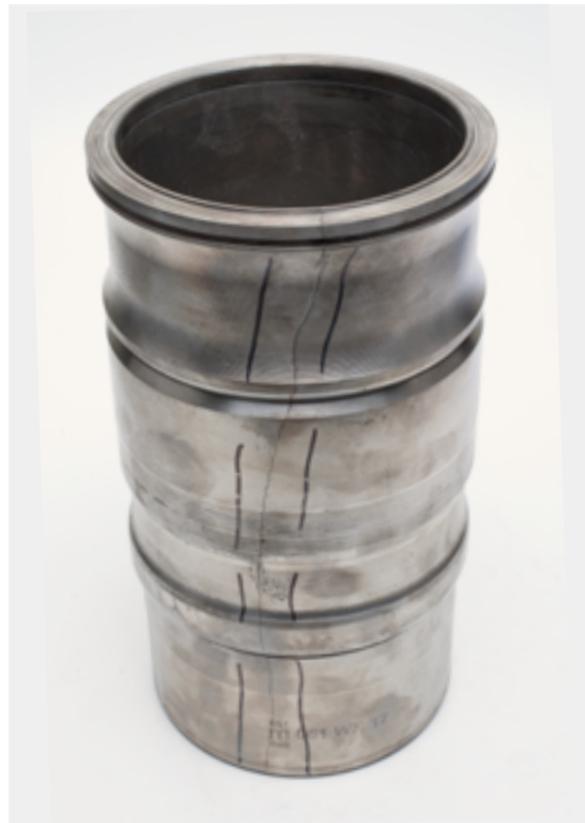
Fig. 1: Longitudinal crack in a cylinder liner

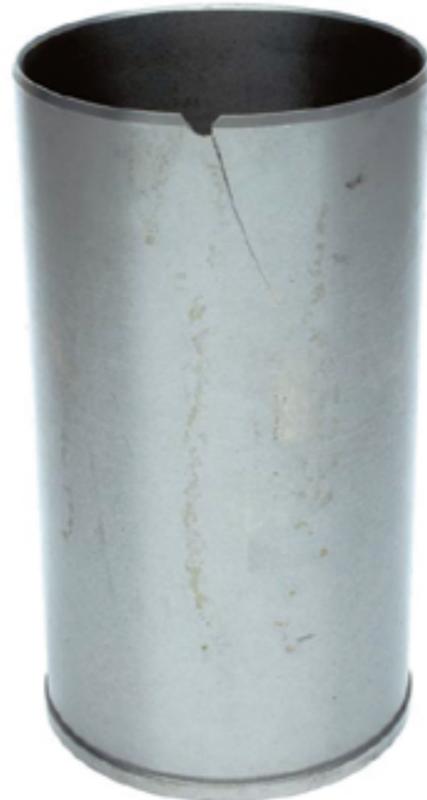
Fig. 2: Longitudinal crack in the lower end of a cylinder liner

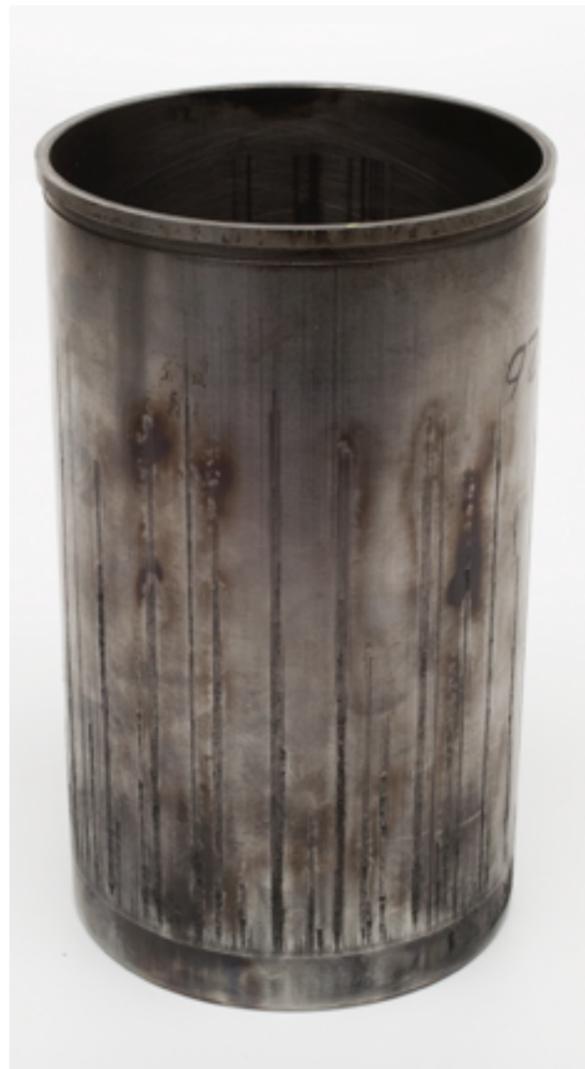
Fig. 2a & b: Seizure marks on the outside of the cylinder liner (around the entire circumference)

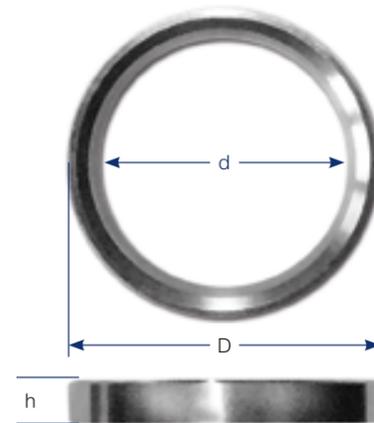
Major dimensions of a valve seat insert

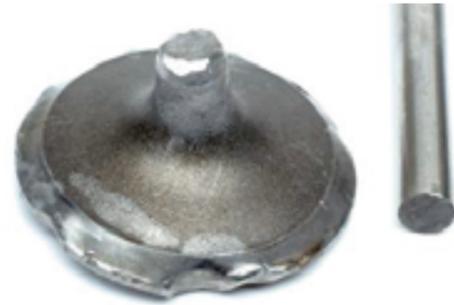
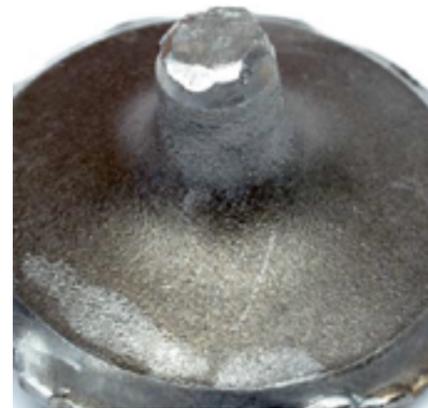
Fig. 2b: Vibration fracture with fracture surface on the valve stem

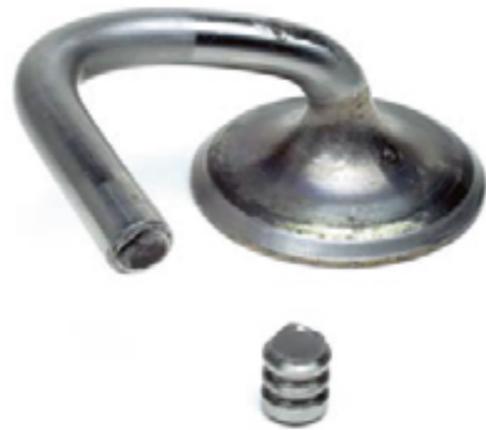
Fig. 1: Severely deformed valve

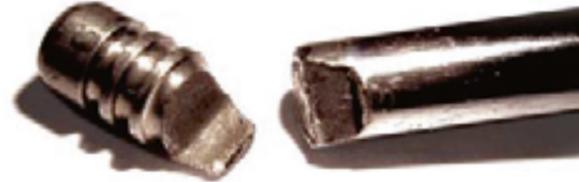
Fig. 2: Valve base broken at the groove (forced fracture/bending stress)

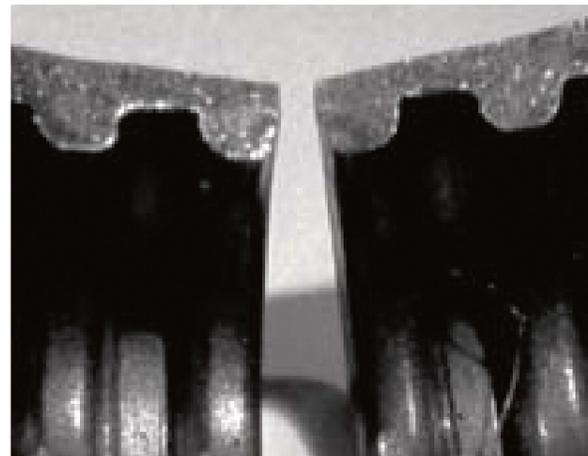
Fig. 3: Deformation of the valve collets along the reinforcing ribs

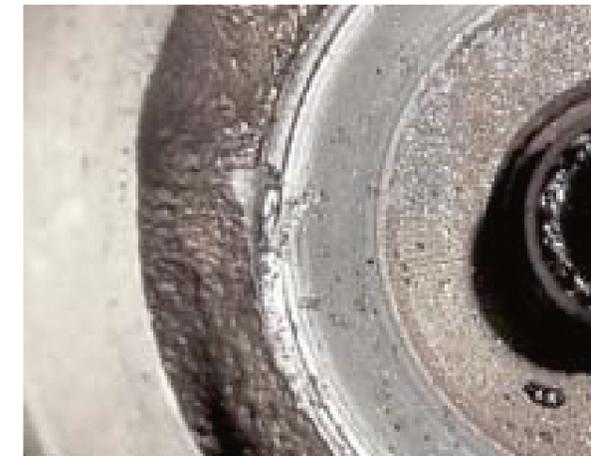
Fig. 5: Marks on the cylinder head caused by a valve spring installed at an angle

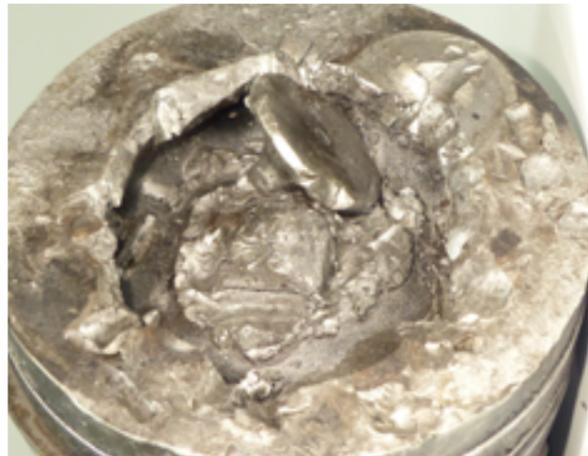
Fig. 1: Valve disk broken off and hammered into the piston

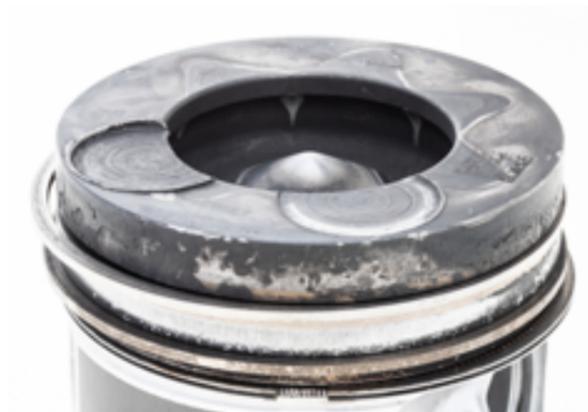
Fig. 2: Valve impact marks on the top of the piston

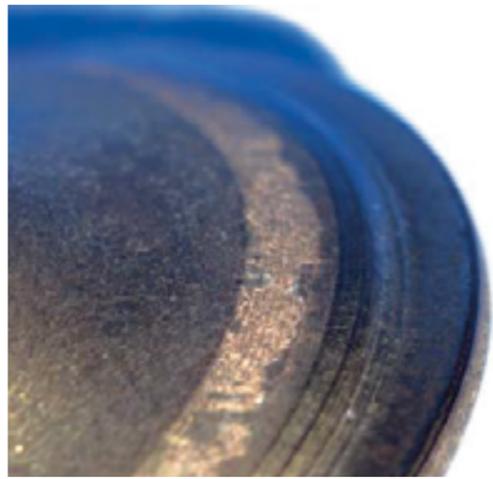
Fig. 1: Heavy wear on the sealing surface

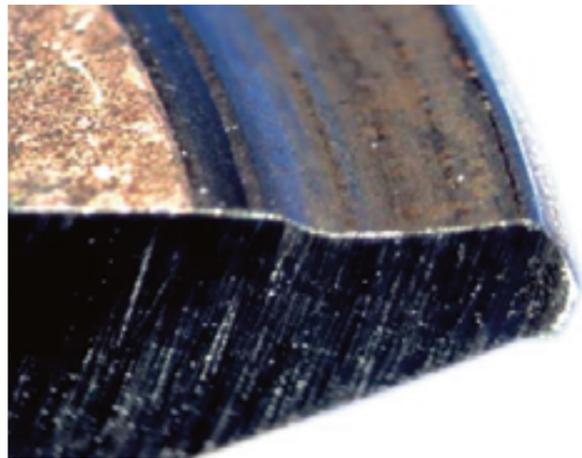
Fig. 2: Close-up of the sealing surface

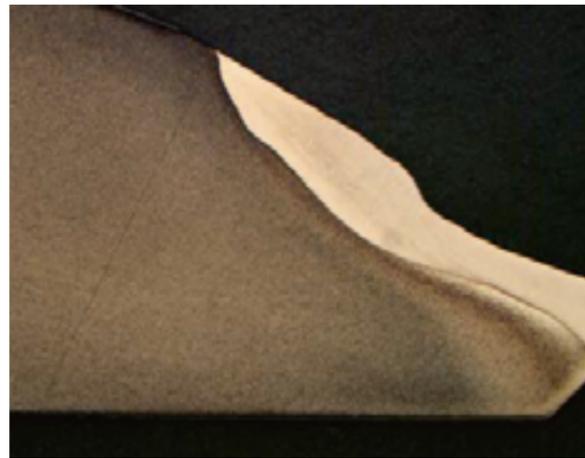
Fig. 3: Severely worn sealing surface (with Stellite hard-facing)

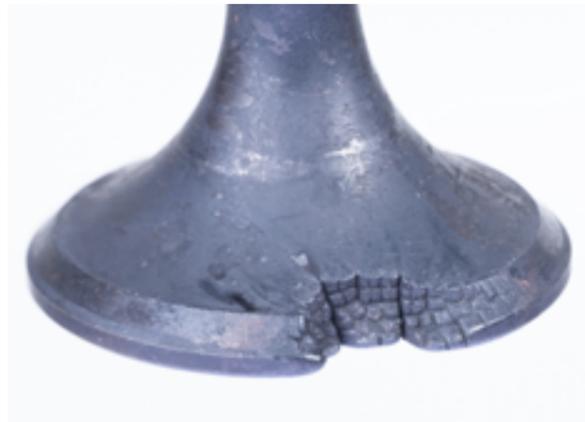
Fig. 1: Hole burned through a valve

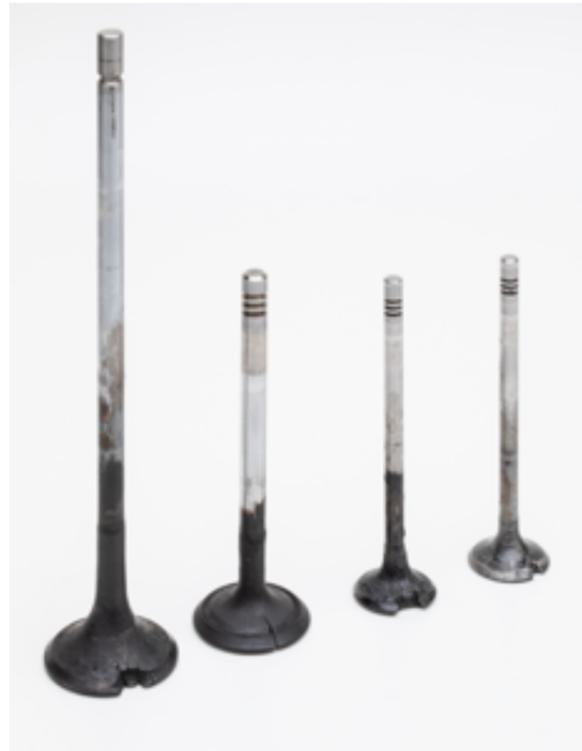
Fig. 2: Cracks and melting damage at various stages

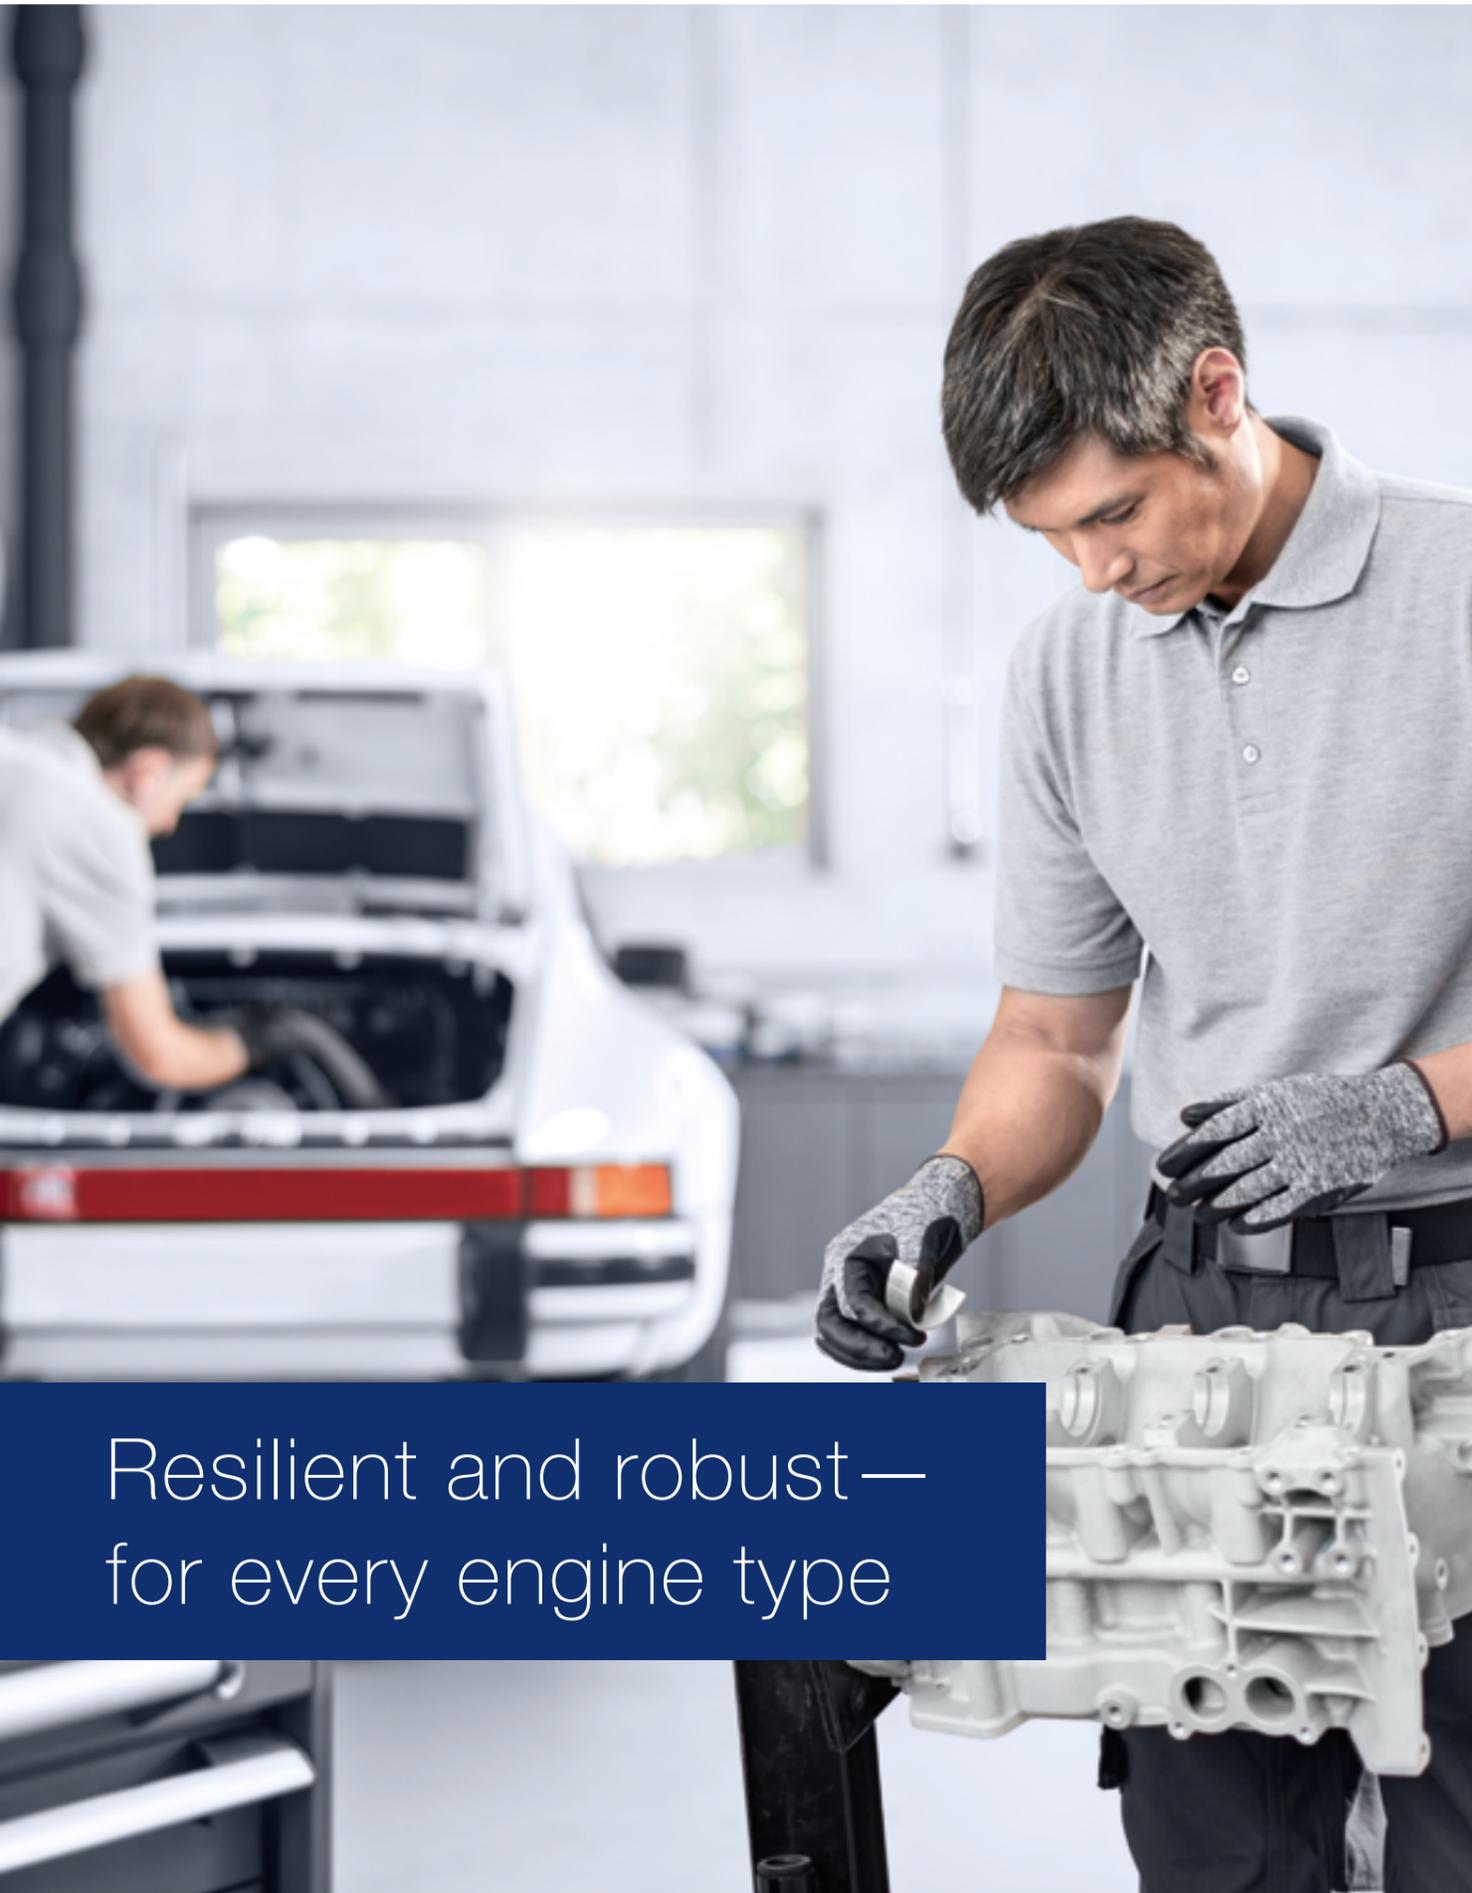
Resilient and robust—  
for every engine type

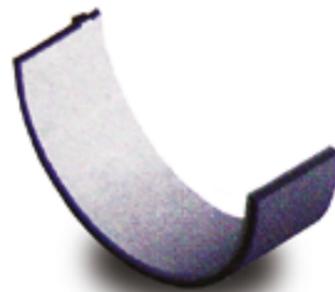
Two-component bearing

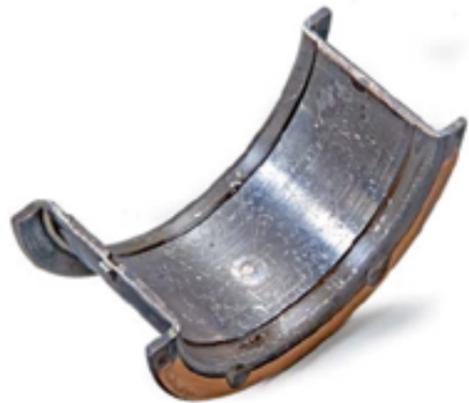
Fig. 1: Signs of wear in the center of a bearing

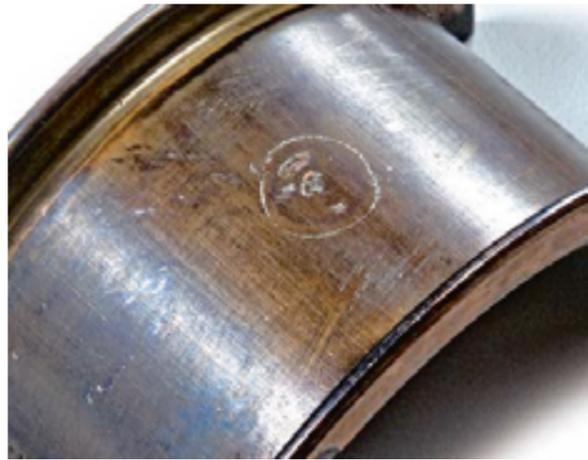
Fig. 2: Impression of a foreign object on the outer surface of a bearing

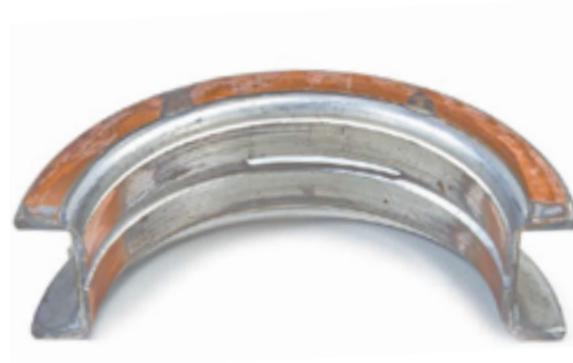
Fig. 1a: Wear on the running surface near the joint face of the bearing

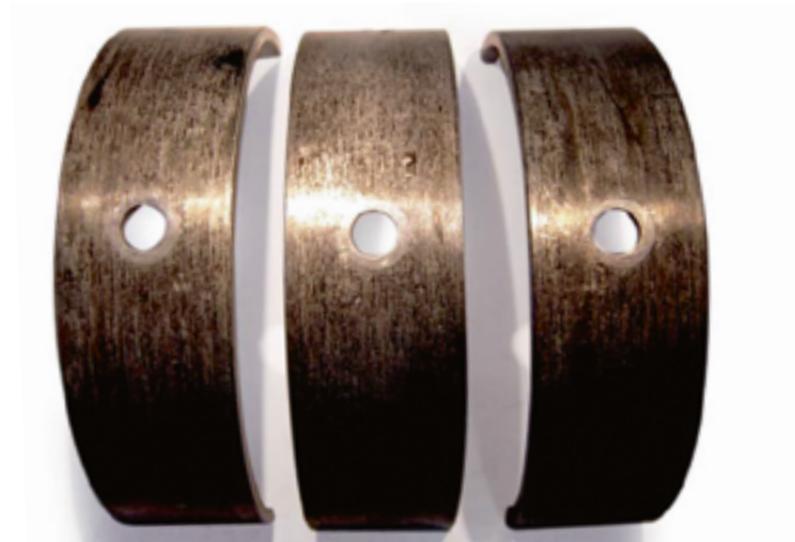
Fig. 1: Polished areas on the outer surface of bearings

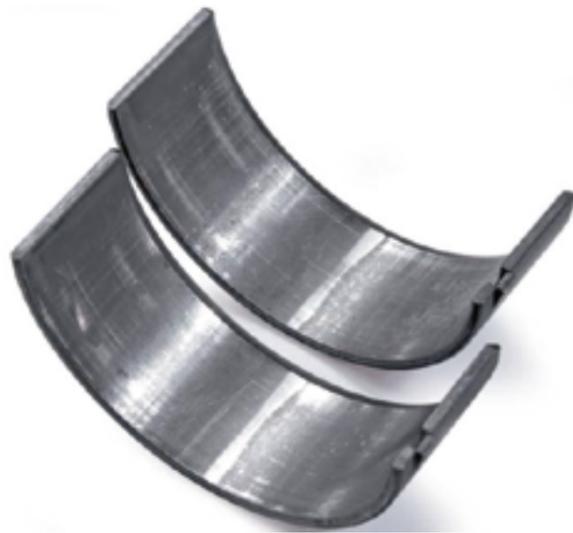
Fig. 1: Worn outer edges of bearings

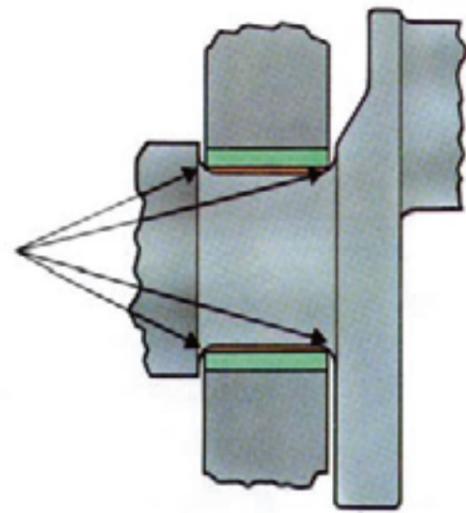
Fig. 2: Excessive radius on the bearing journals

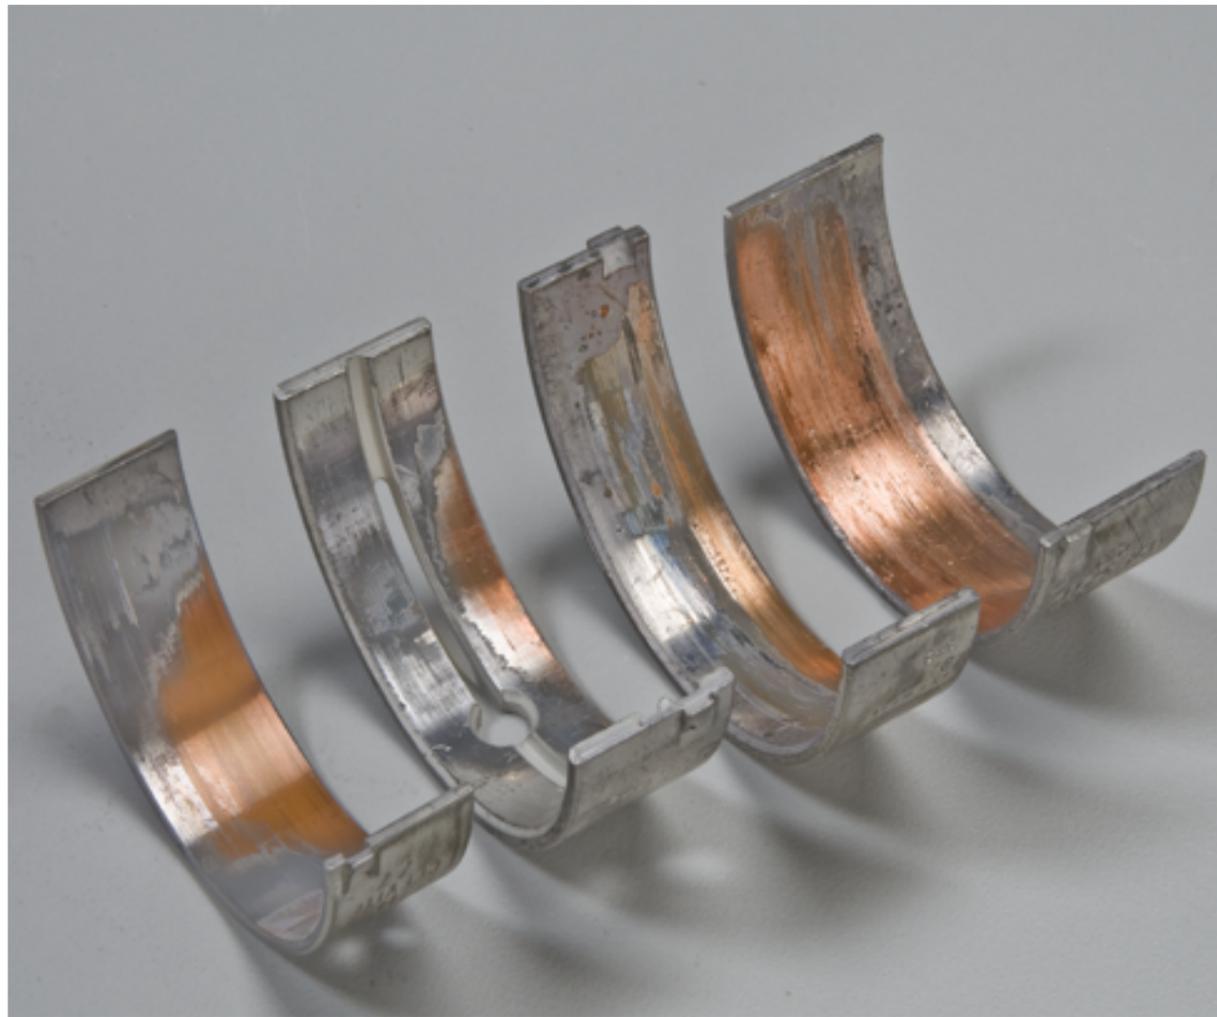
Fig. 1: Deep circumferential score marks

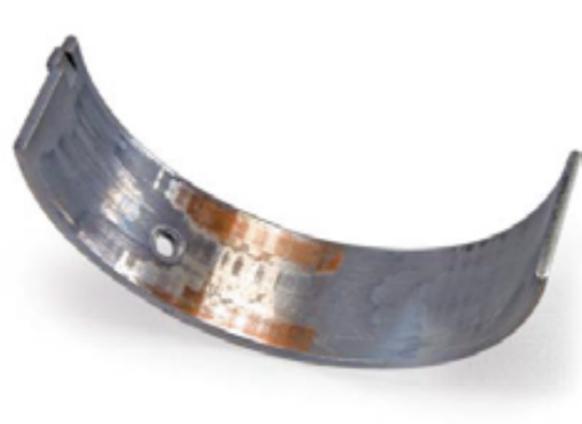
Fig. 1: Uneven wear on the bearing bushings, bearing layer partially removed

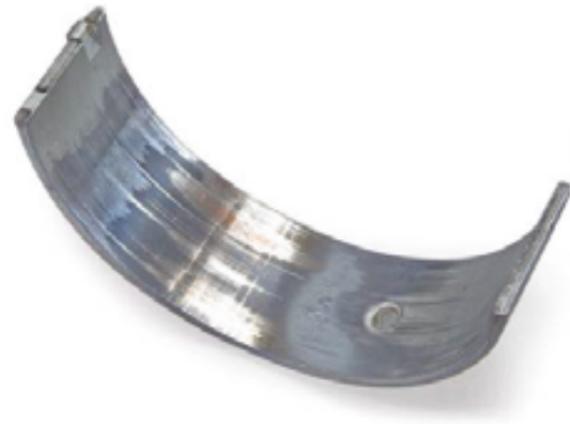
Fig. 2: Uneven wear on the bearing bushings

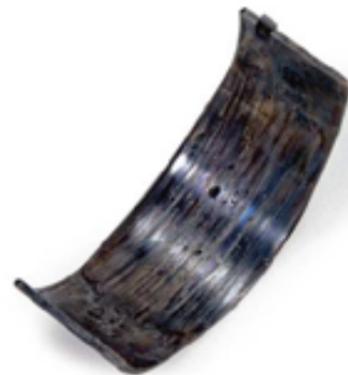
Fig. 2: Severely worn and spun bearing

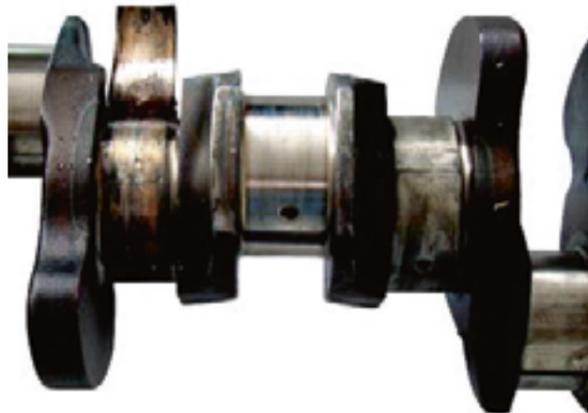
Fig. 3: Bearings welded to the crankshaft

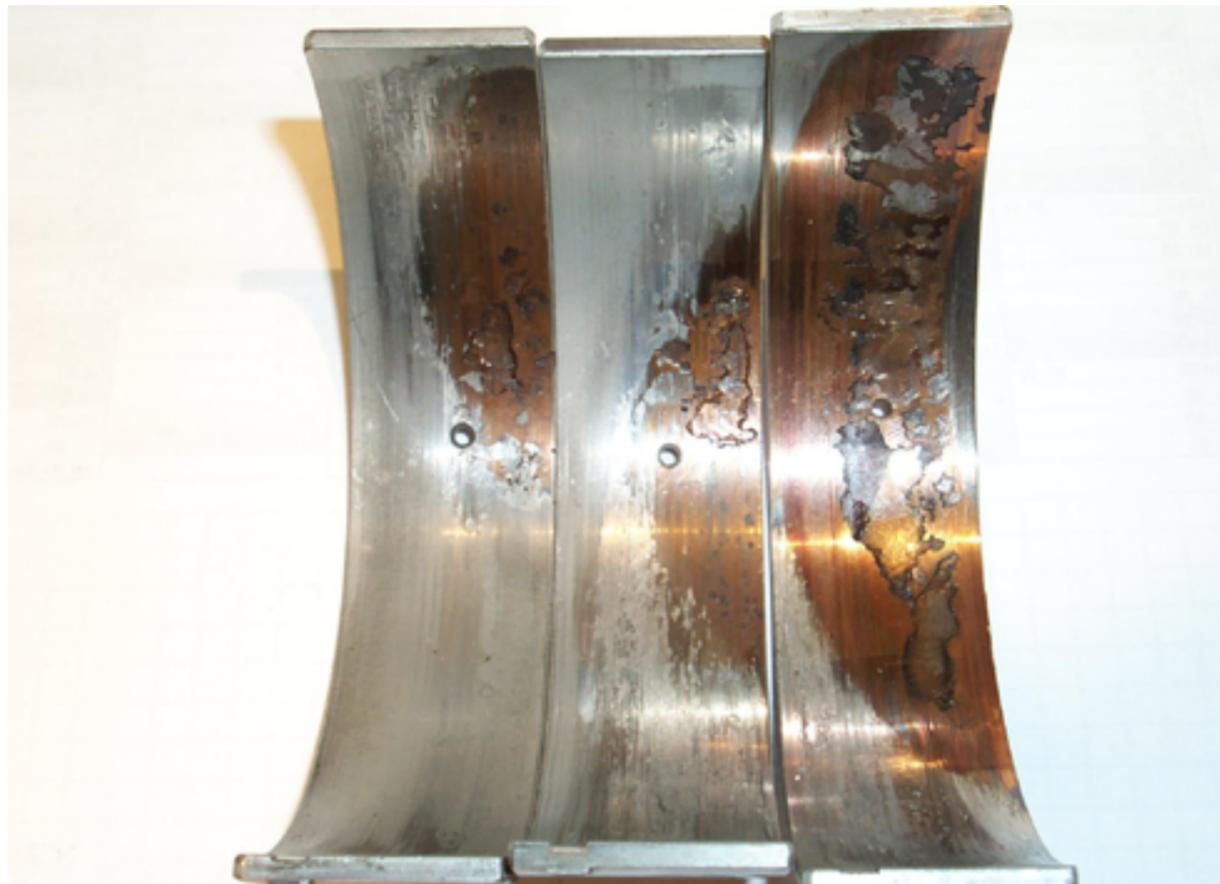
Fig. 1: Pitting of material caused by mechanical overload or an oil film with insufficient load-carrying capacity

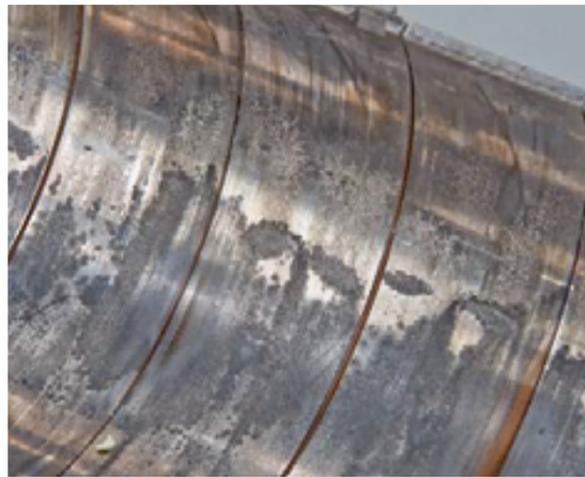
Fig. 1a: Bearing layer burned by chemically aggressive substances in the oil
