# Engine components

Damage scenarios:  
Causes, remedies, and avoidance

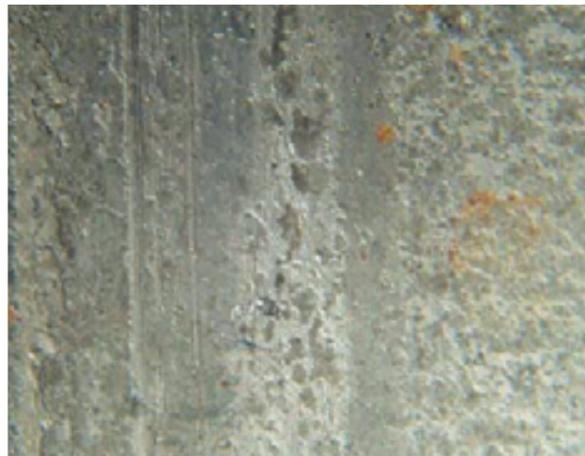
Fig. 1b: The eroded bearing material is clearly visible in this close-up

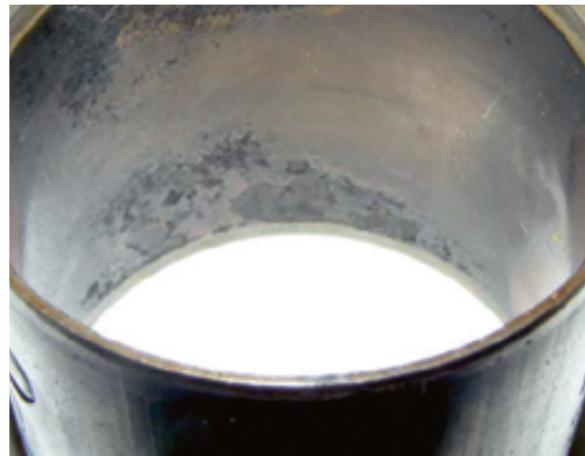
Fig. 2: Damaged connecting rod bushing

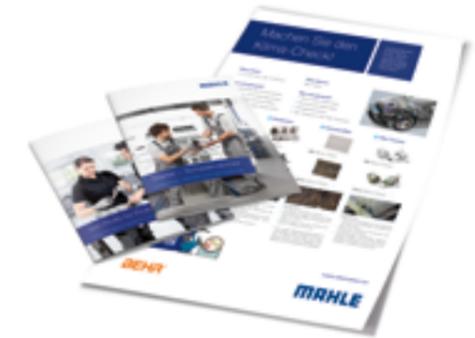
Do you have technical questions? We're happy to help:
