# The challenge of REPLACING FUEL FILTERS

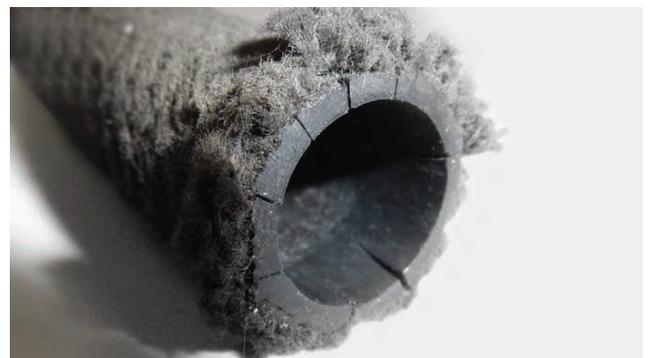
One common cause for the feared bleed air is defective fuel lines. Rubber hoses in particular are prone to this problem. The high temperatures in the engine compartment and the continuous vibrations lead to wear effects on the fuel hoses. The illustration shows an extreme example from the field. The photo was taken after a filter change, during which the embrittled hose was kinked slightly. One of the cracks thereby expanded to the point that bleed air was drawn in: this was the cause of the failure.

A fuel line cracked due to embrittlement: the cause of bleed air entering the system.

The fuel lines at the injectors and the fuel return lines to the tank should also be checked very carefully. Fuel lines must be run in the vehicle and on the engine such that they do not abrade under vibration and are not damaged by hot, rotating, or moving components. Therefore, the mounting points and protective covers on the vehicle should always be checked every time the filter is changed.

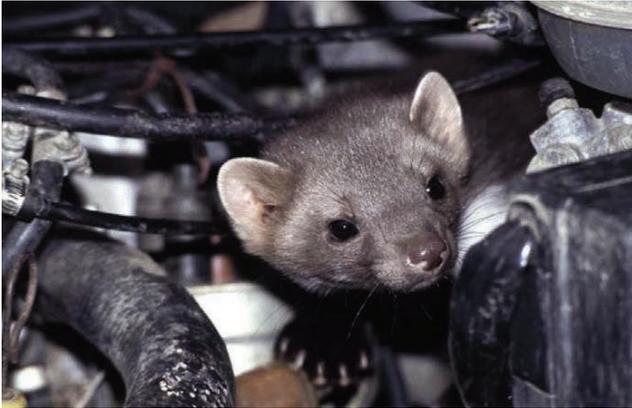
Another cause of bleed air in the fuel system is the Martes foina, the beech marten. Typically native to rural areas, the small predator is drawn to the residual heat of the engine space in the engine compartment, especially in the evening and at night. There it finds soft insulation material on the bulkhead and the inside of the bonnet. But water hoses, ignition cables, air conditioning hoses, and fuel lines also attract the rodents. Martens have very sharp teeth that can easily perforate the lines. When observed more closely, teeth marks that look like pinpricks are evident. If a marten damages a fuel line, undesired bleed air can be drawn in. The results: the engine is hard to start, runs roughly, or dies out.

Another cause of bleed air being drawn in could be an uninvited guest in the engine compartment.

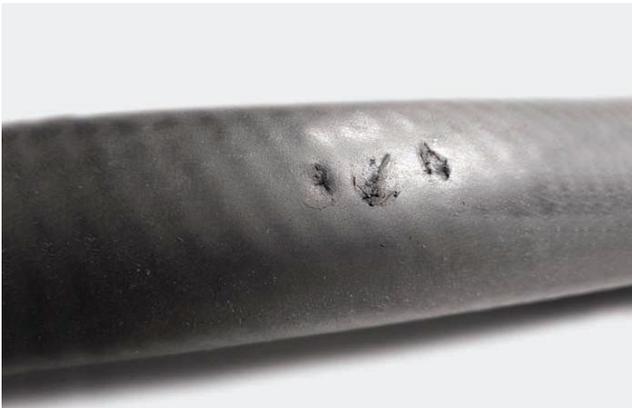
Typical damage scenario for rodent gnawing: small teeth marks on the fuel line through which bleed air is drawn in.

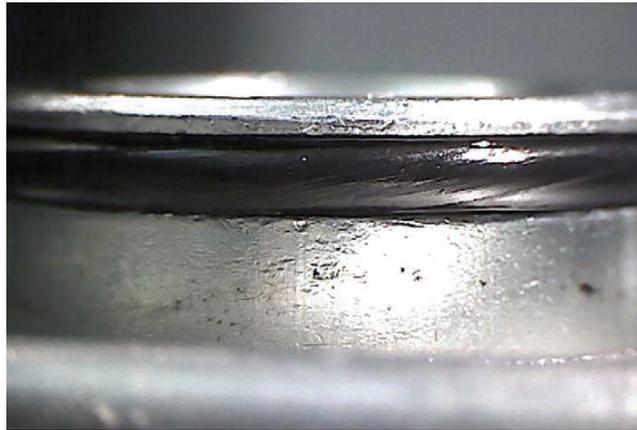
An O-ring that becomes twisted during installation causes leaks. The ring should therefore be coated with an appropriate lubricant (fuel or oil) before the cover is put in place.

Another risk is that the O-ring becomes twisted during the fitting of the preheating valve or the housing cover. This can be prevented by coating the O-ring with clean diesel fuel prior to installation. In general: when lubricating gaskets, the medium that will be sealed against later should be used, because the gasket material is resistant to this medium and will thus not be corroded. (Therefore, clean diesel fuel should be applied to the gaskets for diesel filters, and lubricate oil filter gaskets with clean engine oil.)

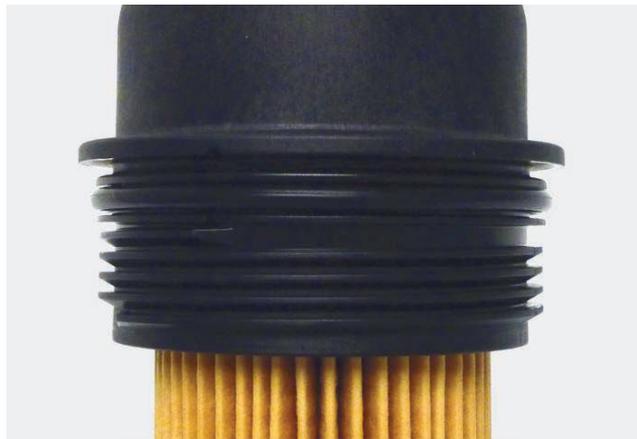
Fuel filters with screw covers: only a correctly placed O-ring is truly leakproof.

For screw covers on fuel filters, the correct position of the O-ring must also be checked: it must be seated completely in the provided groove. For more information, see the Technical Messenger TM 6/2012, downloadable at [www.mahle-aftermarket.com](http://www.mahle-aftermarket.com).

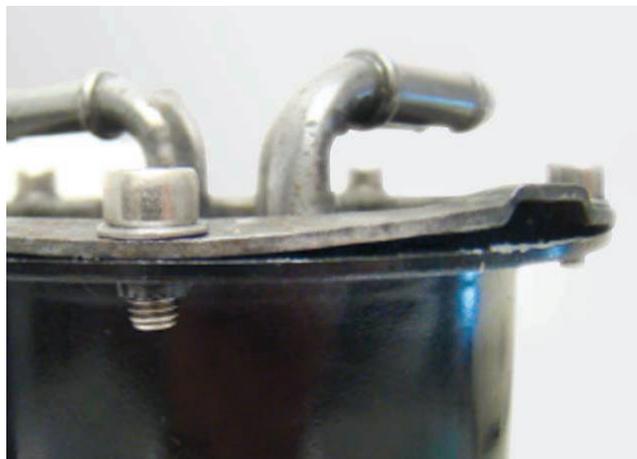
A fuel filter housing cover deformed by defective opening and/or closing.

For snap-on covers of filter housings, such as are used in some VW applications, care must be taken that the cover is not deformed when it is either opened or closed, as otherwise leaks may occur. Please also follow our TM 5/2012 at [www.mahle-aftermarket.com](http://www.mahle-aftermarket.com).
