Thermal Management

Damage scenarios: causes,
remedies, and avoidance

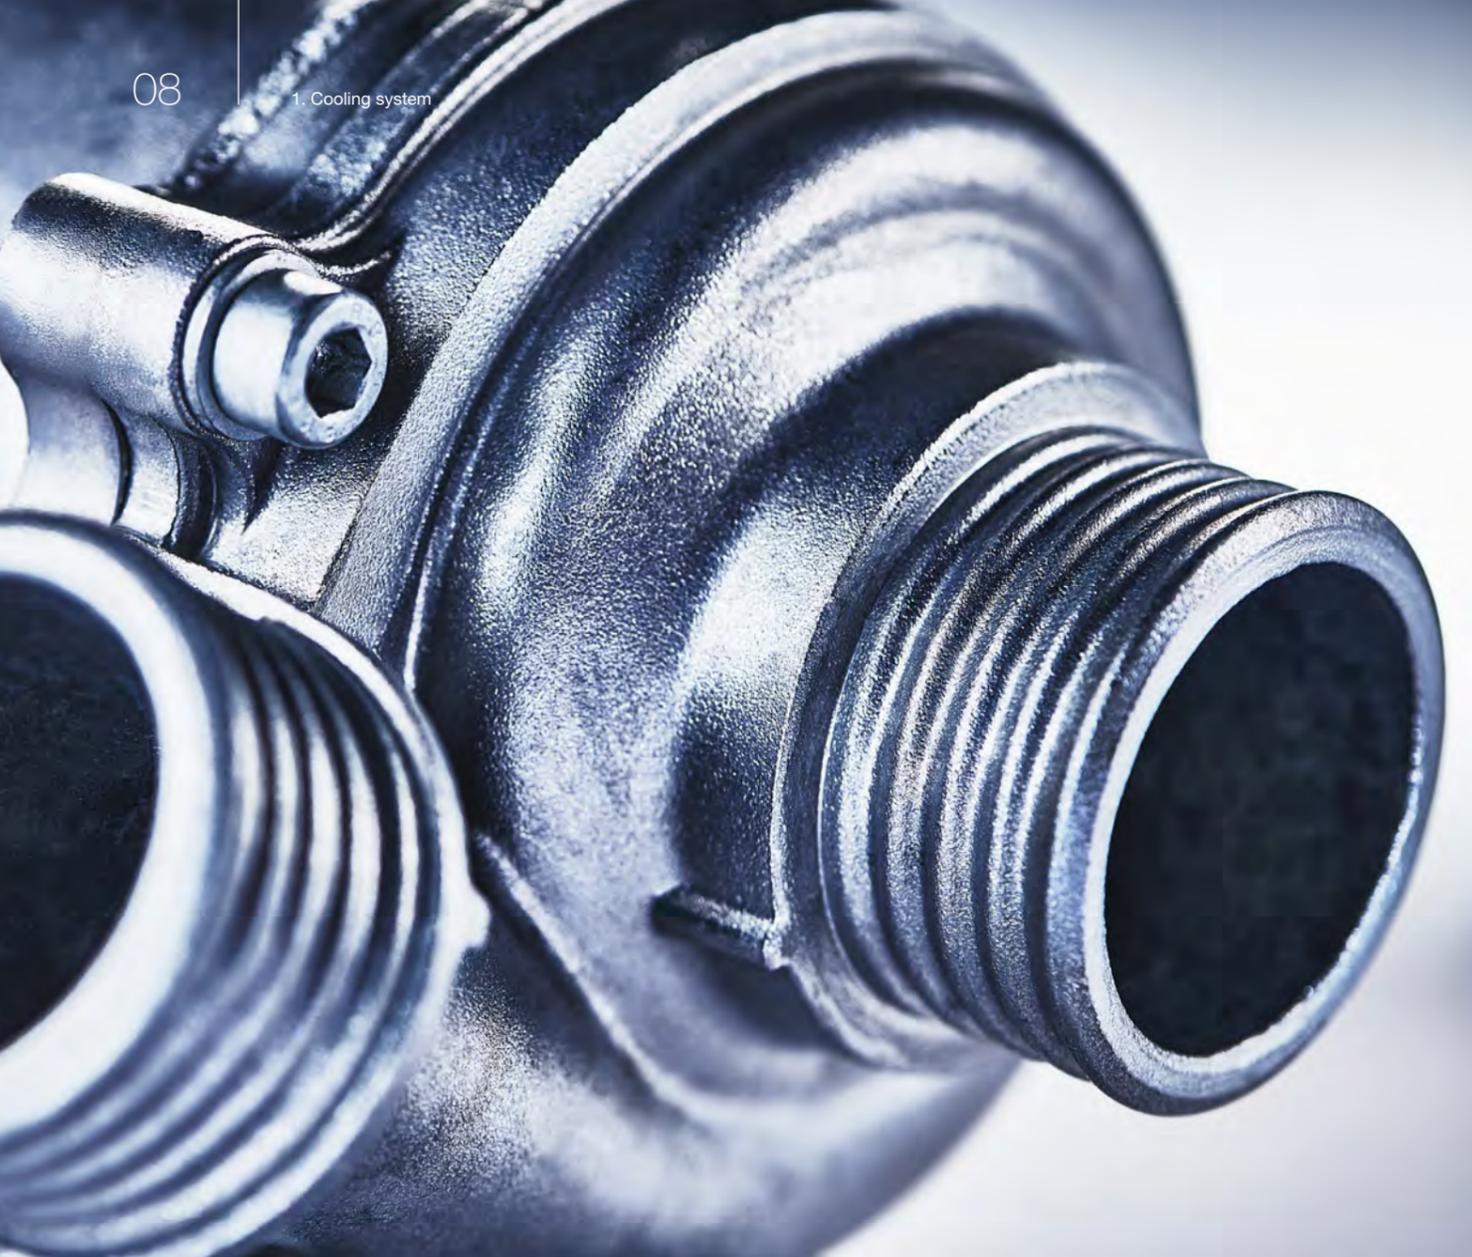
- Noises
- Leaks
- Belt pulley flanks damaged
- Bearing damage
- Engine overheating

- Bearing damage due to excessive belt tension
- Belt not in alignment
- No antifreeze in the system (seal in the pump needs antifreeze for lubrication)

Fig. 2: Coolant pump with bearing damage

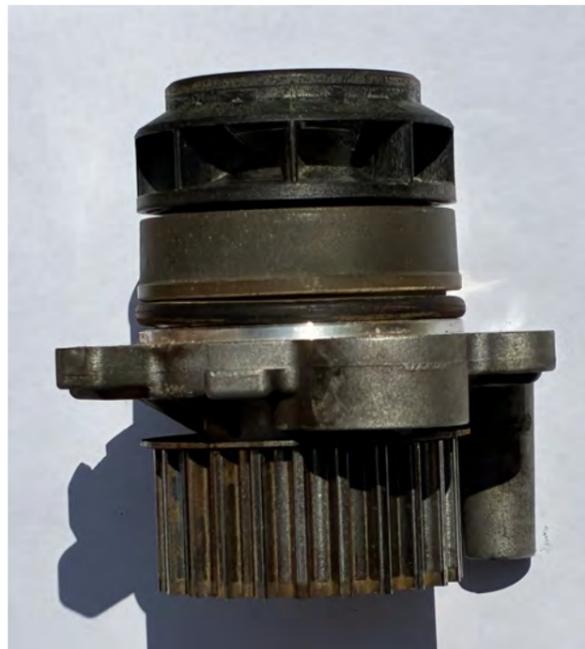
- Coolant pump is not circulating coolant
- Loose impeller
- Engine overheating

- Too little antifreeze in the engine
- Engine has been started with frozen coolant, causing the impeller to detach from the shaft
- Engine/coolant has overheated, causing thermal damage to the plastic impeller

Fig. 1: Plastic impeller detached from shaft

- Check coolant level regularly. However, this should only be done when the engine is cold.
- Take care to use the correct blend of water and antifreeze so that the coolant does not freeze at low temperatures.
- If an engine's coolant temperature is too high, finding and eliminating the cause is vital in order to avoid consequential damage.

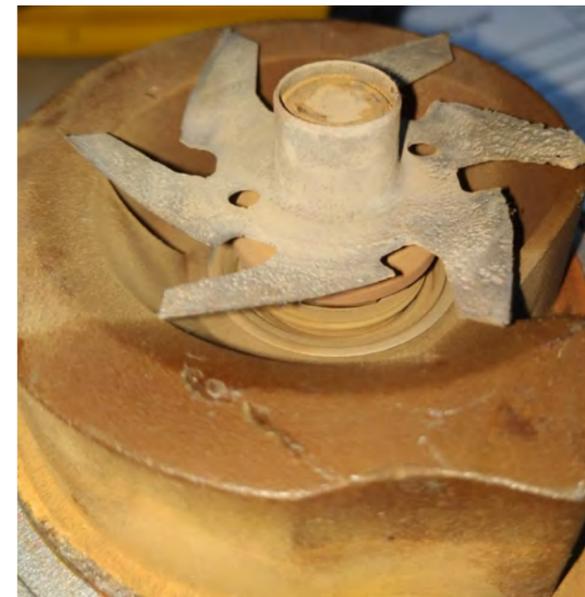
- Engine overheating
- Cavitation on impeller
- Corrosion on pump housing

- Unsuitable antifreeze
- No antifreeze in coolant
- No overpressure in cooling system (defective valve in expansion tank)
- Exhaust gases are entering the coolant through a defective head gasket, changing the pH value of the coolant

Fig. 1: Cavitation on coolant pump

- Use coolant according to the manufacturer's specifications and mix it with deionized water as directed. Antifreeze not only lowers the freezing point of the coolant, but also increases its boiling point. In addition, antifreeze lubricates the coolant pump and provides protection against corrosion.
- Check the valves in the expansion tank cap.

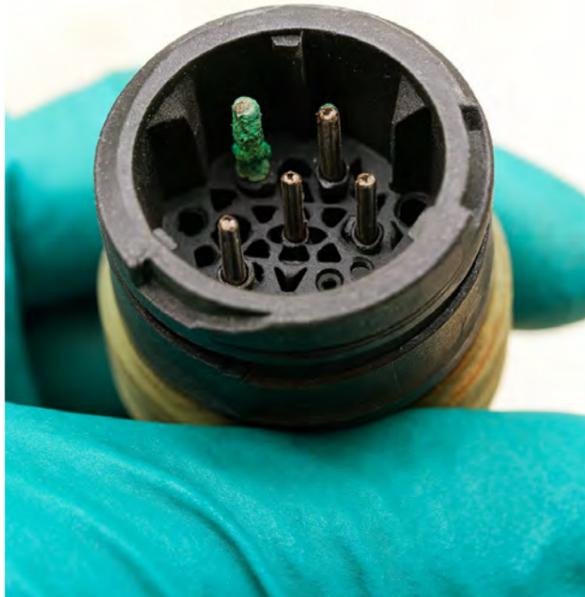
- Engine overheating (defective e-water pump)

- Electrical fault (short circuit, interruption)
- Defective fuse
- Broken cable
- Corrosion on plug connection
- Defective pump

Fig. 1: Corrosion on the connector plug

- Check the power supply to the coolant pump.
Possible causes of an interruption: the electrical fuse, corrosion on plug connections, a fault at the grounding point, defects in the cable harness.

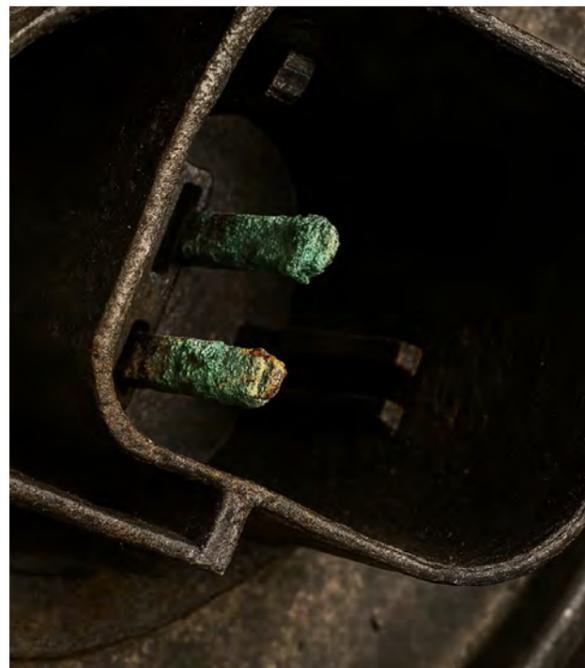
Fig. 2: Corrosion on plug connection

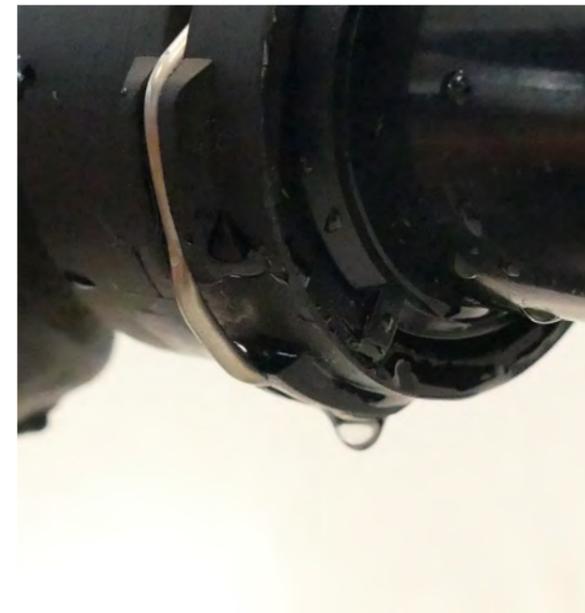
- Coolant leaking from the thermostat

- Seal on hose's quick-release coupling was not replaced

Fig. 1: Leaky O-ring

- Always replace seals on all opened connections in the cooling system.

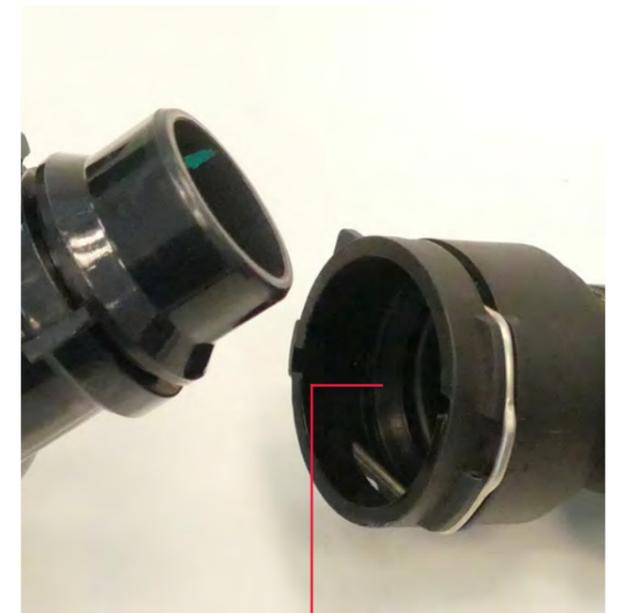
Fig. 2: Quick-release coupling

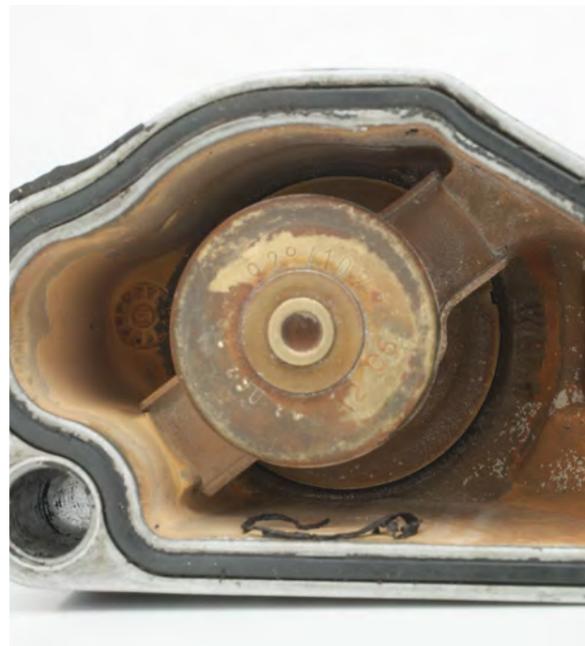
- Cooling system not bled correctly
- Thermostat jammed in "closed" position
- Thermostat jammed in "open" position
- Corrosion due to unsuitable or insufficient concentration of antifreeze
- Foreign objects (sealant residue, parts of the impeller of the old water pump, sealing compound) in the cooling system

Fig. 2: Corrosion on thermostat

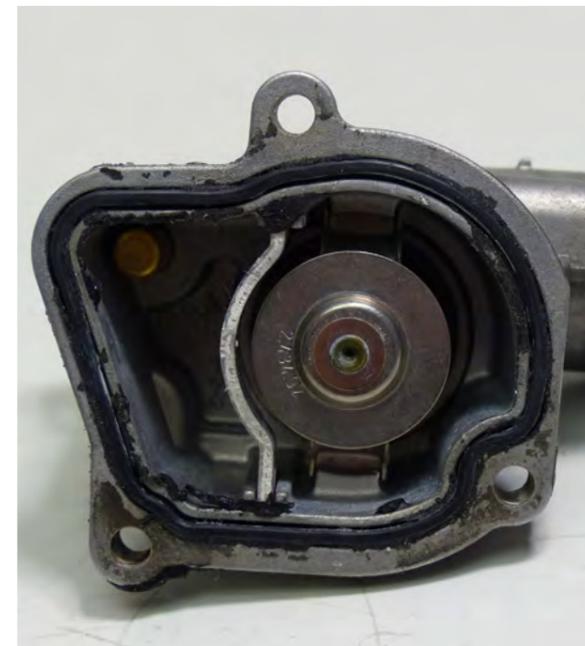
- Leaky thermostat housing
- Additional sealing compound applied to the thermostat

- Seal damaged by additional use of sealing compound

Fig. 1: Sealing compound on thermostat housing

thermostat seals. Oil causes seals used for coolant to swell and crack.

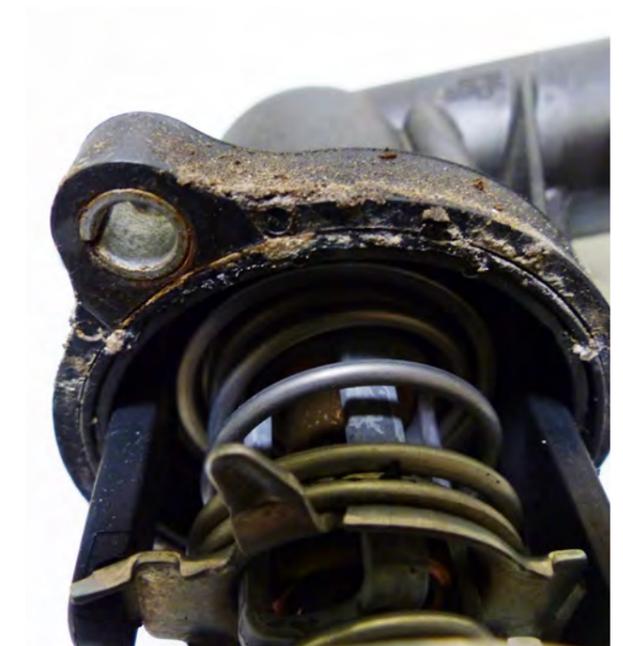
Fig. 2: Seal damaged by additional sealing compound

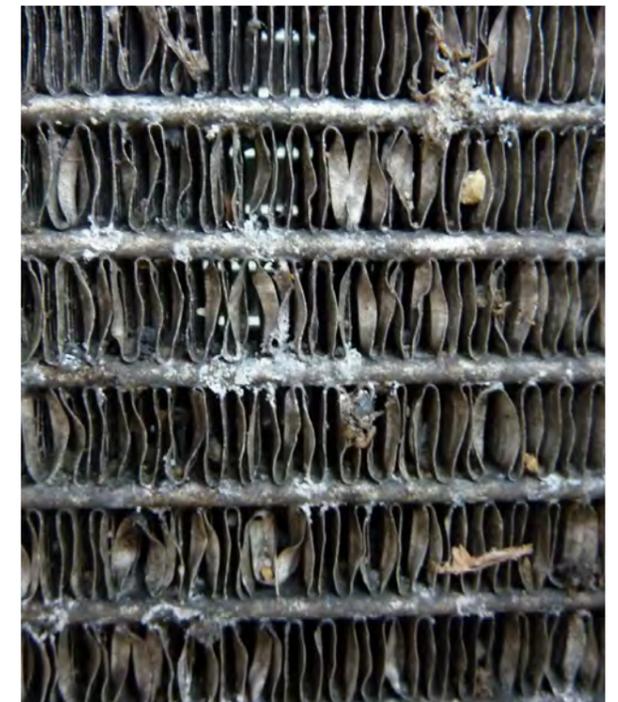
- Inadequate cooling performance
- Increased engine temperature
- Radiator fan runs continuously
- Poor air conditioning performance

- Inadequate heat exchange due to external soiling of the cooling fins (dirt, insects, leaf debris)
- Contaminants between condenser and radiator (leaves, dirt)

Fig. 2: Contaminants and deformed cooling fins

Never use a high-pressure cleaner, as the water jet will damage the cooling fins.

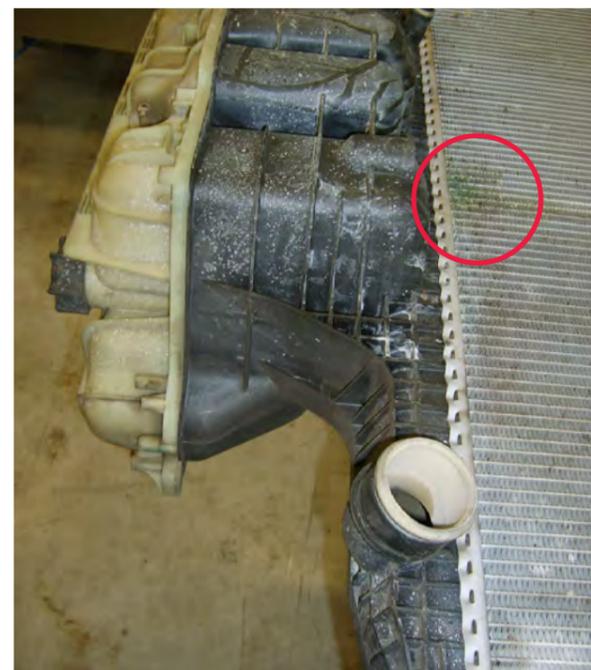
- In truck radiators with top-mounted expansion tanks, space must be left to allow for pressure equalization. If this space is also filled with coolant, excess coolant will escape via the pressure relief valve in the blue cap and run down the outside of the radiator core. This gives the impression that the radiator is leaking.

Fig. 1: Radiator appears to be leaking

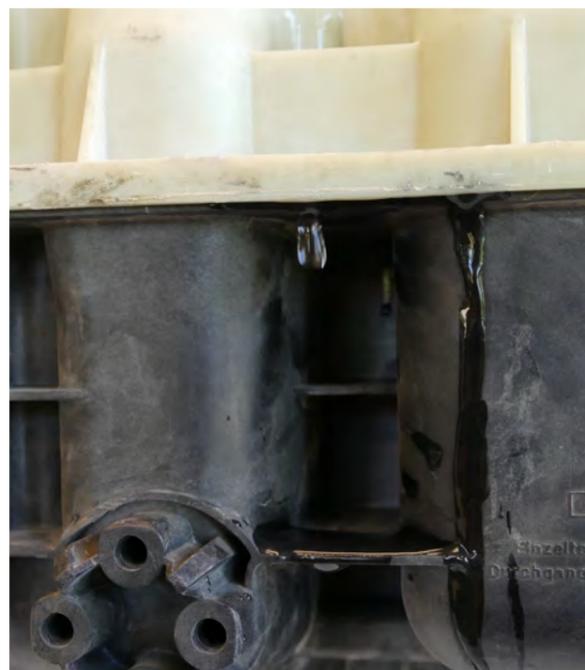
Fig. 2: Coolant dripping from expansion tank

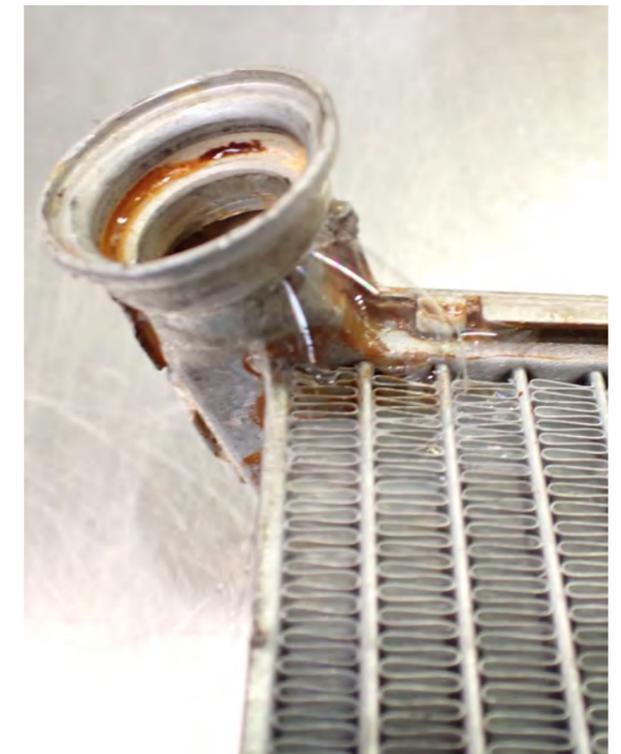
Fig. 2: Leaky heat exchanger due to corrosion

- Clean the heat exchanger with a suitable flushing unit. Then install a high-quality cabin filter to prevent future soiling.
- If there are leaks in the cooling system, the heat exchanger must be replaced. Never add sealant to the cooling system.

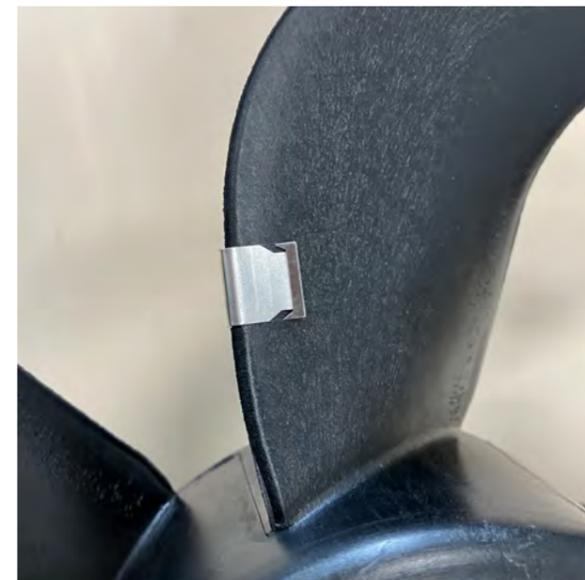
- Counterbalance weights have been removed
- Broken fan
- Dirt on the fan

Fig. 1: Metal clip as balancing weight

- Fans are finely balanced during manufacturing to ensure they operate with minimal vibration. The balancing weights (metal clips on the fan blades) must **not** be removed.
- Mechanical damage, deformation, or fractures lead to noises and vibrations. Install the fan and fan shroud carefully and do not bend them.

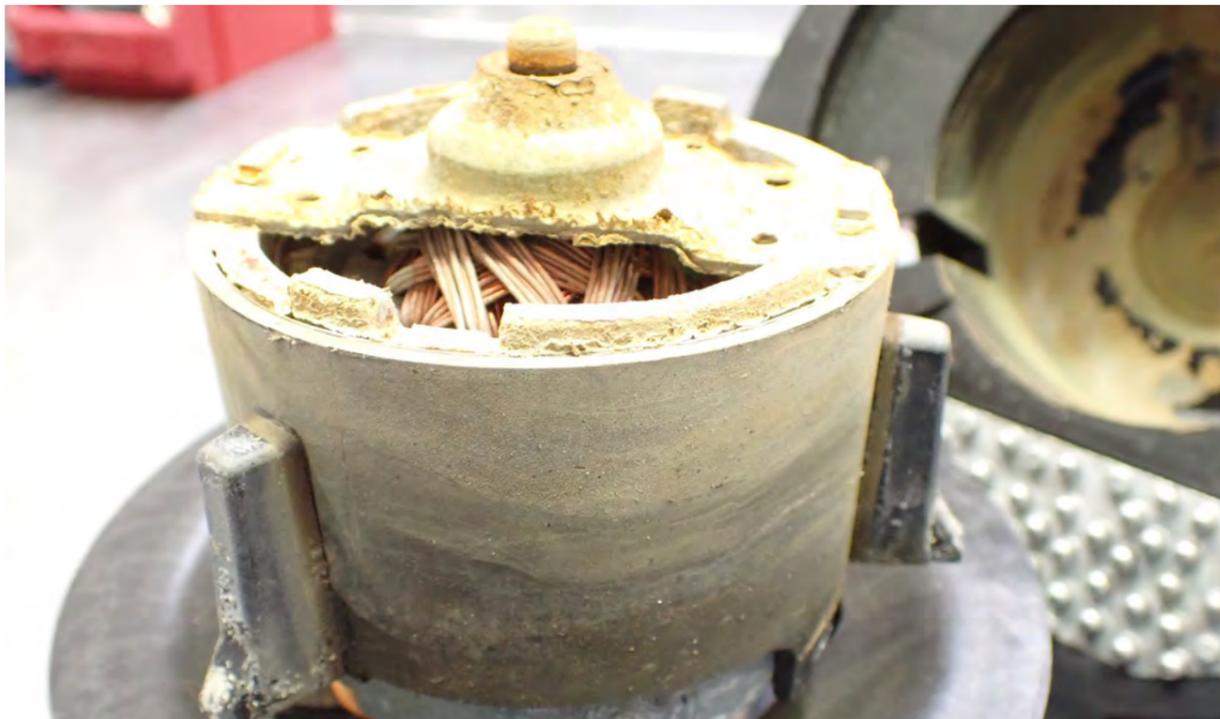
Fig. 4: Corrosion on the blower motor

- Replace the cabin filter annually. The air flow reduces if the filter is heavily soiled.
- Check whether the disconnected blower can be turned freely by hand. Stiffness reduces the air flow. Stiffness can also overload the controller (burnout).
- Regularly clean leaves and dirt from the water drain holes in the car body. Any rain water that accumulates could get into the blower and cause damage.

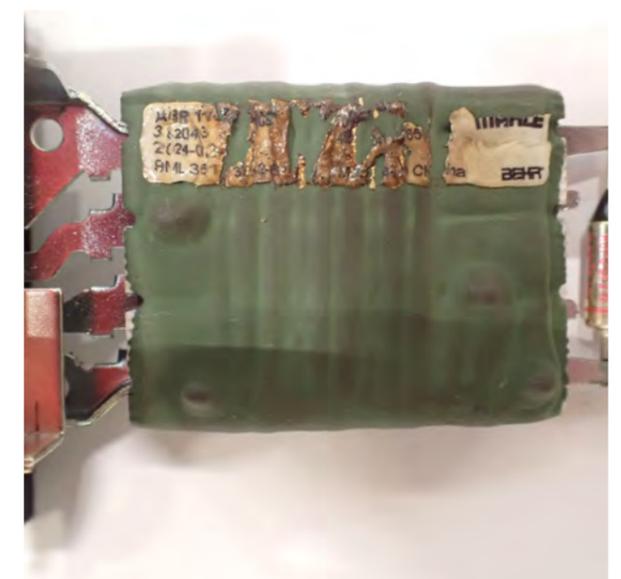
Fig. 2: Thermally overloaded blower controller

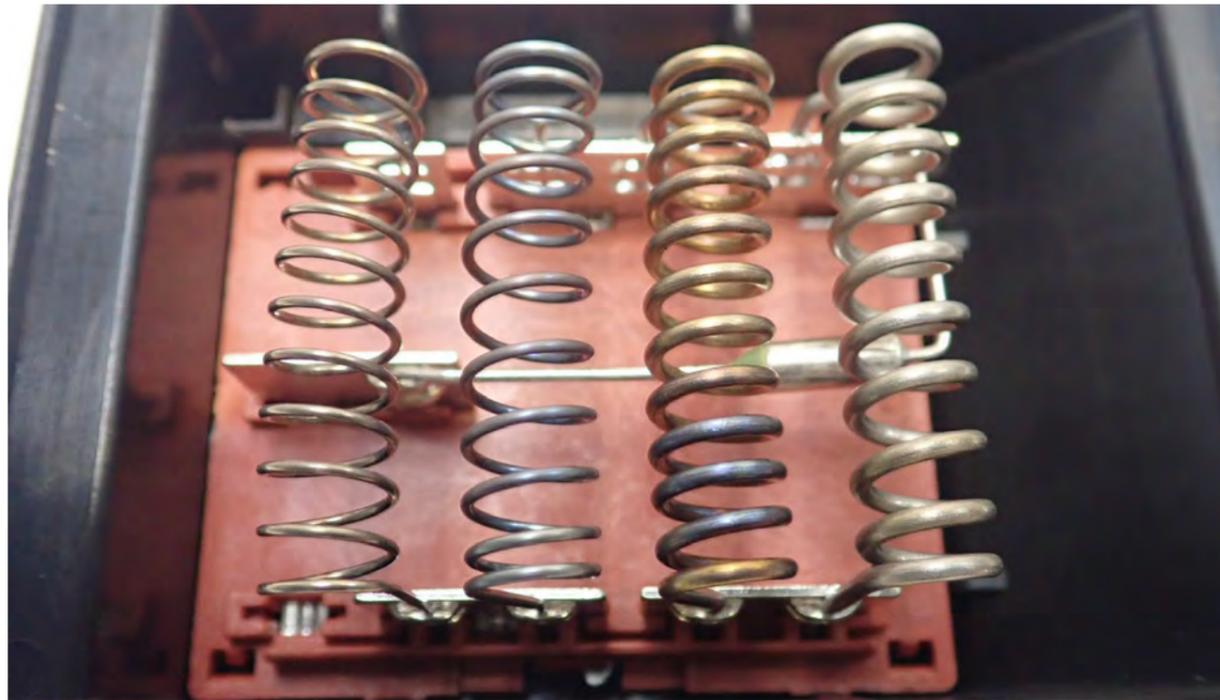
Fig. 3: Controller overloaded due to defective fan

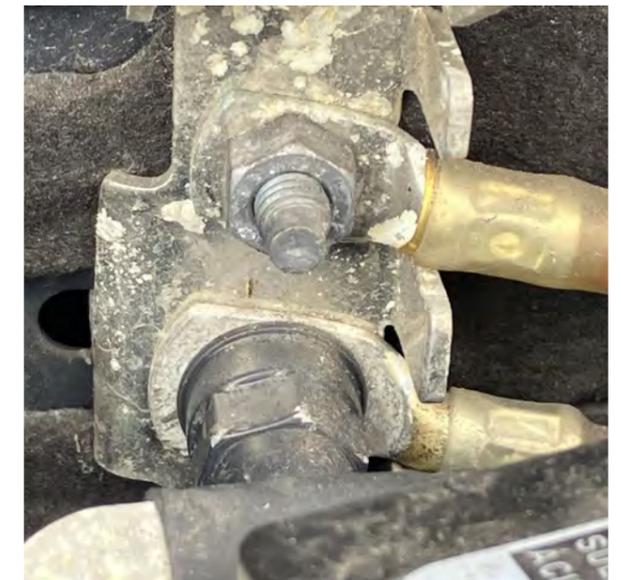
Fig. 2: Corrosion on the grounding point

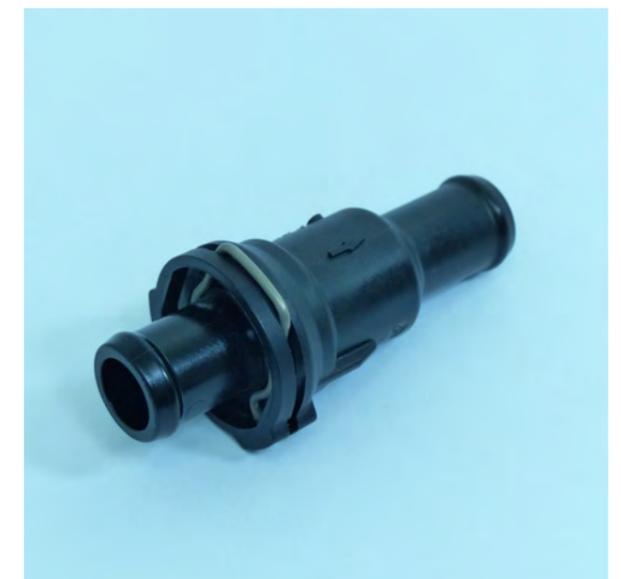
Fig. 2: Thermostat for transmission oil heat exchanger

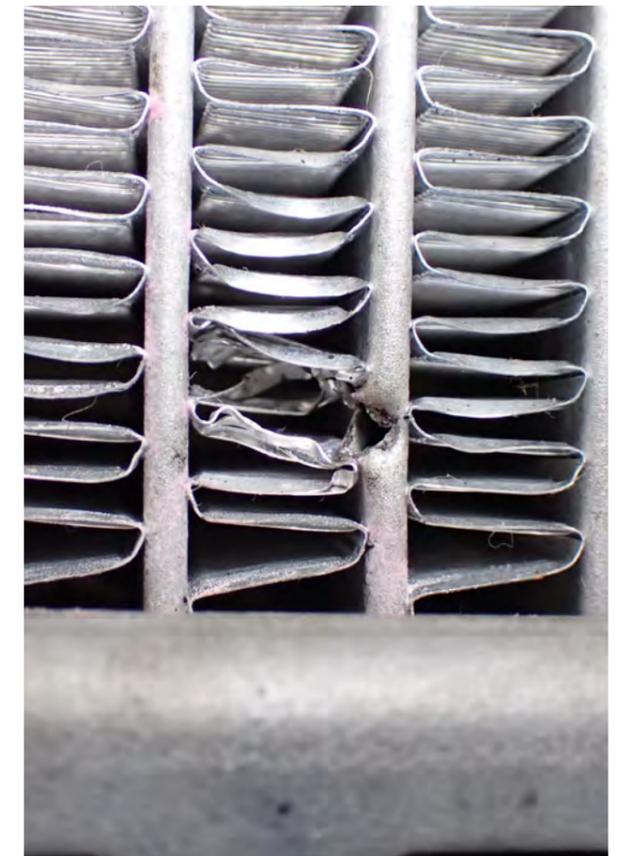
Fig. 3: Stone chipping

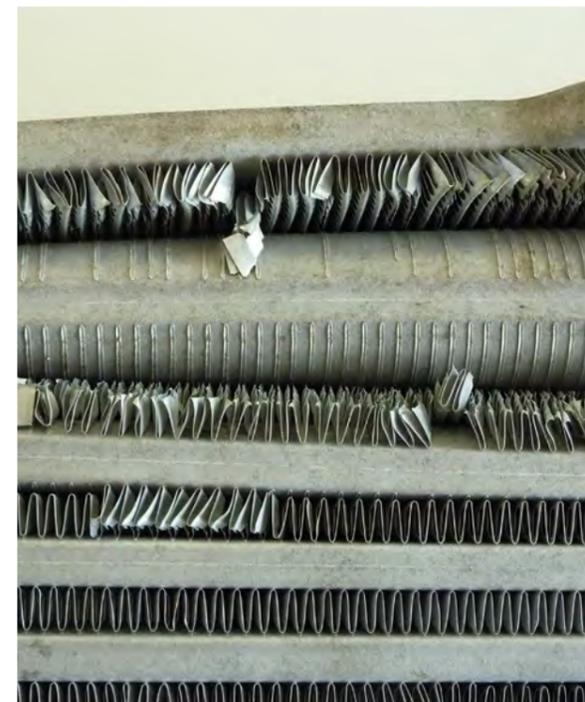
- A swollen charge air cooler is a clear sign of excessively high boost pressure. Check that the turbocharger regulation system is working properly and moving freely.
- A defective (closed) recirculation air valve can lead to extreme pressure peaks in the charge air path when the throttle valve is closed.

Fig. 1: Swollen tube

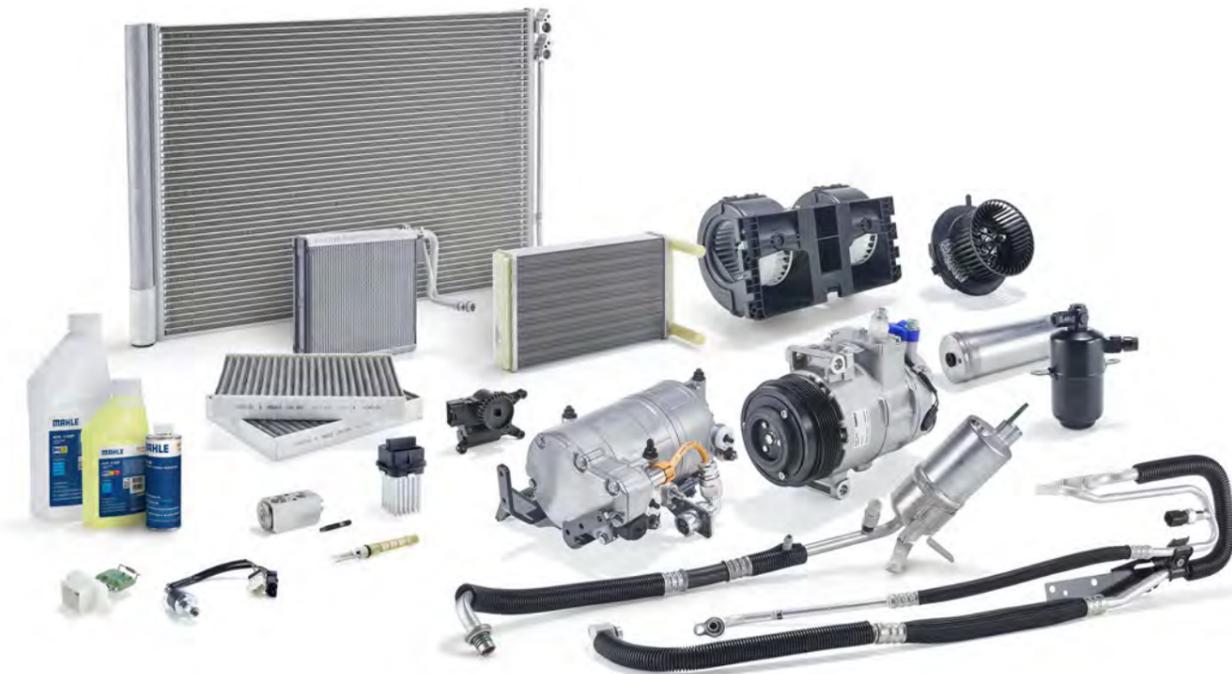
is known as the low-pressure side (LP: blue). The air conditioning compressor compresses the gaseous refrigerant, heating it to a high temperature. The refrigerant is then forced through the air conditioning condenser at high pressure in a process that extracts heat from the hot refrigerant, causing it to condense, i.e., change state from gas to liquid. Next, the filter-drier separates out contaminants and any moisture from the now liquid refrigerant. This ensures the effectiveness of the system and protects

Fig. 1: Air conditioning system components

the components from damage due to contaminants. The refrigerant now passes from the filter-drier to the expansion valve, which basically functions like a weir. Upstream of the weir, the value maintains a constant pressure, but downstream of the weir, the increase in volume causes the pressure to drop. Since the expansion valve is located directly upstream of the evaporator, the refrigerant expands into the evaporator. During evaporation (the change of state from liquid to gas), evaporation cooling is released. The

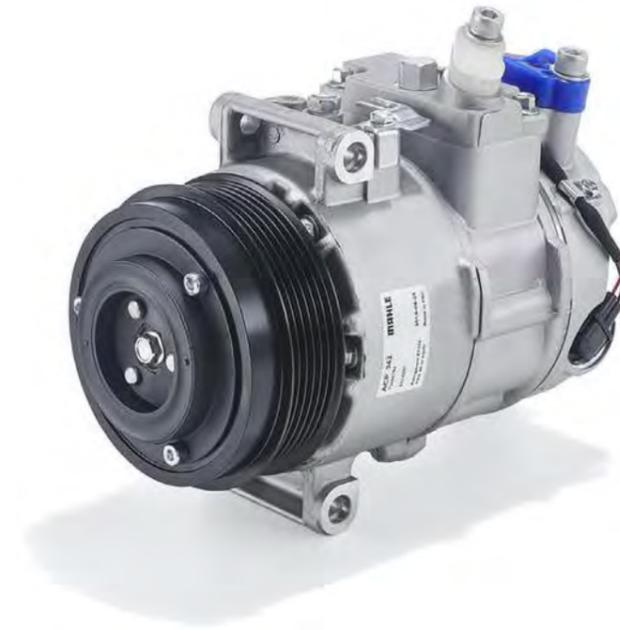
The air conditioning compressor is driven by the vehicle engine via a V-belt. The pistons in the compressor suck in the gaseous refrigerant and compress it.

Fig. 1: Air conditioning compressor

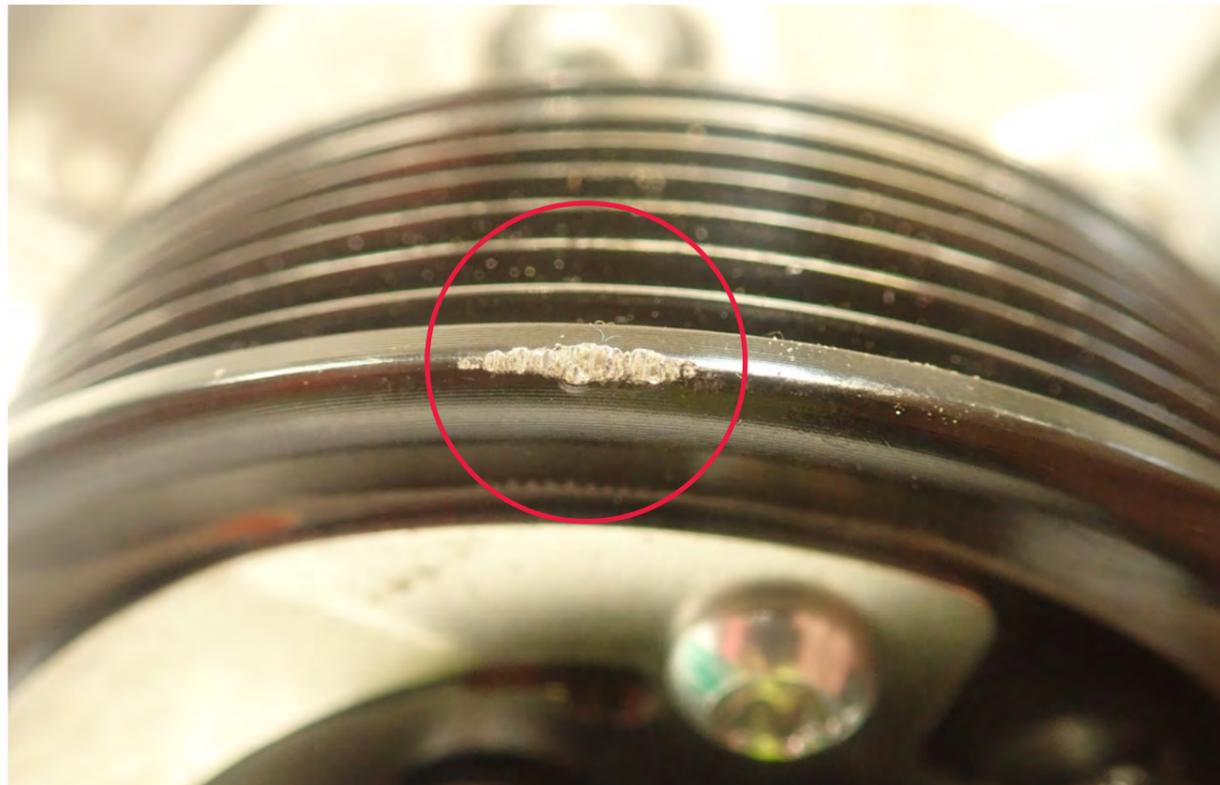
Fig. 1: Damaged belt pulley

- Transport the compressor carefully. Improper fitting may cause the belt pulley to deform.
- After accident damage, check the belt pulley for runout using a dial gauge

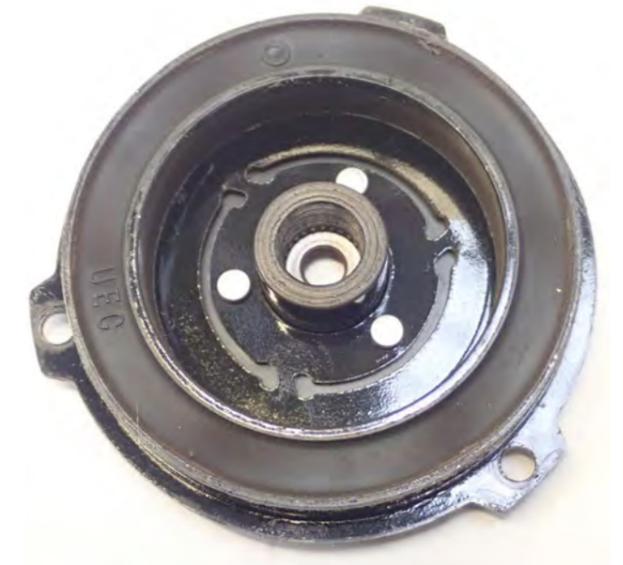
Fig. 2: Worn out teeth in the hub

- Vibrations in the belt drive put the teeth under load in both directions of rotation, causing mechanical wear to the teeth. As a result, the belt pulley no longer transmits power to the compressor.
- Check whether the overrunning alternator pulley is working properly. Inspect the belt tensioner and vibration damper on the crankshaft.
- If the automatic transmission is shifting hard, a transmission oil flush is strongly recommended.

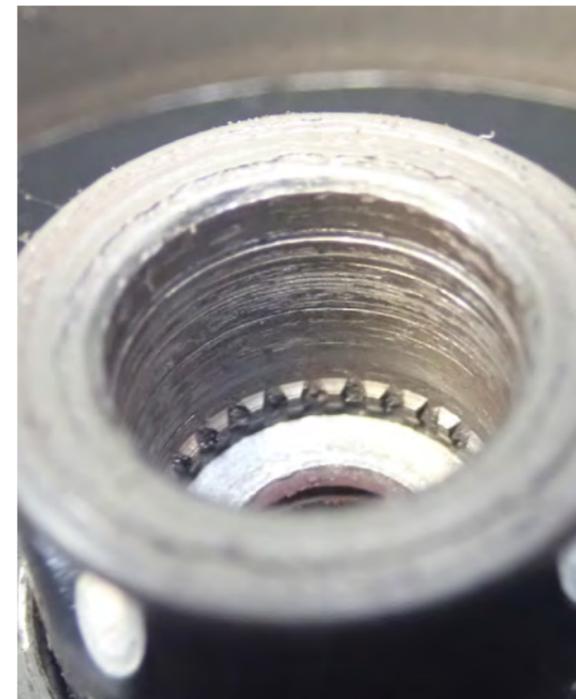
Fig. 3: Worn out teeth

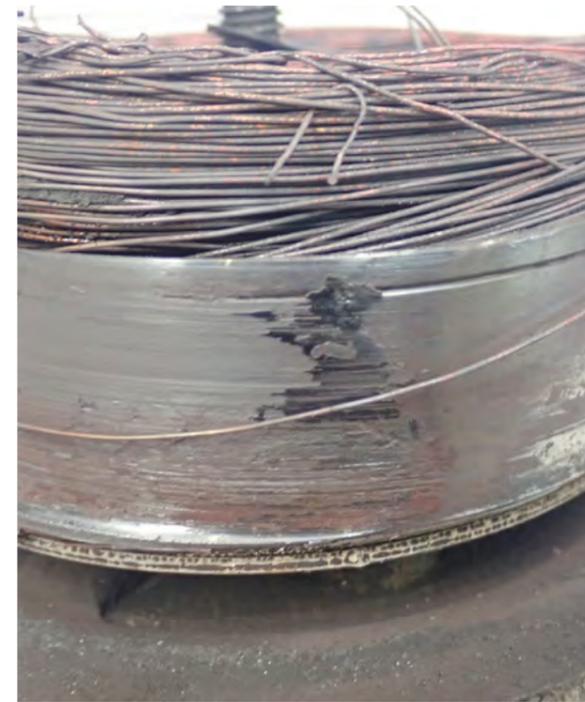
Fig. 1: Scuff marks on the coil body and burned-out coil

- Replace the compressor and belt.
- Check belt tensioner is working properly and replace if necessary.

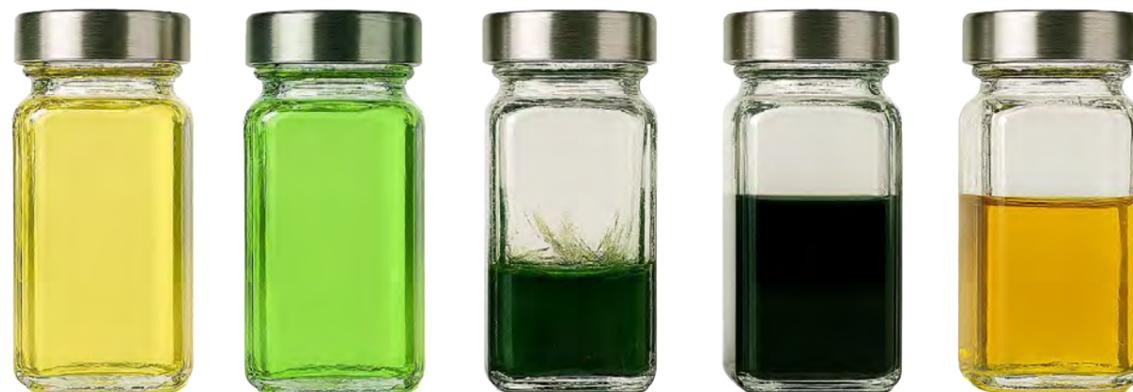
Black, burned compressor oil

Fig. 1: Black, burned compressor oil

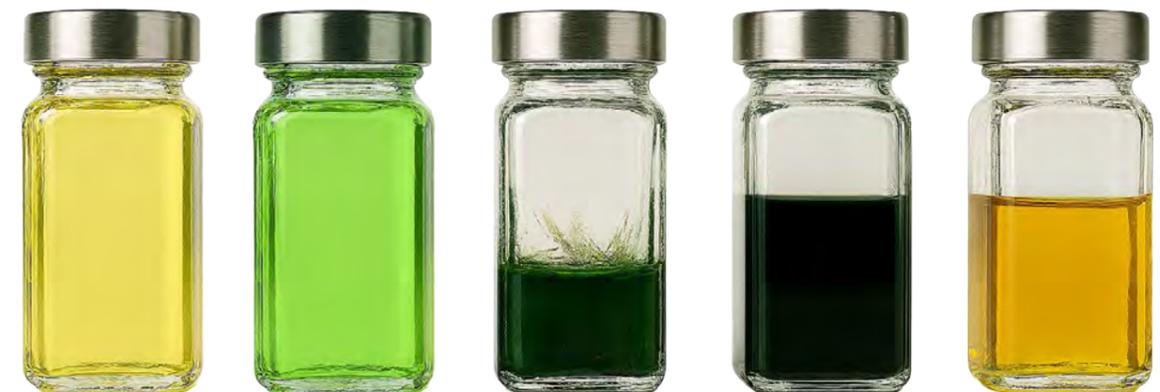
Very high water content in PAG oil

Fig. 1: Orange oil

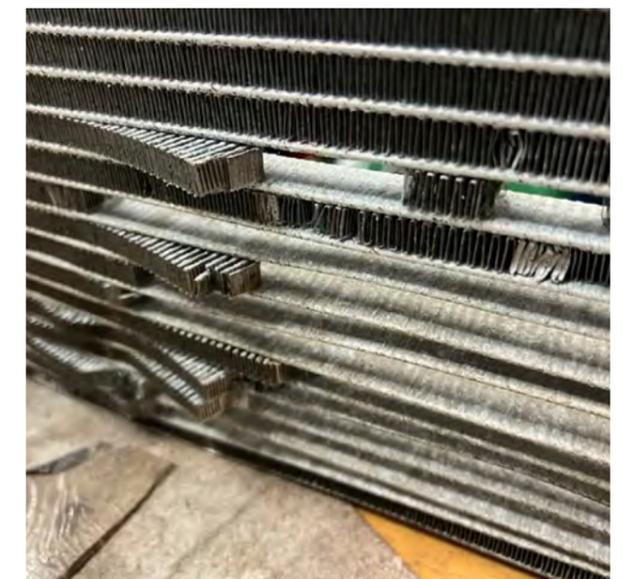
Fig. 2: Corroded cooling fins

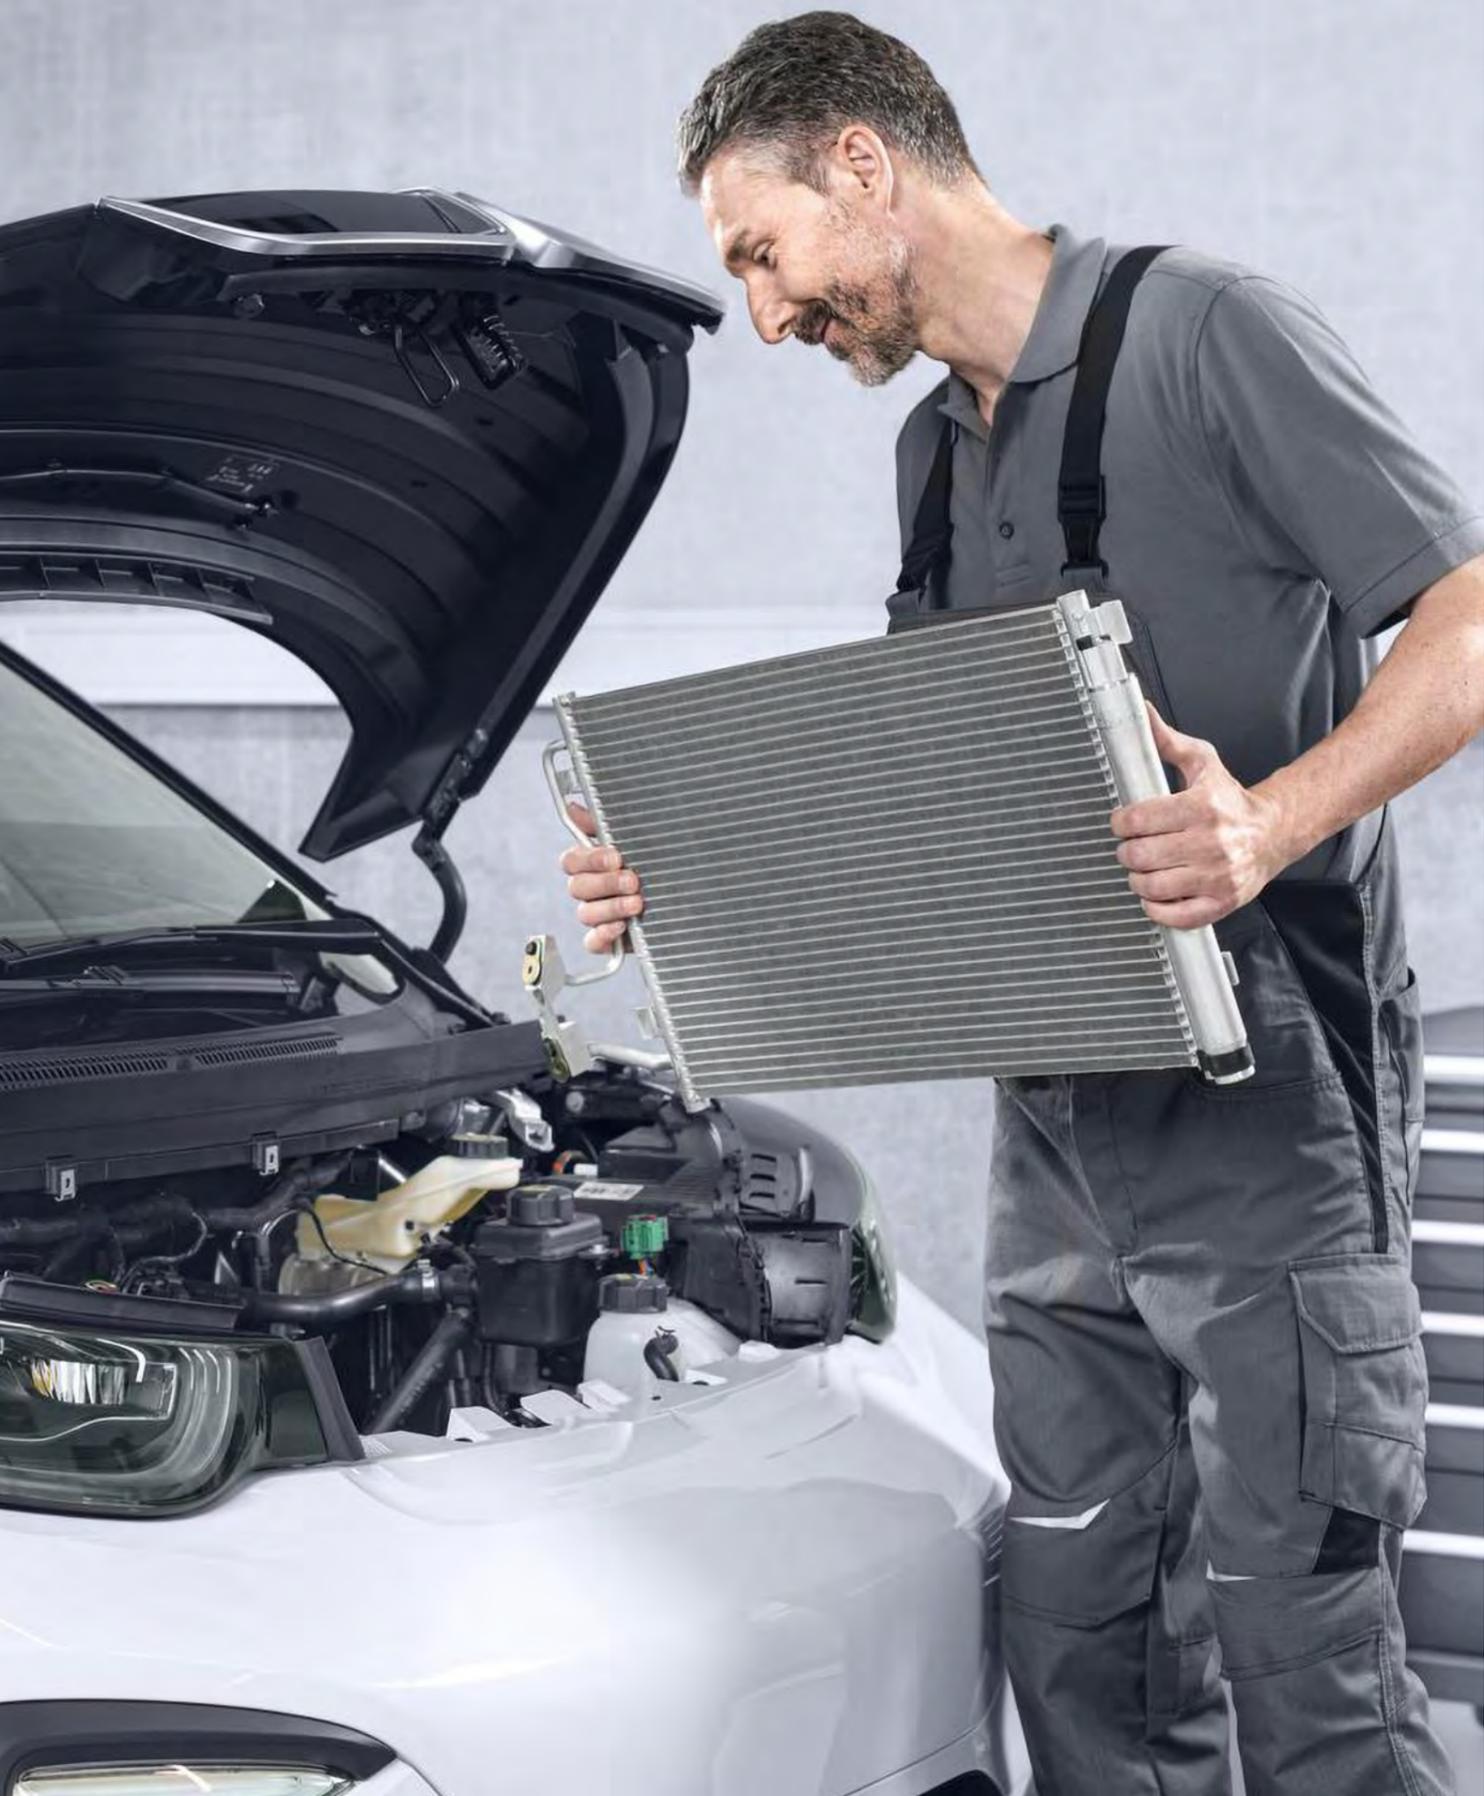
Fig. 1: Mechanical damage (stone chipping)

- Leaky condensers must be replaced. Never add sealants to the system. These sealants have little or no effect, and they will damage all the valves in an air conditioning service unit.
- Care should be taken not to damage the tubes when unpacking and installing the condenser.
- When washing the vehicle, do not spray wheel rim cleaner or insect remover onto the condenser.

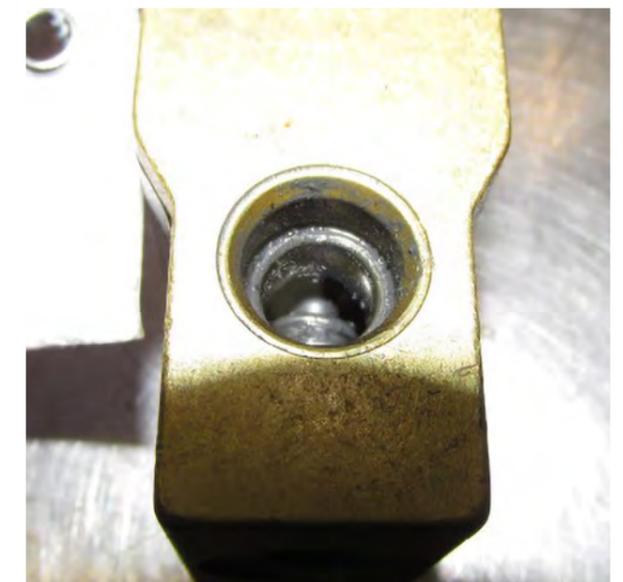
Fig. 2: Contaminants in the expansion valve

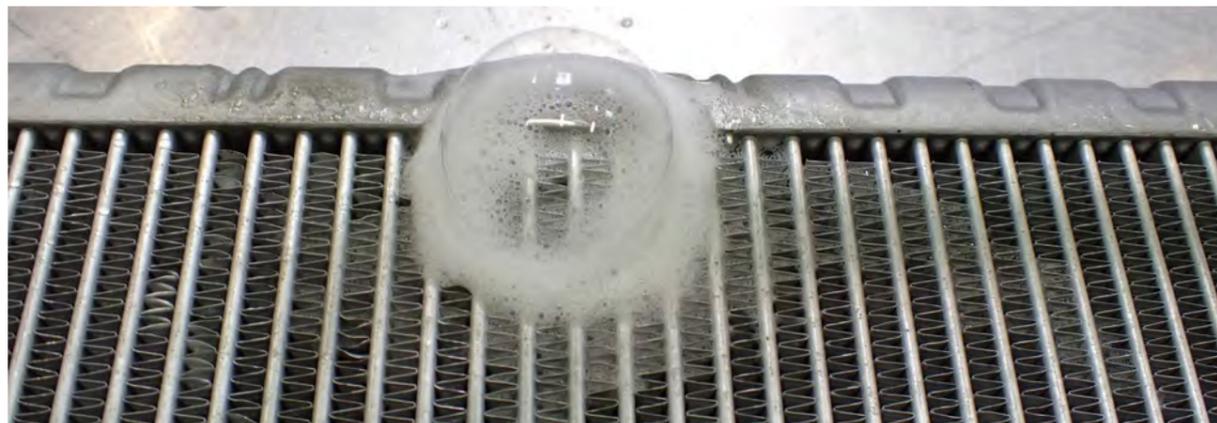
Fig. 3: Leaky evaporator

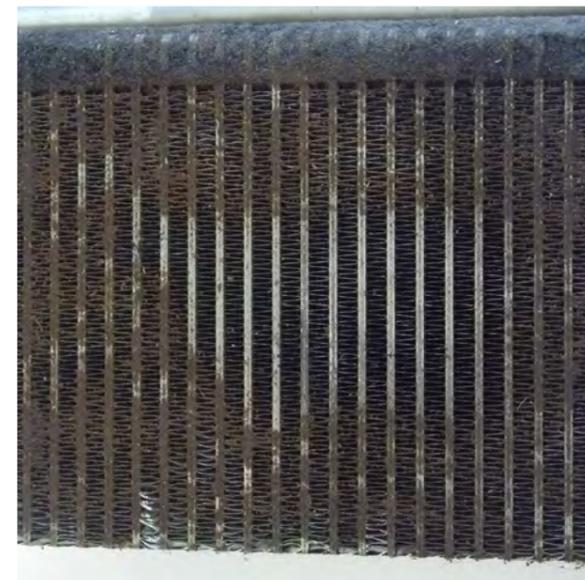
Fig. 1: Fouled and clogged evaporator

- Always fit high-quality cabin filters and replace them regularly—every year or every 15,000 km.
- Switch off the air conditioning 5 minutes before reaching your destination to allow the surface of the evaporator to dry.
- Treat the cabin using MAHLE OzonePRO, for example.
- Clean and disinfect the evaporator with an alcohol-based cleaner.

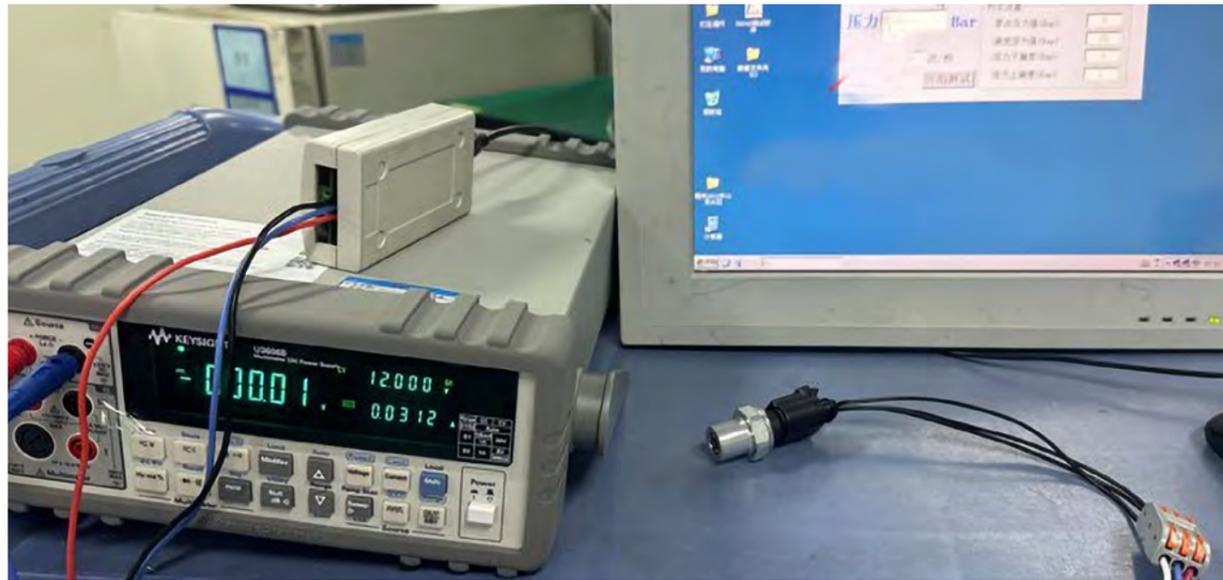
Fig. 4: Testing a pressure switch in the laboratory
