# Thermal Management

Damage scenarios: causes, remedies, and avoidance

This brochure summarizes typical damage scenarios, describes their causes, and provides tips for avoiding similar damage in the

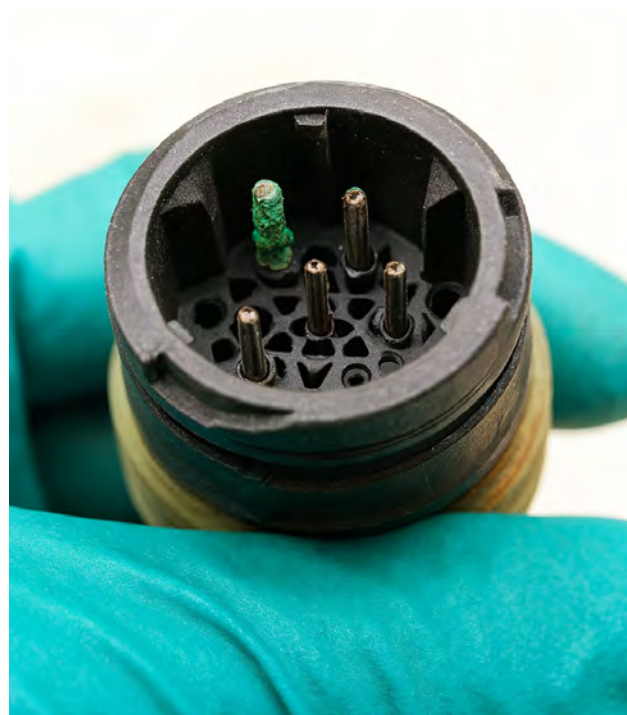
- Engine overheating (defective e-water pump)

- Electrical fault (short circuit, interruption)
- Defective fuse
- Broken cable
- Corrosion on plug connection
- Defective pump

Fig. 1: Corrosion on the connector plug

- Check the power supply to the coolant pump.  
Possible causes of an interruption: the electrical fuse, corrosion on plug connections, a fault at the grounding point, defects in the cable harness.

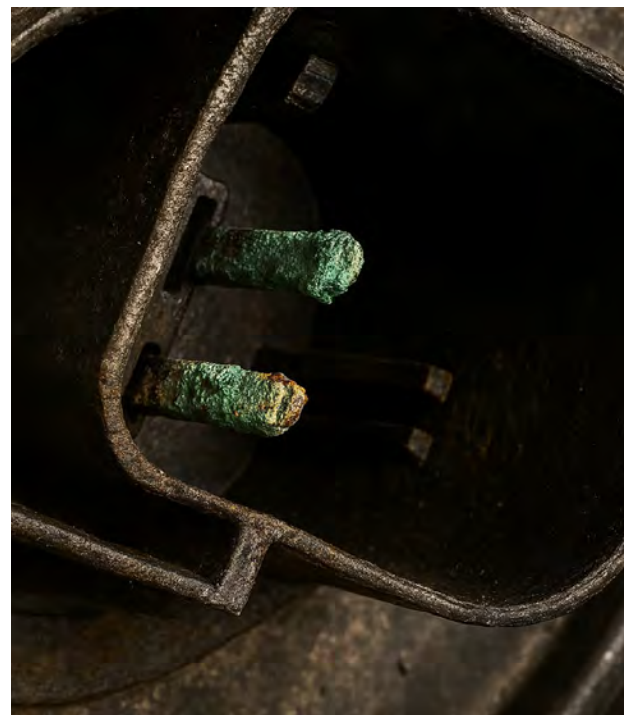
Fig. 2: Corrosion on plug connection

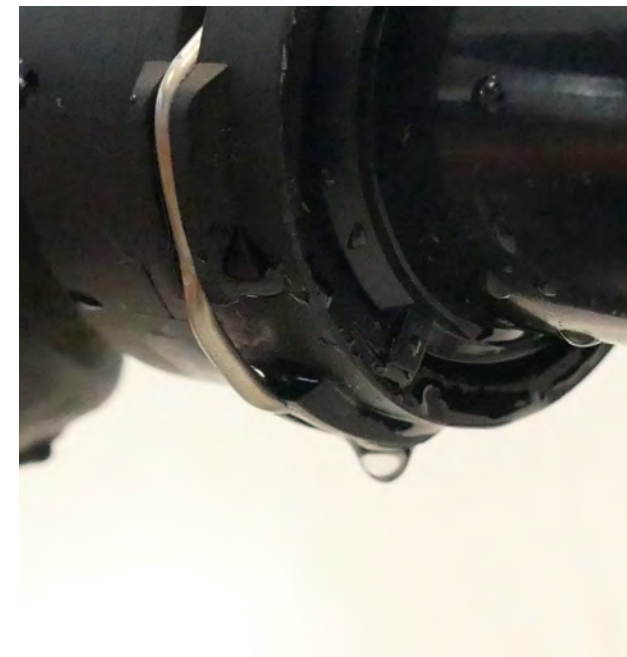
- Coolant leaking from the thermostat

- Seal on hose's quick-release coupling was not replaced

Fig. 1: Leaky O-ring

- Always replace seals on all opened connections in the cooling system.

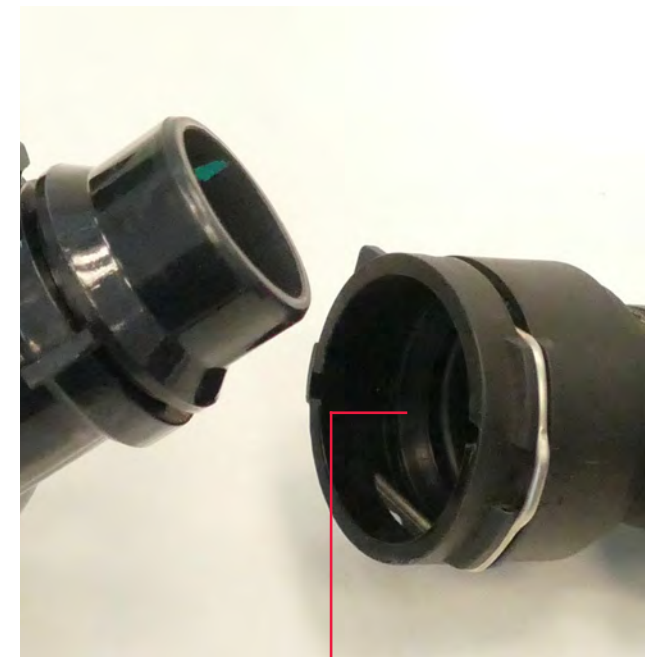
Fig. 2: Quick-release coupling

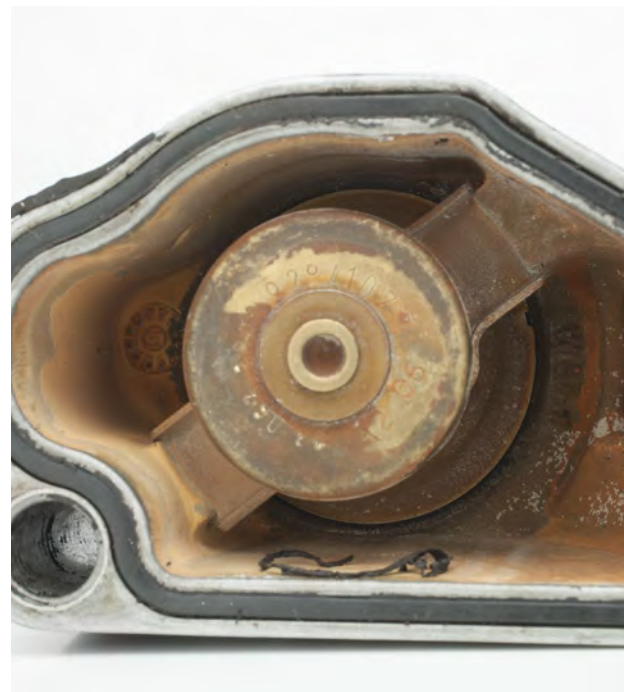
- Cooling system not bled correctly
- Thermostat jammed in "closed" position
- Thermostat jammed in "open" position
- Corrosion due to unsuitable or insufficient concentration of antifreeze
- Foreign objects (sealant residue, parts of the impeller of the old water pump, sealing compound) in the cooling system

Fig. 2: Corrosion on thermostat

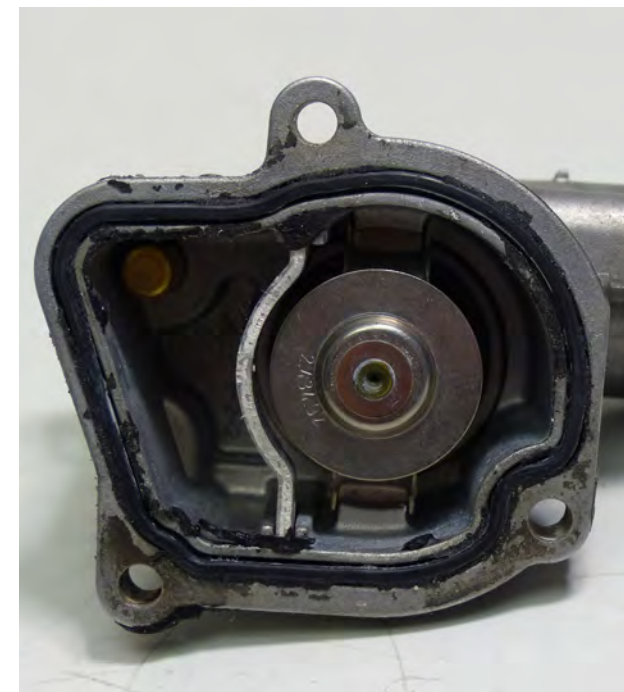
- Leaky thermostat housing
- Additional sealing compound applied to the thermostat

- Seal damaged by additional use of sealing compound

Fig. 1: Sealing compound on thermostat housing

thermostat seals. Oil causes seals used for coolant to swell and crack.

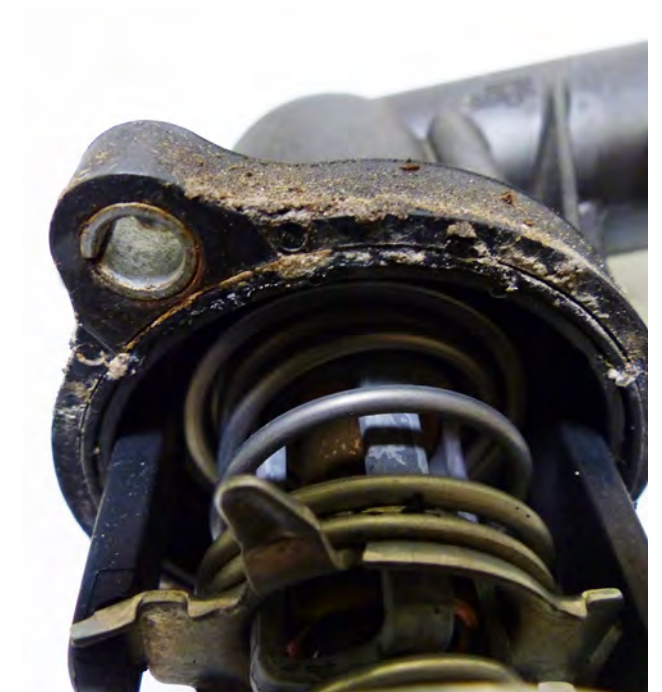
Fig. 2: Seal damaged by additional sealing compound

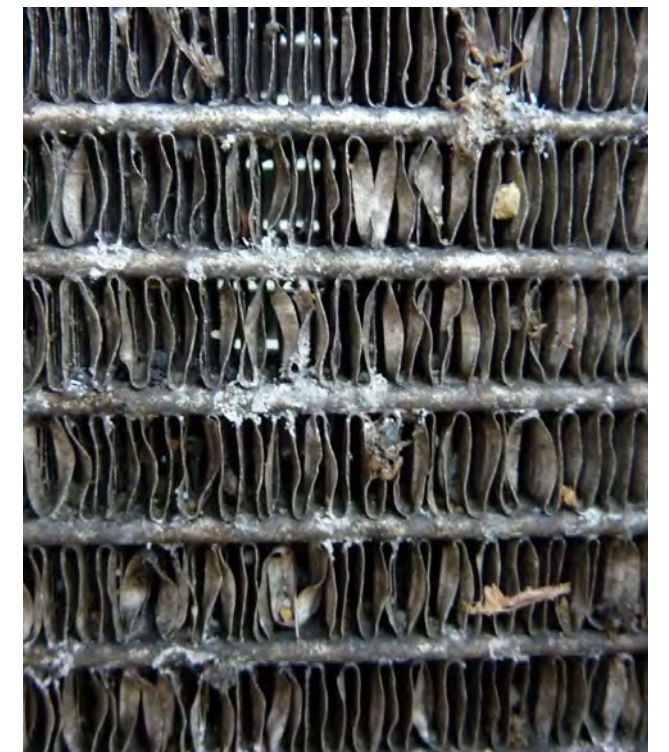
- Inadequate heat exchange due to external soiling of the cooling fins (dirt, insects, leaf debris)
- Contaminants between condenser and radiator (leaves, dirt)

Fig. 2: Contaminants and deformed cooling fins

Never use a high-pressure cleaner, as the water jet will damage the cooling fins.

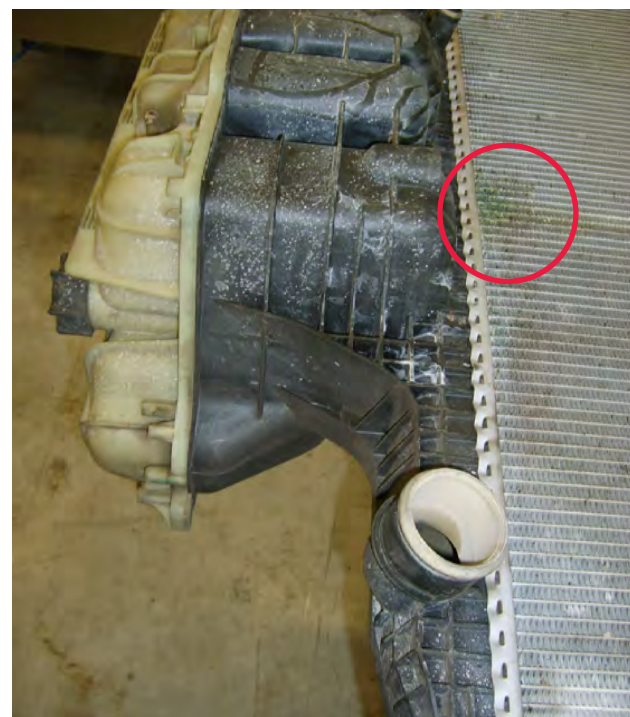
- In truck radiators with top-mounted expansion tanks, space must be left to allow for pressure equalization. If this space is also filled with coolant, excess coolant will escape via the pressure relief valve in the blue cap and run down the outside of the radiator core. This gives the impression that the radiator is leaking.

Fig. 1: Radiator appears to be leaking

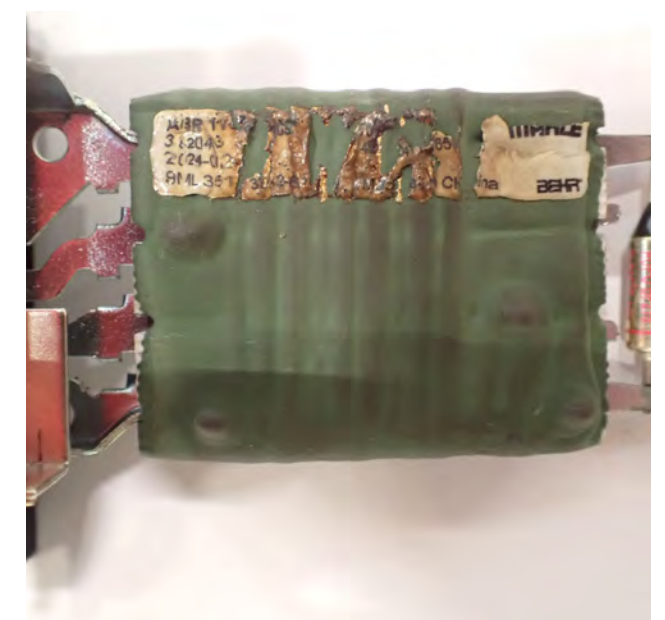
Fig. 2: Thermally overloaded blower controller

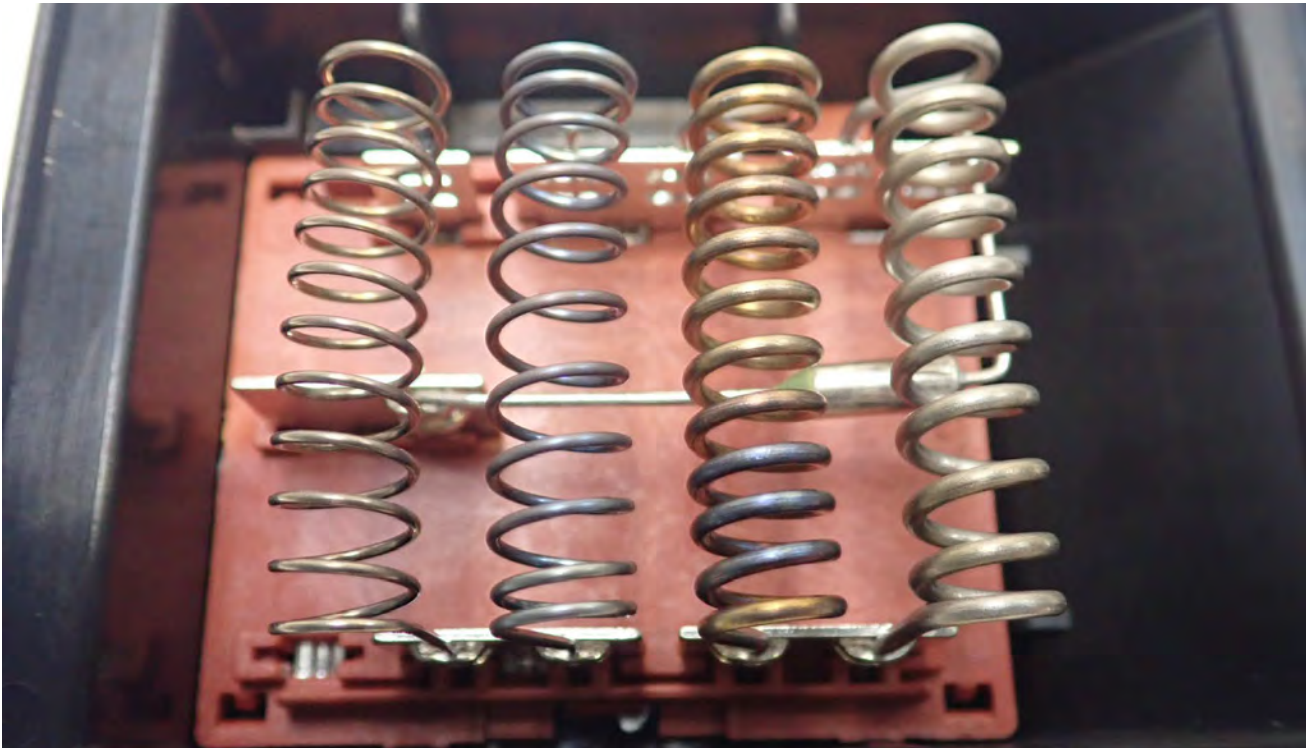
Fig. 3: Controller overloaded due to defective fan

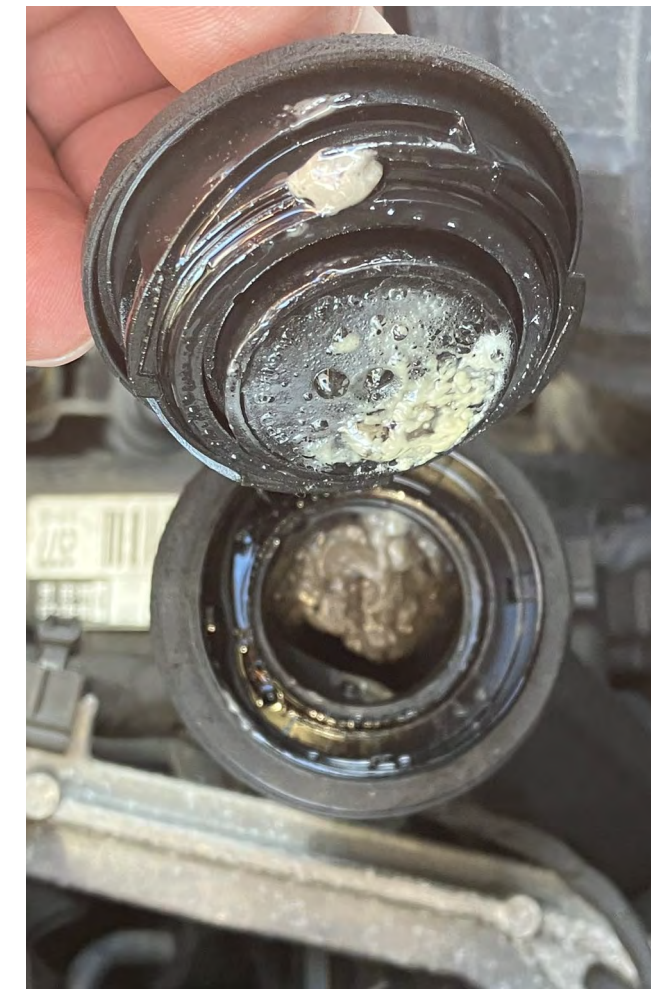
Fig. 3: Oil-in-water emulsion in the oil filler neck

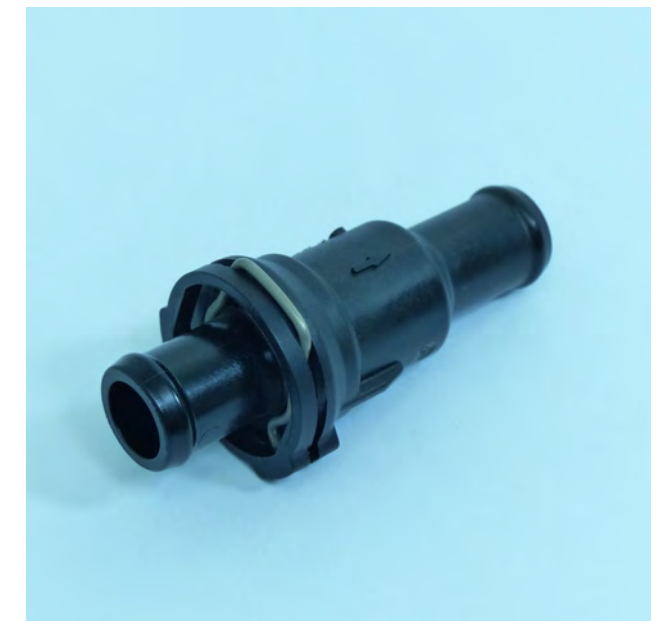
Fig. 2: Thermostat for transmission oil heat exchanger

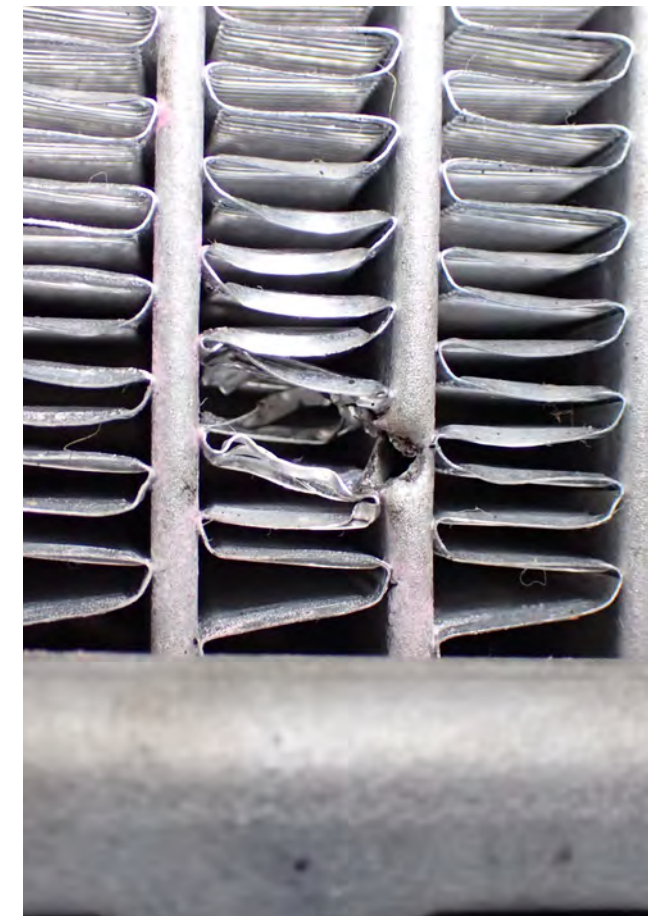
Fig. 3: Stone chipping

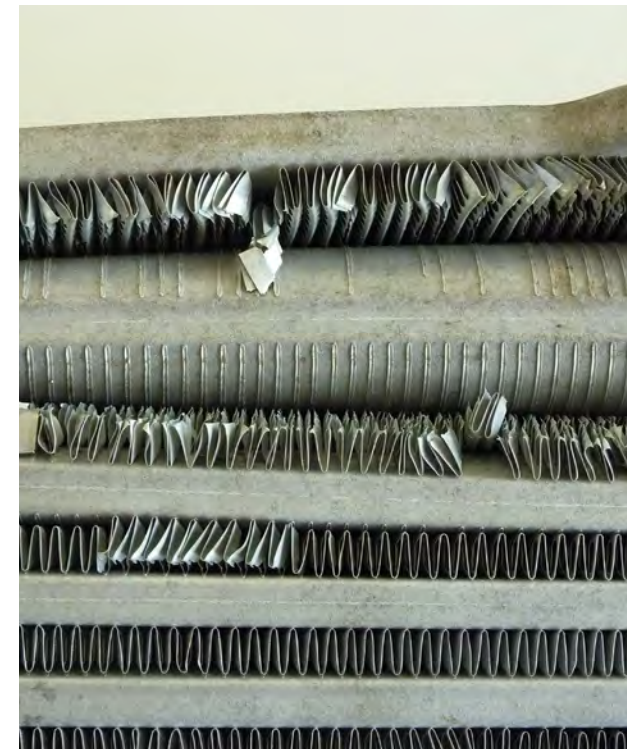
Fig. 1: Swollen tube

- A swollen charge air cooler is a clear sign of excessively high boost pressure. Check that the turbocharger regulation system is working properly and moving freely.
- A defective (closed) recirculation air valve can lead to extreme pressure peaks in the charge air path when the throttle valve is closed.

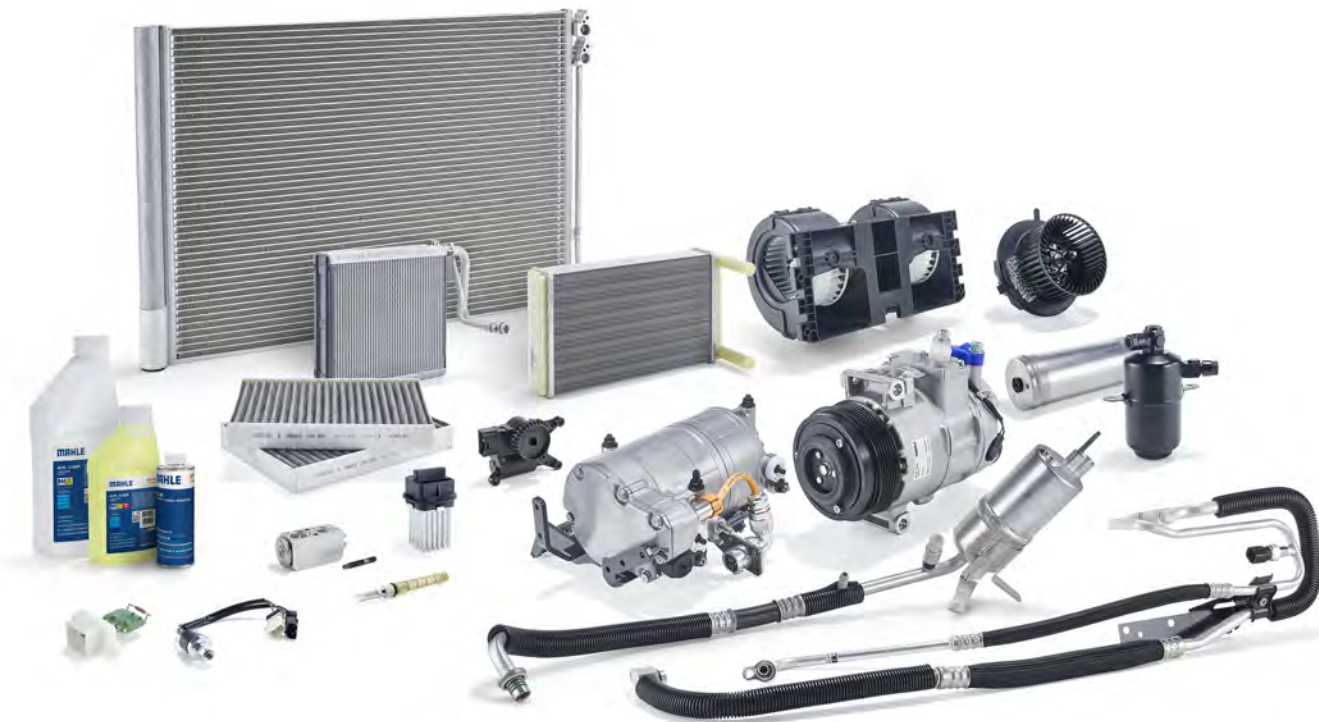
is known as the low-pressure side (LP: blue). The air conditioning compressor compresses the gaseous refrigerant, heating it to a high temperature. The refrigerant is then forced through the air conditioning condenser at high pressure in a process that extracts heat from the hot refrigerant, causing it to condense, i.e., change state from gas to liquid. Next, the filter-drier separates out contaminants and any moisture from the now liquid refrigerant. This ensures the effectiveness of the system and protects

Fig. 1: Air conditioning system components

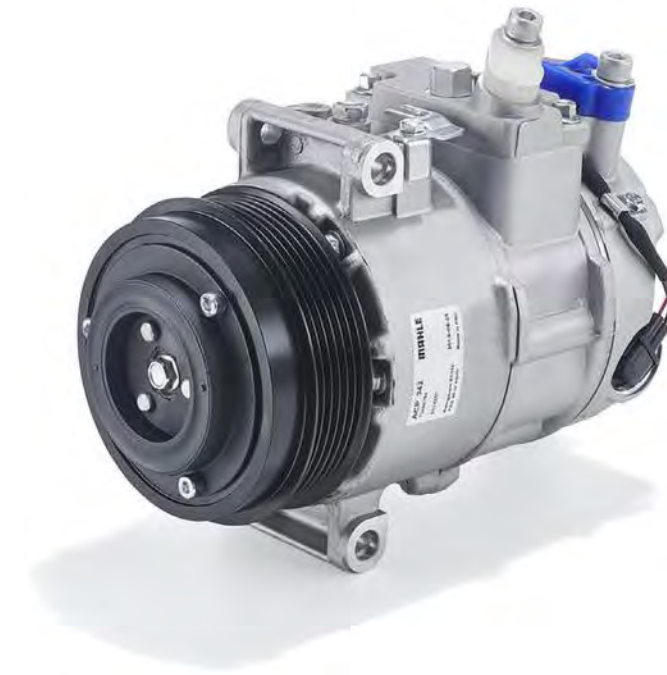
*The air conditioning compressor is driven by the vehicle engine via a V-belt. The pistons in the compressor suck in the gaseous refrigerant and compress it.*

Fig. 1: Air conditioning compressor

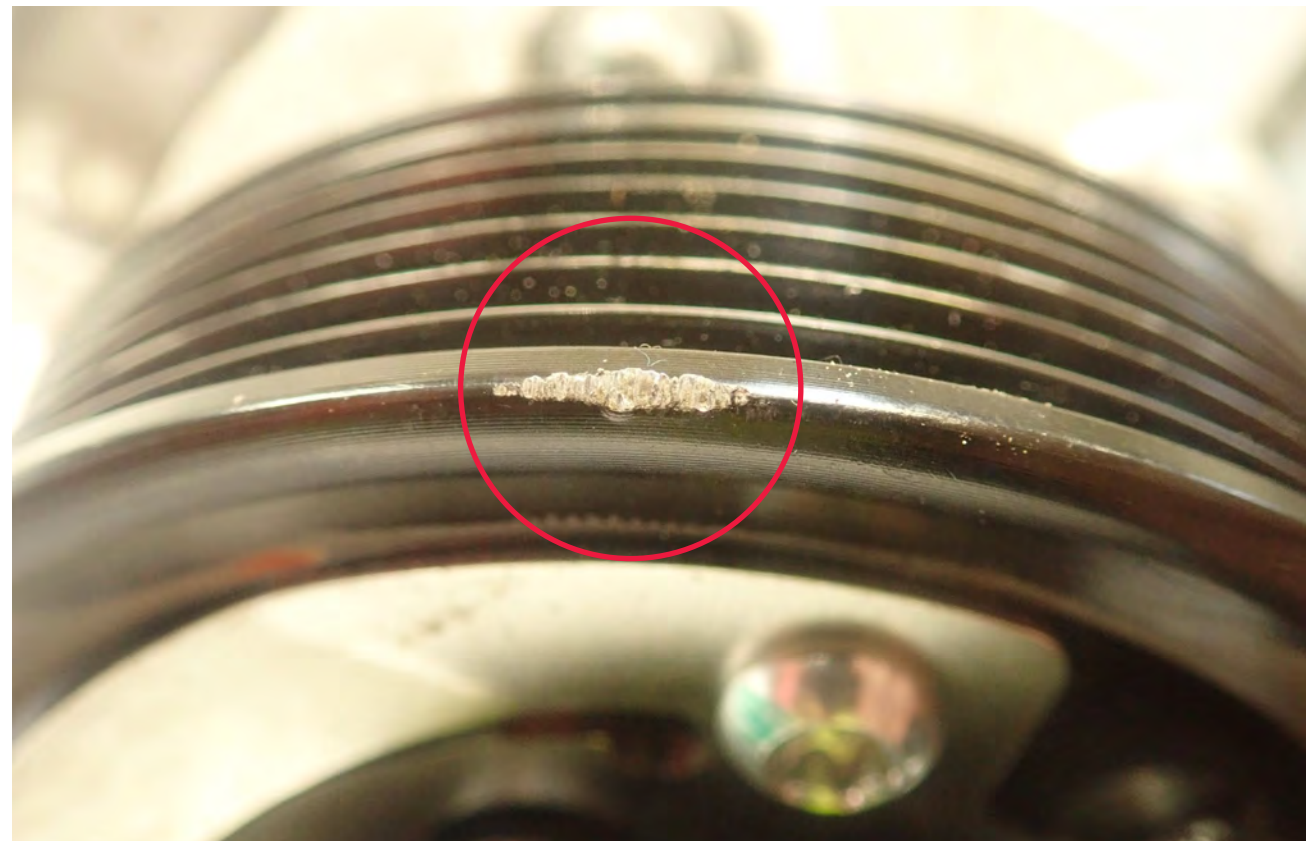
Fig. 1: Damaged belt pulley

- Transport the compressor carefully. Improper fitting may cause the belt pulley to deform.
- After accident damage, check the belt pulley for runout using a dial gauge

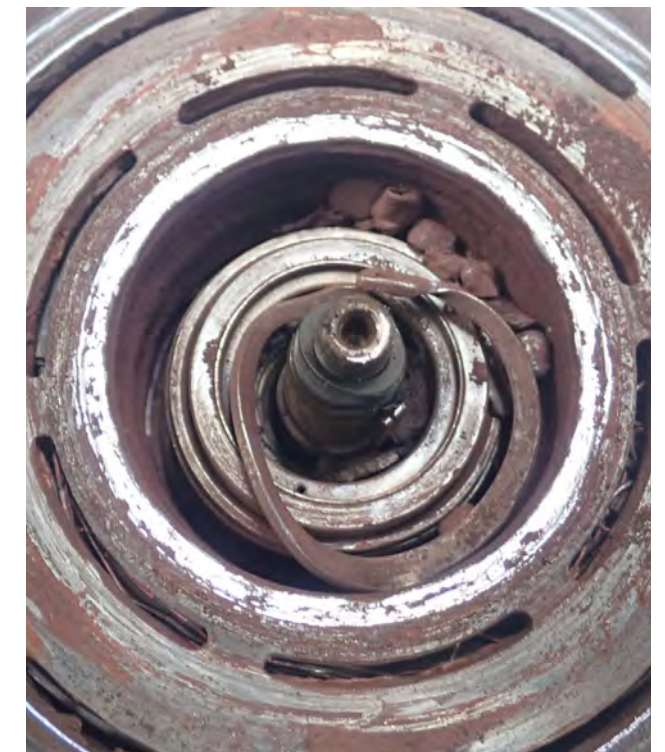
Fig. 2: Defective ball bearing

- Replace the compressor and belt.
- Check belt tensioner is working properly and replace if necessary.

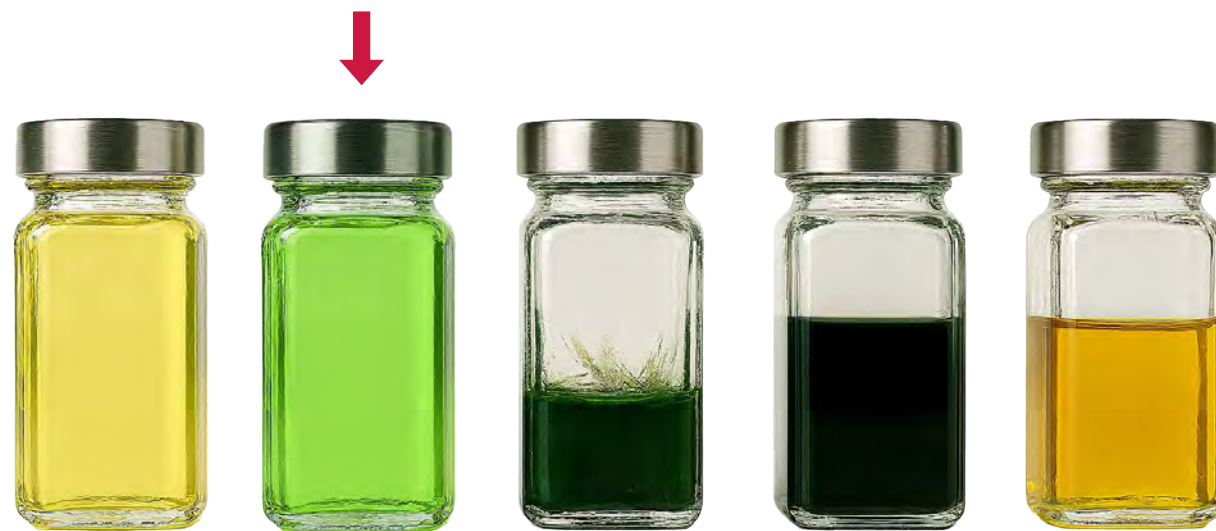
Too much contrast agent in the oil

Fig. 2: Green oil

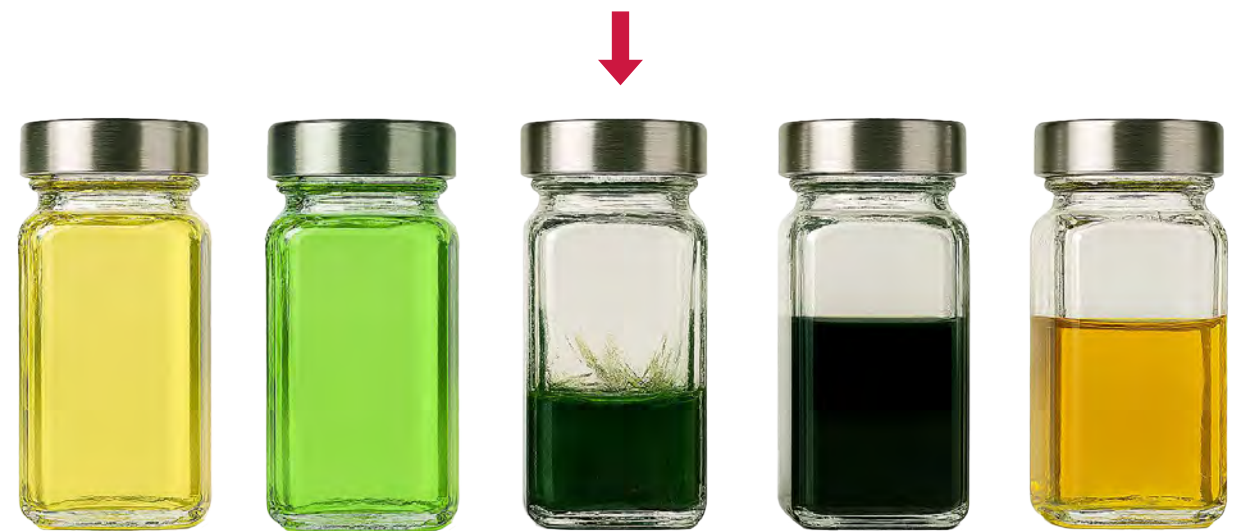
Contaminated oil with metallic abrasion particles and chips

Fig. 1: Silvery, dark-green oil

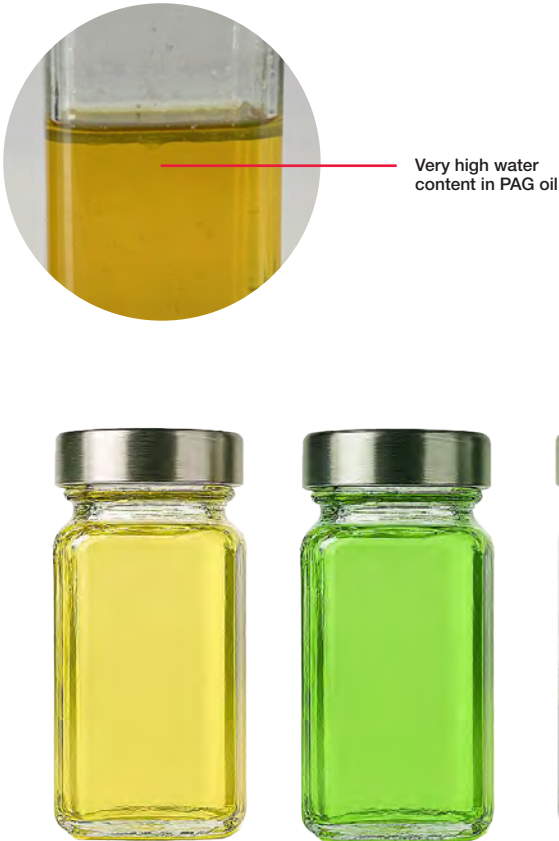
Fig. 1: Orange oil

- The filter-drier should be replaced at every air conditioning service, every two years. If the air conditioning system is opened to replace a component, a new filter-drier must be fitted. The absorption capacity of the granules (silica gel) in the drier is limited. Moisture that enters the compressor oil reacts chemically with the oil. This causes orange discoloration and also produces acids that attack nonferrous metals in the system in particular. The chemical reaction between moisture and PAG oil is irreversible. The vacuum of an air conditioning service unit cannot remove moisture from the oil.
- The system must be flushed thoroughly.
- Filter-drier and expansion valve must be replaced.

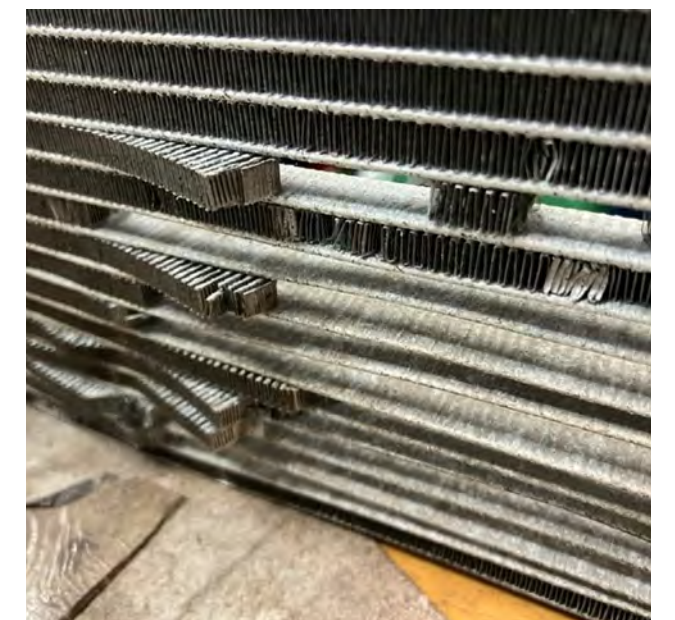
Fig. 2: Corroded cooling fins

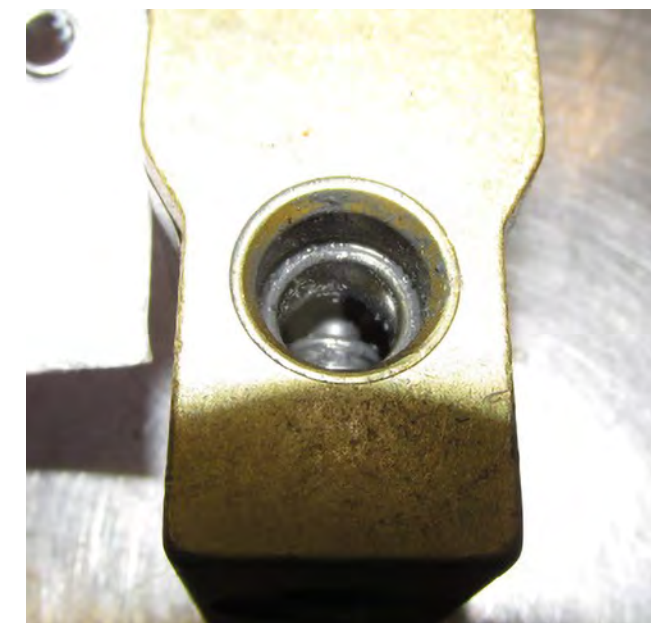
Fig. 2: Contaminants in the expansion valve

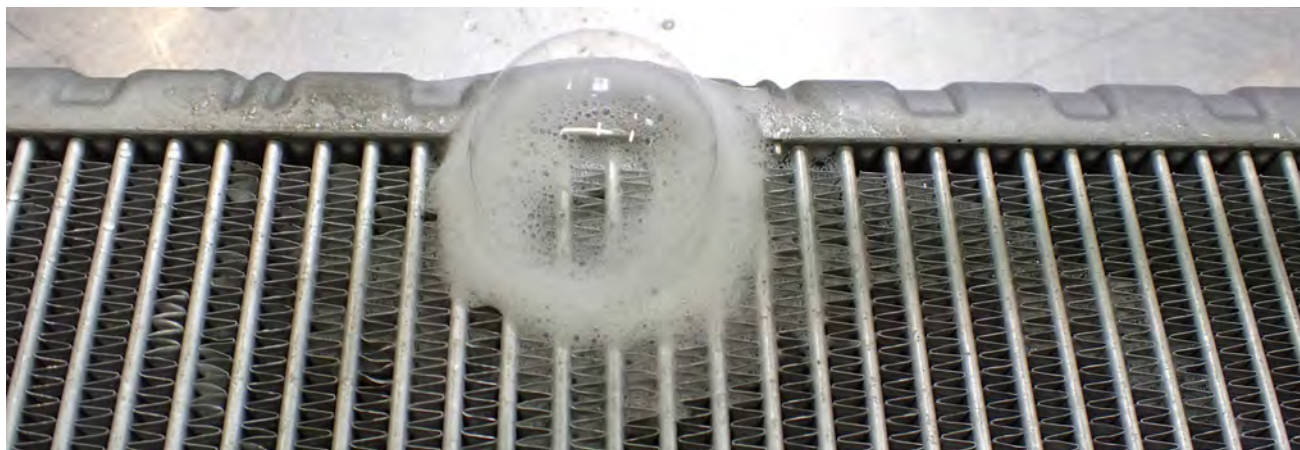
Fig. 3: Leaky evaporator

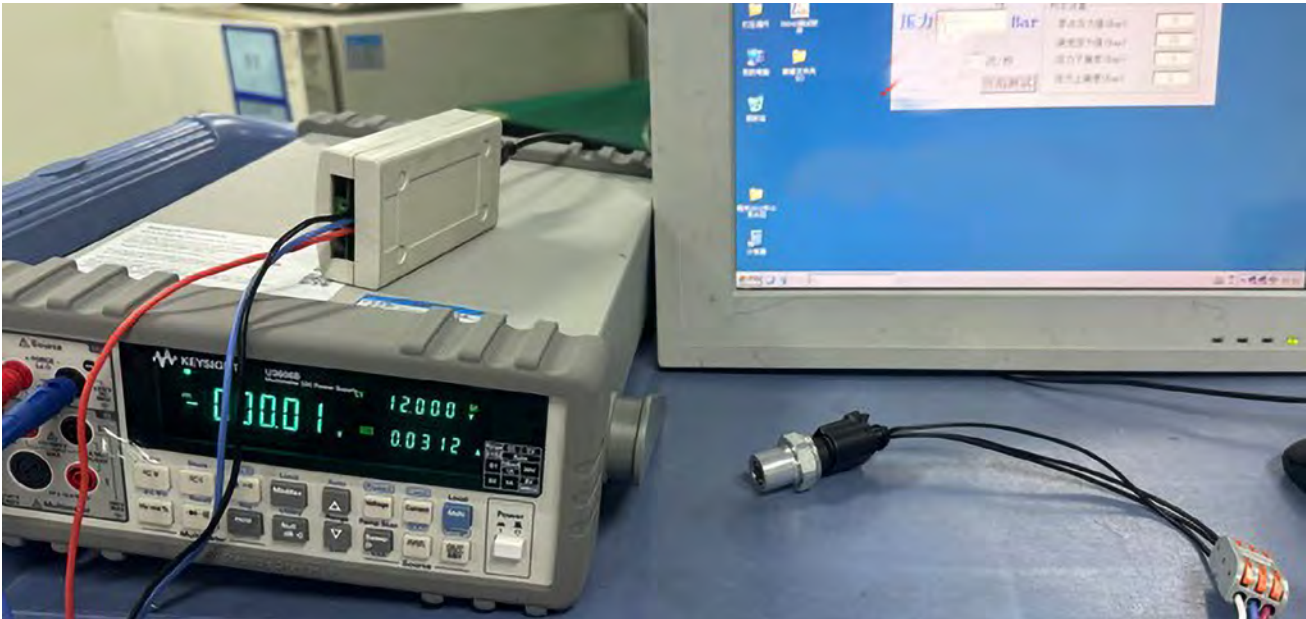
Fig. 4: Testing a pressure switch in the laboratory
