### Issue no. 06/2016: Thermal problems after a thermostat change: air in the cooling circuit

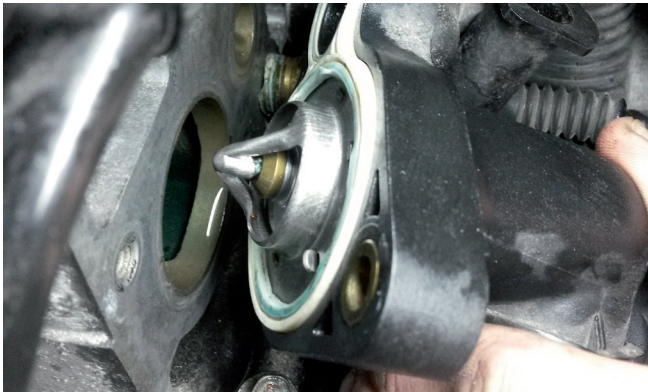
In order to replace the thermostat, the cooling circuit of the engine needs to be opened—as a result, cooling water escapes and air enters the system (see Figure 1). If these increasingly complex systems are not completely bled after the repair, air pockets remain in the circuit.

Figure 1: When the cooling circuit is open, cooling water escapes and air enters the system.

This not only results in inadequate cooling water circulation (and thus poor heating and cooling performance), but can also lead to serious engine damage—because the trapped air can potentially cause local overheating.

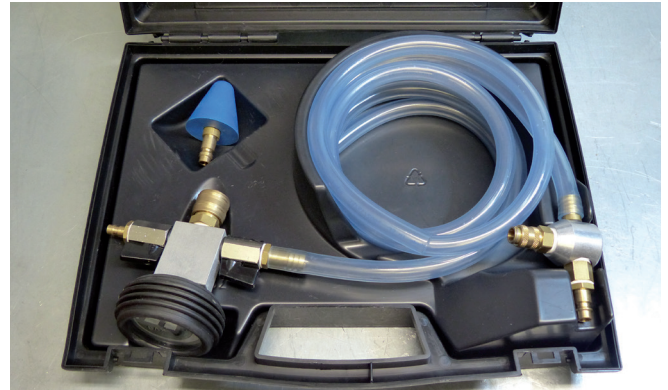
Using a vacuum-venting device to fill the circuit has proved to be very reliable (see Figure 2). By means of a standard repair shop compressed air connecti-

Figure 2: Standard vacuum-venting device.

**IMPORTANT!** It is imperative that the cooling circuit is completely bled each time it is opened!

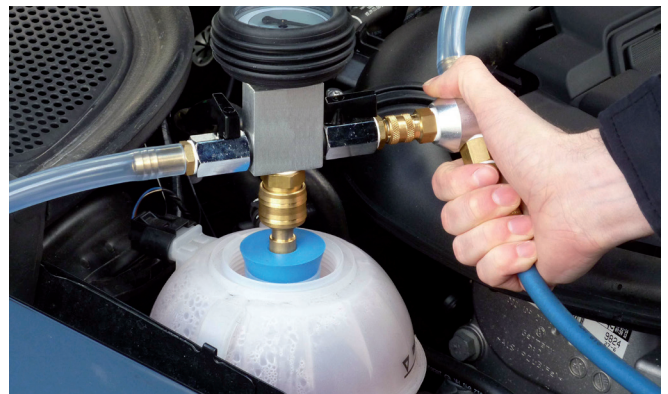
on, this creates a vacuum in the cooling system (see Figure 3). The air is thereby completely evacuated from the circuit and new coolant is sucked in bubble-free by the vacuum. This ensures that all isolated air pockets are removed from the cooling circuit.

Figure 3: A vacuum is created in the system by means of the Venturi effect.
