Issue no. 08/2016

Shaft separation in alternators

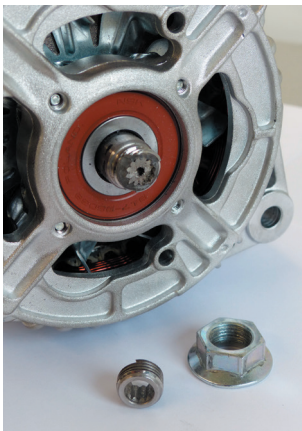
Figure 1: Separated thread

In some cases, the pulley from the old alternator must be fitted onto the new alternator. In doing so, do NOT use an impact driver to tighten the nut, as this can cause the shaft to fracture and separate.

An insufficient tightening torque applied to the nut can also result in significant damage to the alternator, since the inside ring of the rolling bearing is tensioned by means of the pulley nut. Lack of the appropriate pretension leads to increased wear on the shaft and subsequent wobble. The rotor and stator can thus come into contact, ultimately causing a short circuit and the complete failure of the alternator.

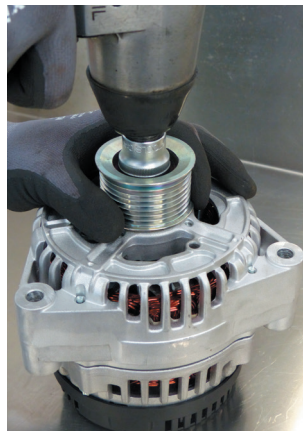
Figure 2: Impact drivers are only used to loosen the pulley, NEVER to tighten it!

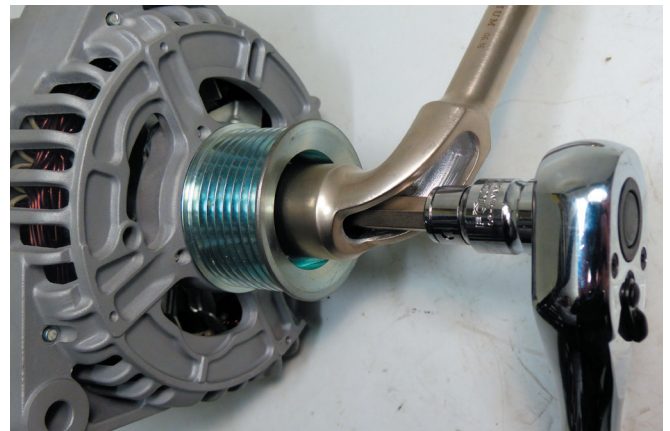
Figure 3: Always use a hold-down tool and torque spanner to tighten the pulley.

Always use an appropriate hold-down tool (hexagon socket or multipoint) to secure the alternator shaft in place and a torque spanner to tighten the pulley nut to specifications.

Tightening torque: M16 x 1.5: **95 Nm** +/- 5 Nm
M27 x 1.5: **152 Nm** +/- 17.5 Nm
