Issue no. 04/2016: Leaky oil filters: oil pressure regulating valve clogged

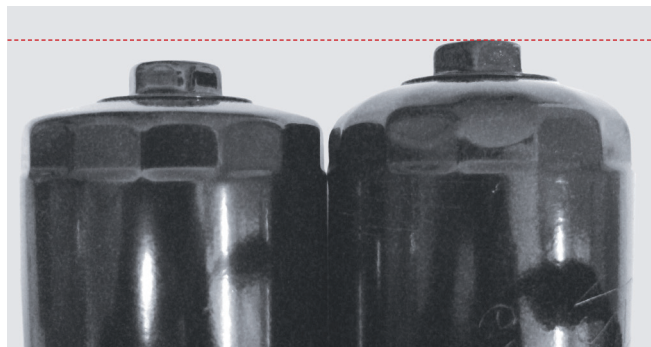
Since the oil pressure is no longer adequately regulated or may even cease to be regulated altogether, extreme pressure peaks of over 30 bar may occur as a result. The oil filter is unable to compensate for this tremendous rise in pressure and deforms (see Figure 3).

Figure 3: Oil filters, side-by-side comparison—left: normal, right: deformed

IMPORTANT! In the damage scenario described above, it is not enough to replace the filter. Make absolutely certain that you inspect and flush the entire oil circuit to remove all deposits. You may also need to replace the oil pump (with integrated regulating valve).

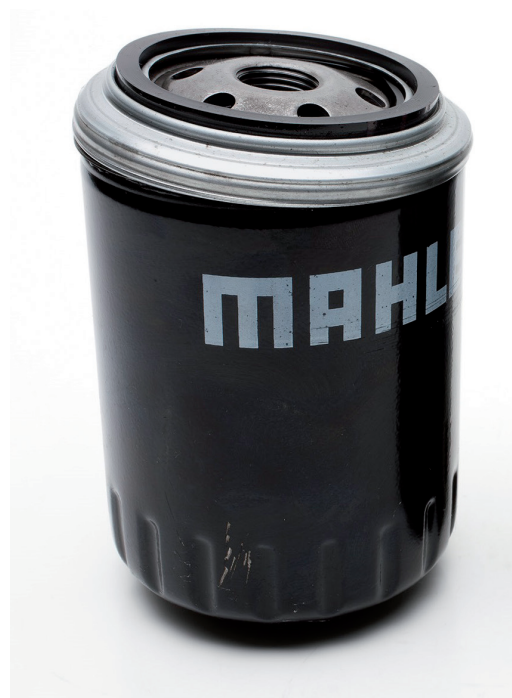
The seal may also become dislodged or the end cap may bulge significantly, giving rise to insufficient contact pressure between the seal and the filter. As a result, oil is lost directly from the screw-on flange or the filter bursts—in which case the entire end cap detaches from the housing (see Figure 4).

Figure 4: Burst oil filter
