Issue no. 03/2016: Decline in turbocharger performance—diesel particulate filter loading limit reached

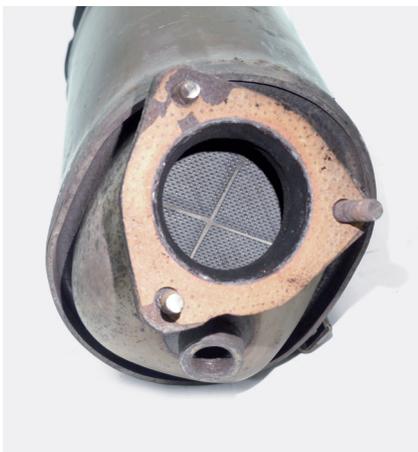
Figure 1: Disassembled diesel particulate filter

When combustion takes place in the engine, extremely fine soot particulates are created which continuously accumulate in the DPF as the exhaust gases are filtered. Unlike a catalytic converter, however, a particulate filter has a limited uptake capacity and must be regenerated or replaced at specific intervals.

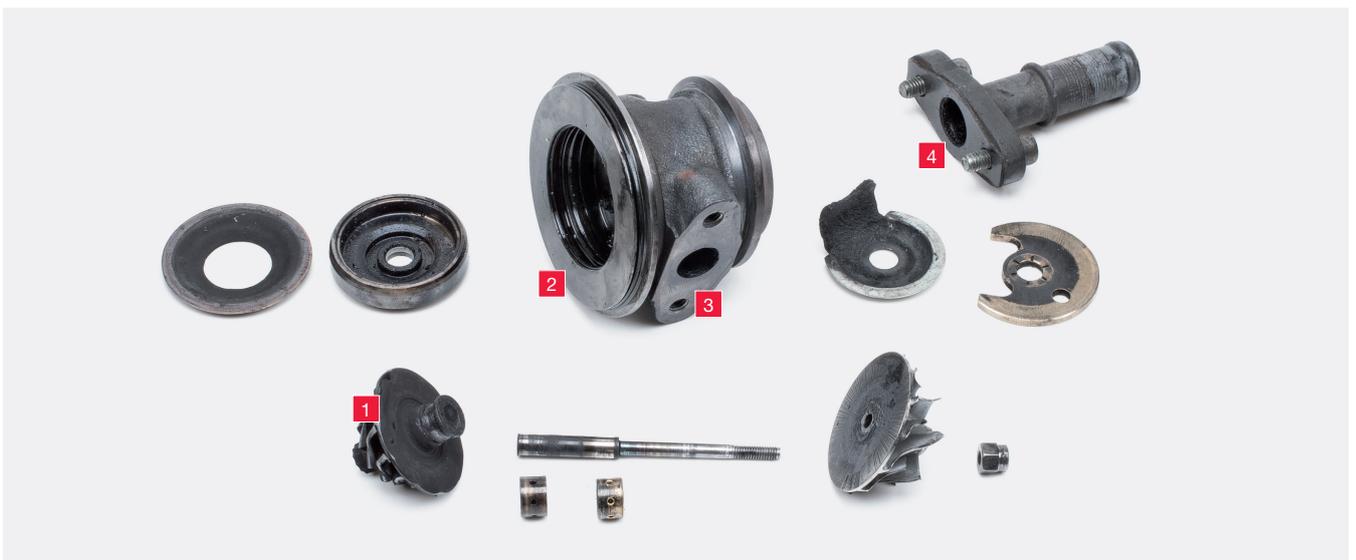
The exhaust gases flow from the engine to the turbocharger and the particulate filter. Due to the excessive counter-pressure, the exhaust gases can no longer pass through the DPF unobstructed; in the worst case, they penetrate the bearing housing, where they strip the oil film from the radial bearings (see figure 2).

Figure 2: Exhaust gas path through the bearing housing—from the turbine wheel **1** into the bearing housing **2** then through the oil drain **3** into the return line **4**

IMPORTANT! When fitting a new turbocharger, be sure to always check the loading status of the diesel particulate filter.

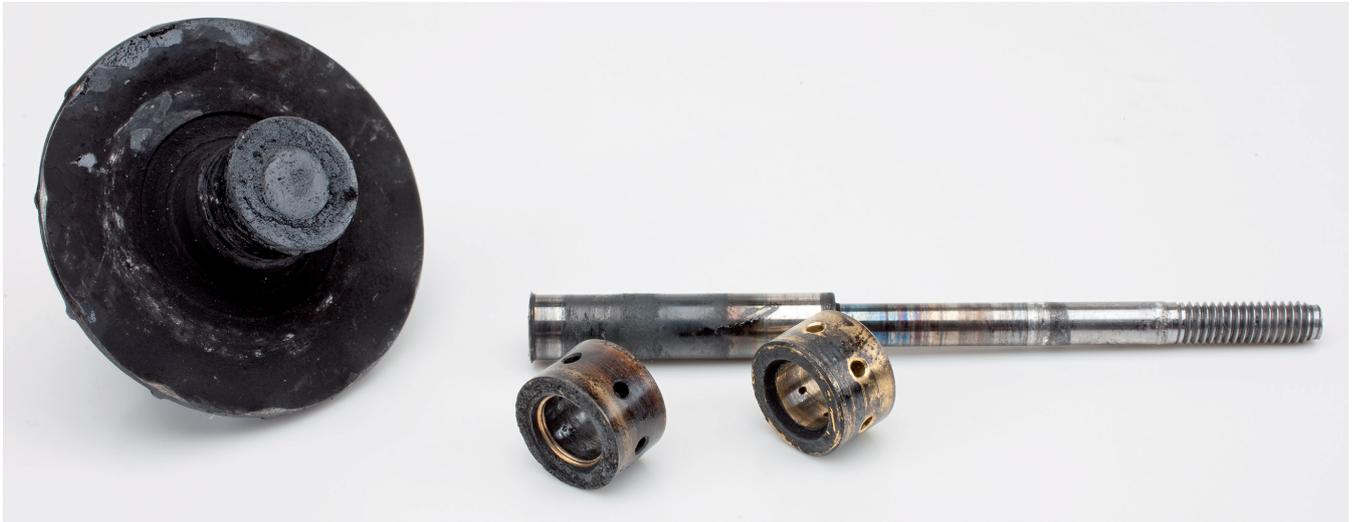
Figure 3: Broken rotor shaft due to insufficient lubrication of the radial bearings

This results in increased wear and may even lead to calcination and subsequent breakage of the rotor shaft (see figure 3). Coked residue in the oil return line to the oil sump is a clear indication of this damage scenario (see figure 4).

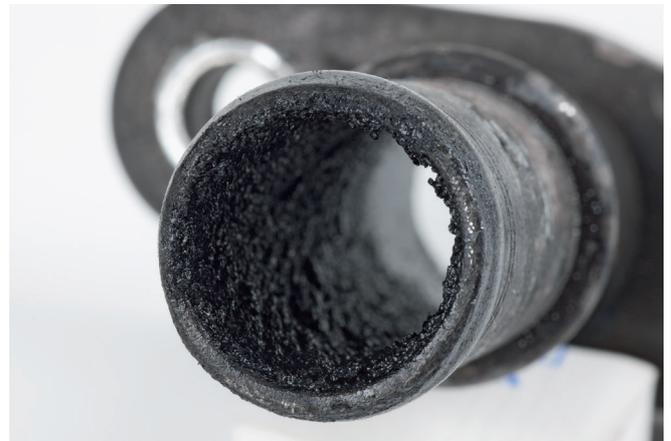
Figure 4: Coked oil return line as a result of exhaust gas penetratio
