Issue no. 09/2017: Connection defect when changing the starter motor

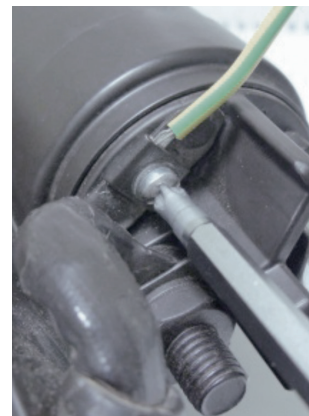
Figure 3: Cable attached to clamp 50 of the solenoid

Important: When removing the starter motor, it is recommended to label connections and cables in order to avoid confusion.
