Issue no. 04/2020

Apparent leakage in MAN radiators

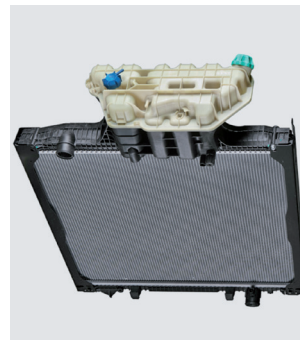
Figure 1: MAN radiator with compensating tank

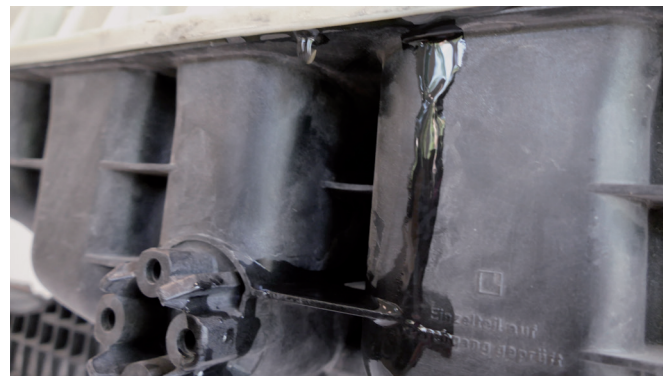
*In MAN radiators, if too much coolant is poured into the expansion tank, it escapes as the engine temperature rises and flows downward via the drains. The coolant escaping between the radiator and the expansion tank is then sometimes mistaken for a leak.*

Figure 3: Excess coolant escaping again around the joint face on the expansion tank

When filling the cooling system, it is important to proceed carefully and ensure the correct quantity of coolant is used. Coolant is also subject to wear and tear and should therefore be replaced regularly according to the manufacturer's specifications to prevent corrosion, lime, cavitation, and deposits in the cooling system. Careful venting of the cooling system prevents malfunctions due to entrapped air.
