### Issue no. 9/2016: Corrosion damage on thermostats

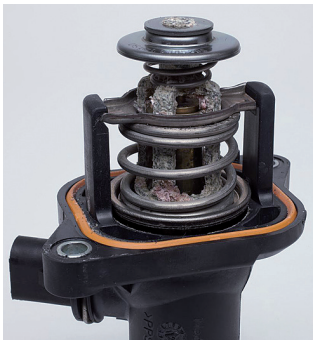
This may occur, for example if the wrong coolant additive is used. Not all additives can be mixed together, and they can even corrode aluminium components (see Figures 1 and 2). The use of tap water containing minerals can also have a negative effect, and a defective earthing cable accelerates damage due to electrolysis.

Figure 1: Obvious signs of corrosion on a map-controlled thermostat (Type TM).

To prevent this phenomenon, fill the cooling circuit with manufacturer-approved coolant additives only, taking care to use the proper ratio of coolant to water. Some vehicle manufacturers also prescribe the use of distilled water. Equipotential bonding between the engine and car body must also be ensured: earthing cables must not show signs of damage (see Figure 3).

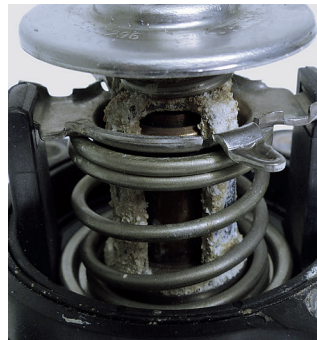
Figure 2: The aluminium has been completely eaten away due to the use of non-approved coolant additives.

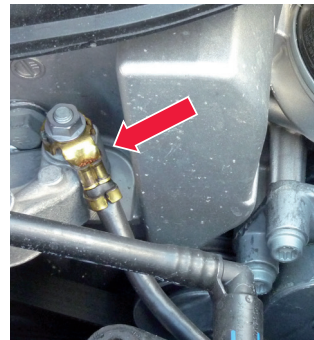
Figure 3: Check the earthing cable to ensure it is properly connected and free of damage.
